SIB 11 07 24

RECALL 24V-608: WATER PUMP ELECTRICAL CONNECTOR – RETROFIT SPLASH PROTECTION CAP

2026-04-17

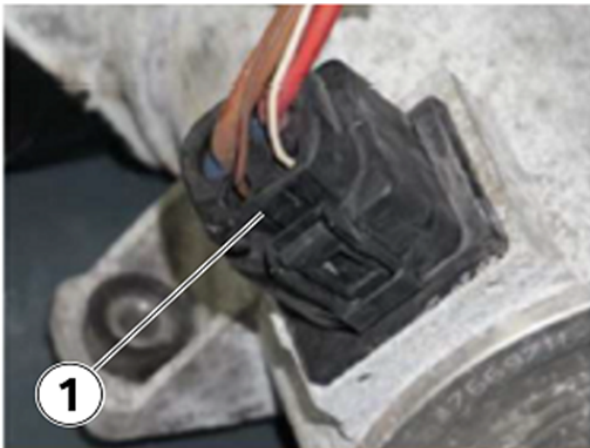
Water pump connector on 400-W electric water pump (1) requires a shield covering on the connector.

Model Vehicles	Splash Guard/Protection Cap Part Number
E84 X1 xDrive28i (All-Wheel Drive Only)	Part Number 61 13 5B6CD47
Or:	
All other Model Vehicles including the E84 X1 sDrive28i (Rear-Wheel Drive)	Part Number 61 13 5B68D04

Follow the procedure in the attachment (B110724_AT_1 SR Repair Procedure).

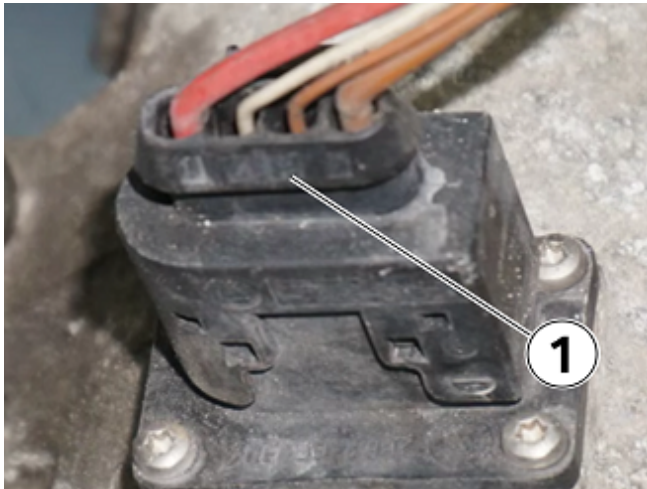
Vehicles with this style pump/connector (shown below) do not require any type of connector shield retrofit or repair.

The 200-W electric water pump engine harness socket and plug connector (1).

For these vehicles, reinstall the components that were removed to perform the required engine harness socket and plug connector inspection.

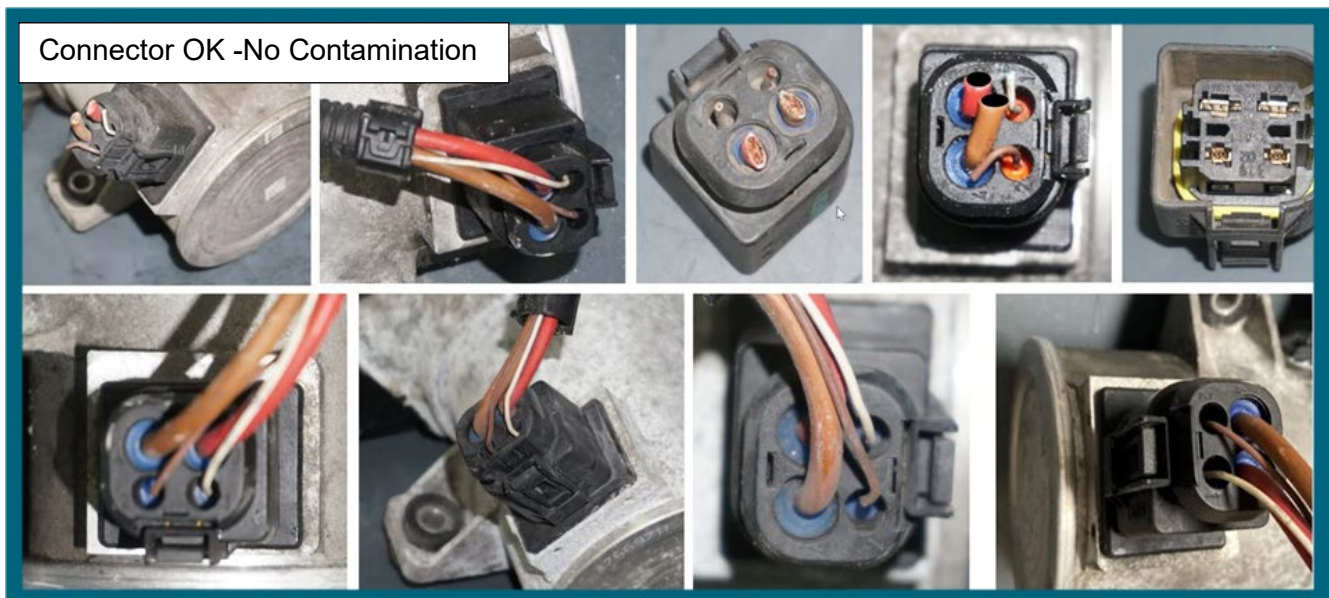
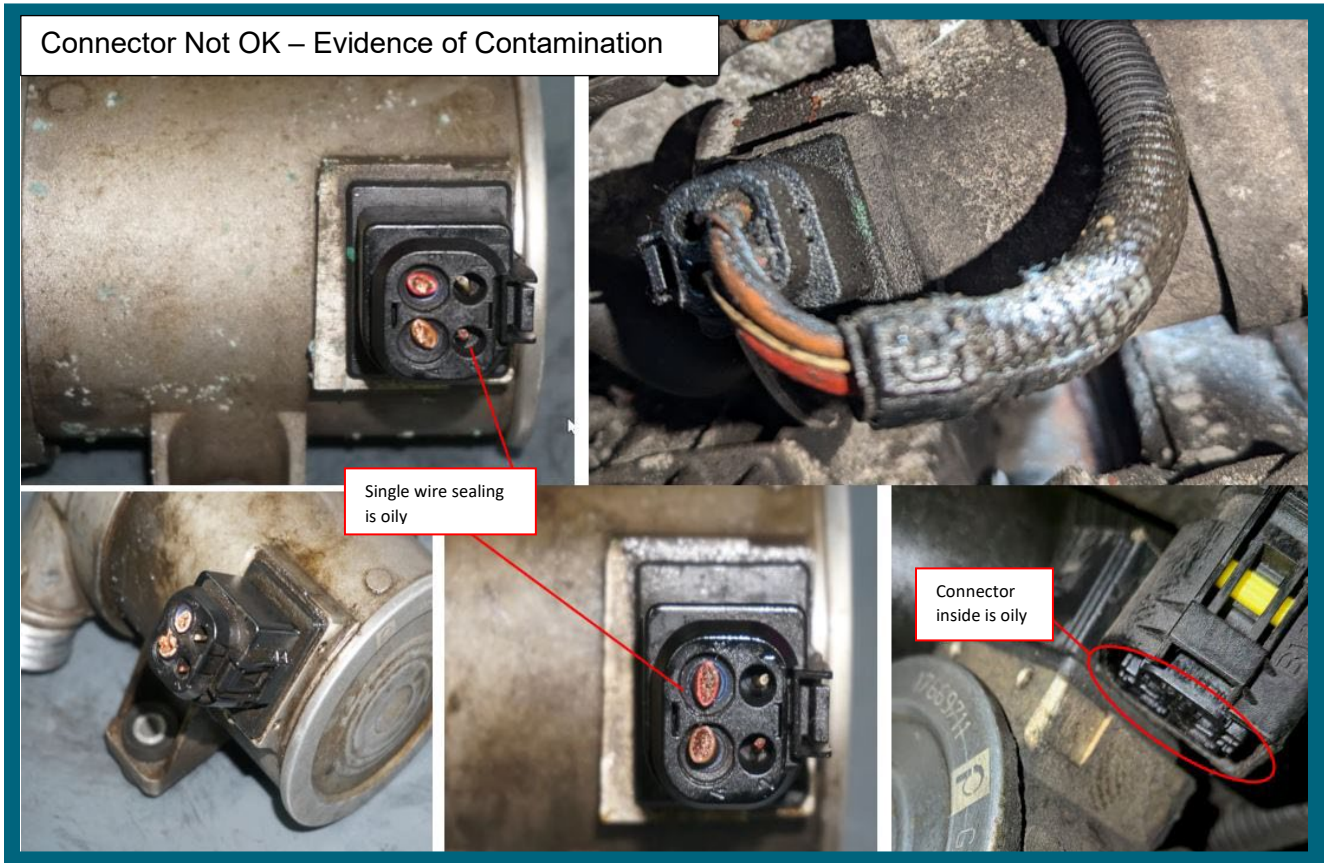
Check the connector for any oily or wet residue on the wiring on the back of the connector. Refer to the illustrations for examples of clean or contaminated connectors.

If the connector is dry or no contamination proceed to **Procedure 2.**

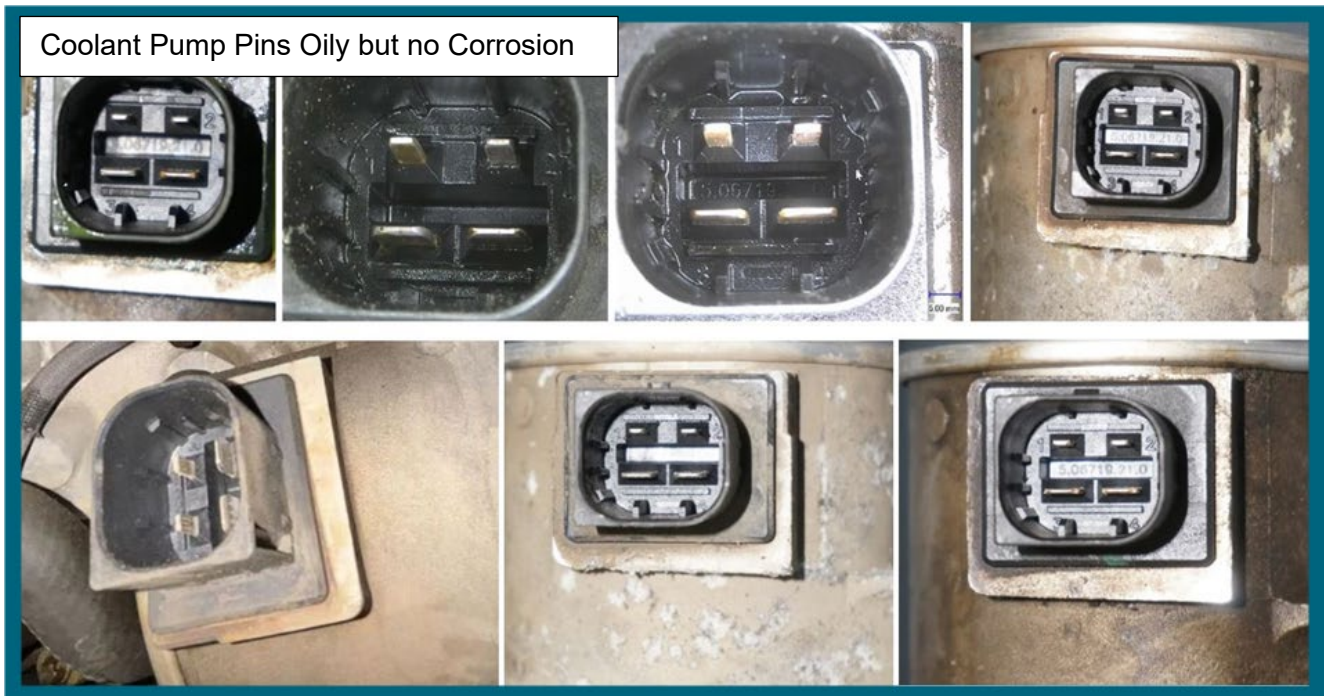
If there is contamination, check the extent of oil residue on the inside of the connection on the coolant pump (illustrations below).

Oil contamination on the connector or oil residue has made it into the connector on the coolant pump:

Replace the connector housing and the pins on the coolant pump connector (wire harness side).
Follow Repair Instruction **REP 6113 4-pin in-line connector, DFK ELA system.**

Clean the connector pins on the coolant pump with a suitable spray cleaner (electronics spray cleaner or spray brake cleaner).

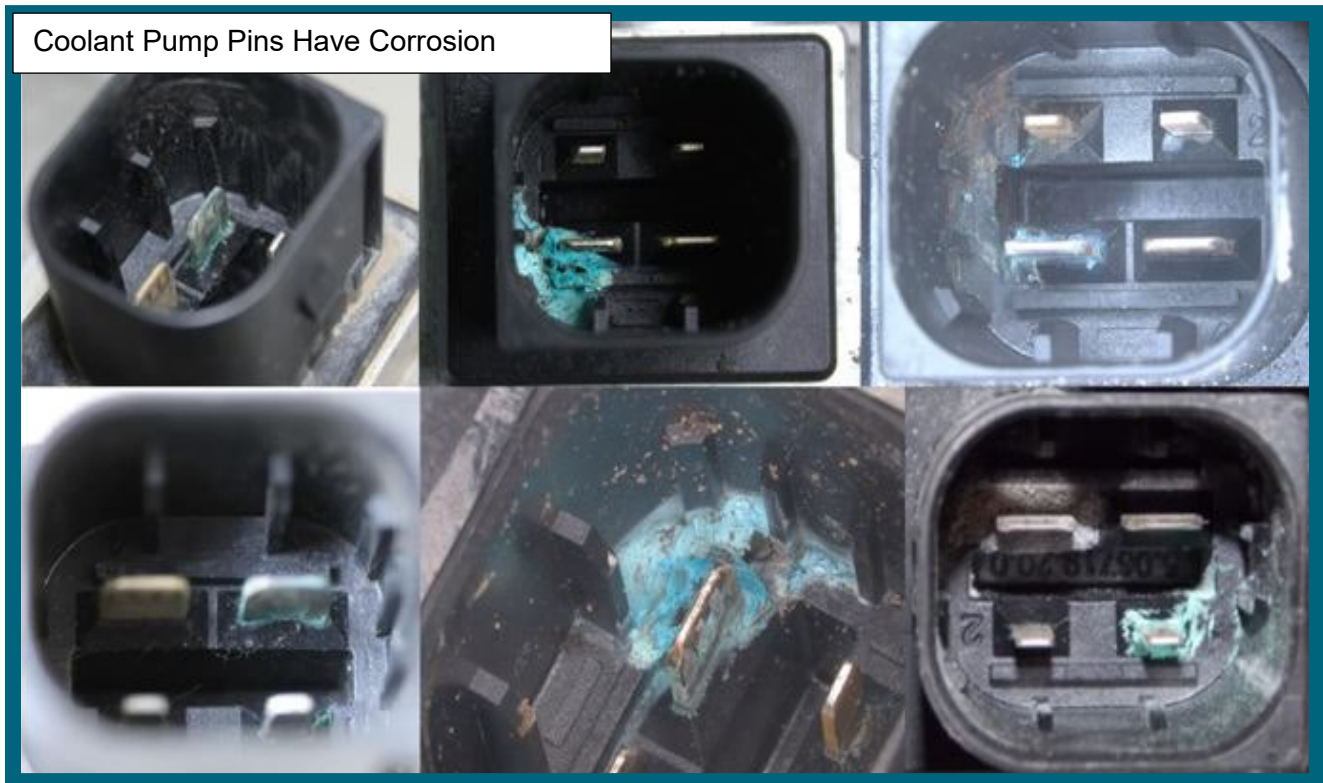
There is oil contamination and the pins on the coolant pump pins show signs of corrosion (illustration above).

Replace the coolant pump following Repair instruction **REP 1151100 Remove and install/replace coolant pump.**

Replace the connector housing and the pins on the coolant pump connector (wire harness side). Follow Repair Instruction **REP 6113 4-pin in-line connector, DFK ELA system.**
