SIB 11 07 24

## RECALL 24V-608: WATER PUMP ELECTRICAL CONNECTOR – RETROFIT SPLASH PROTECTION CAP

This Service Information Bulletin (Revision 6) replaces SI B11 07 24 **dated May 2025**.

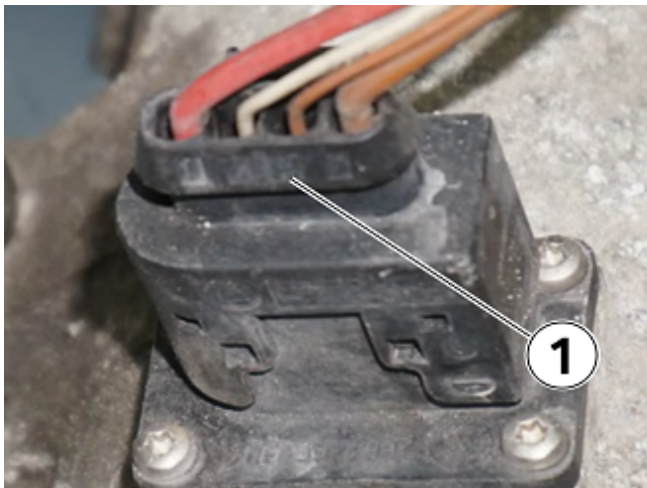
**Vehicles with this style pump/connector (shown below) do not require any type of connector shield retrofit or repair.**

The 200-W electric water pump engine harness socket and plug connector (1).

For these vehicles, reinstall the components that were removed to perform the required engine harness socket and plug connector inspection.

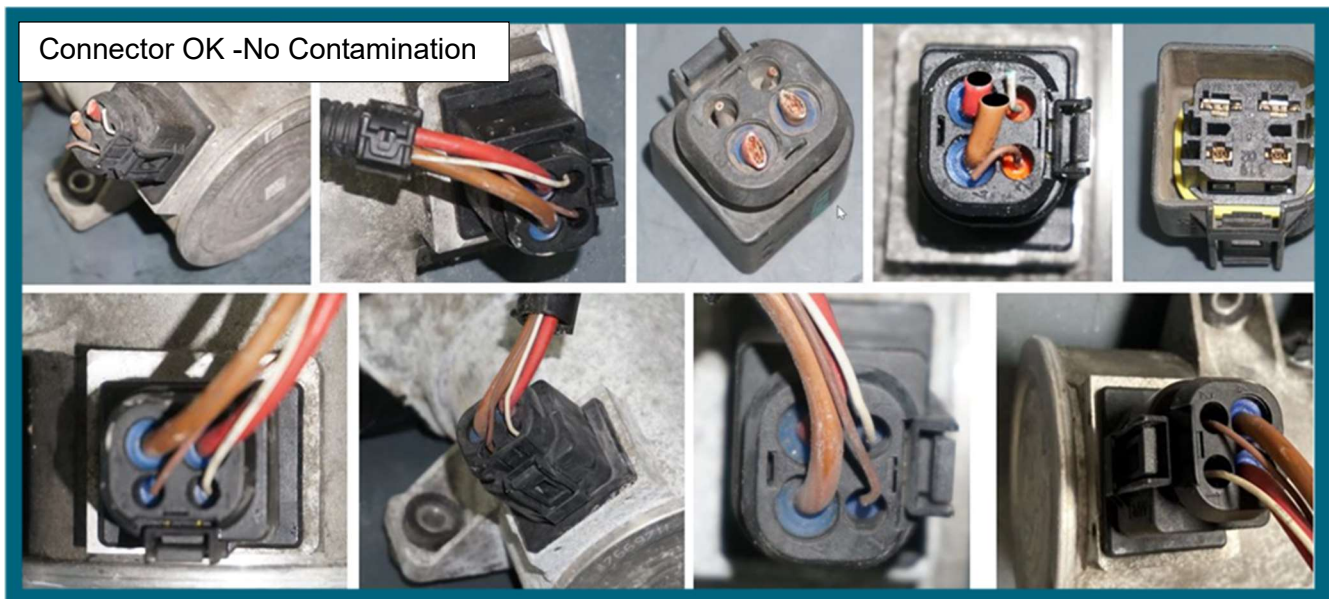
Check the connector for any oily or wet residue on the wiring on the back of the connector. Refer to the illustrations for examples of clean or contaminated connectors.

If the connector is dry or no contamination proceed to **Procedure 2.**

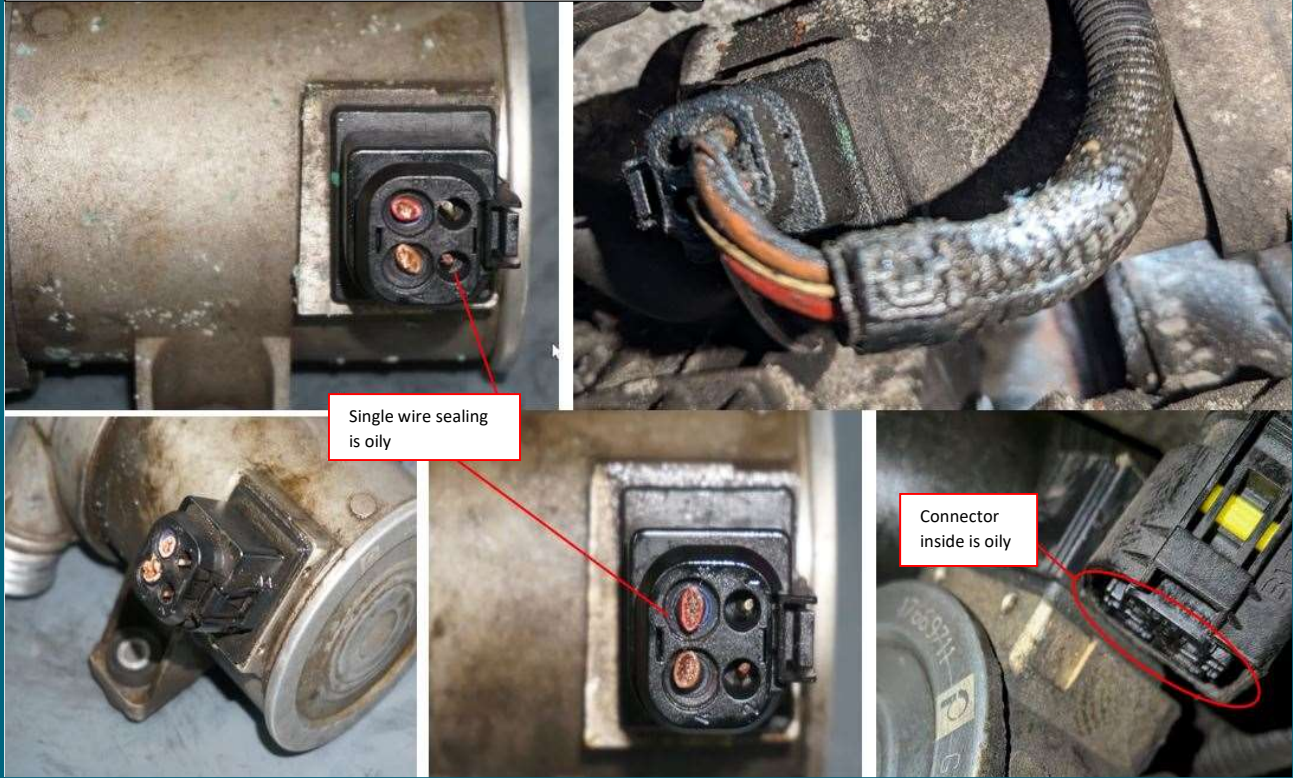
Connector Not OK – Evidence of Contamination

If there is contamination, check the extent of oil residue on the inside of the connection on the coolant pump (illustrations below).

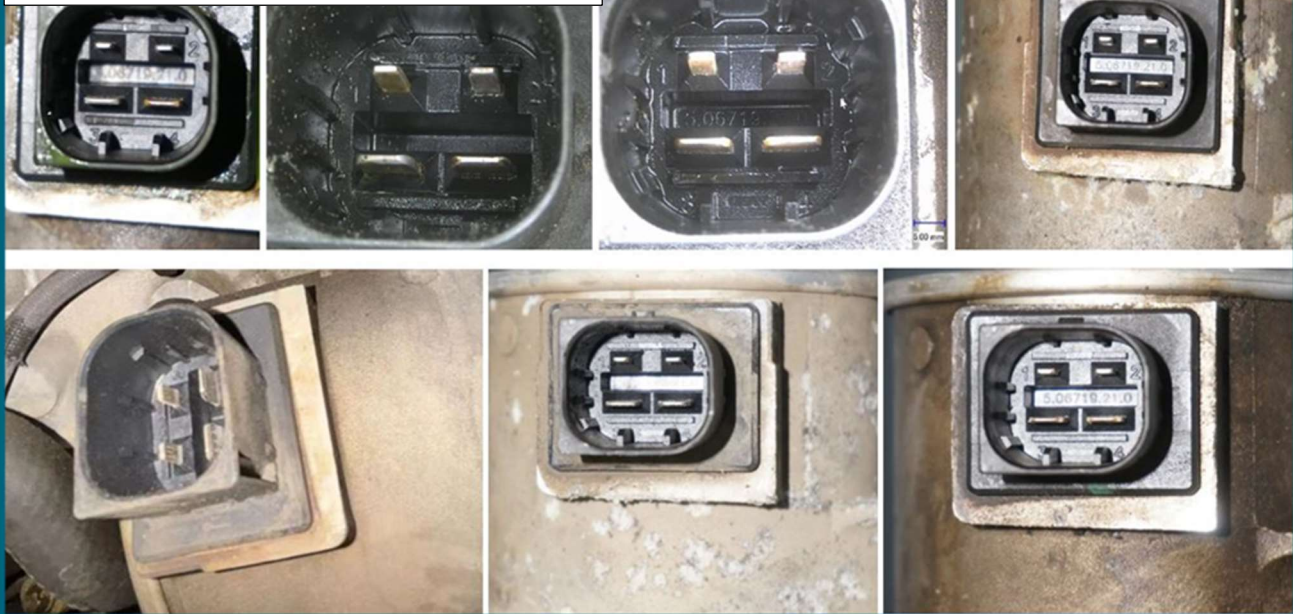
Coolant Pump Pins Oily but no Corrosion

Oil contamination on the connector or oil residue has made it into the connector on the coolant pump:

Replace the connector housing and the pins on the coolant pump connector (wire harness side).  
Follow Repair Instruction **REP 6113 4-pin in-line connector, DFK ELA system**.

Clean the connector pins on the coolant pump with a suitable spray cleaner (electronics spray cleaner or spray brake cleaner).

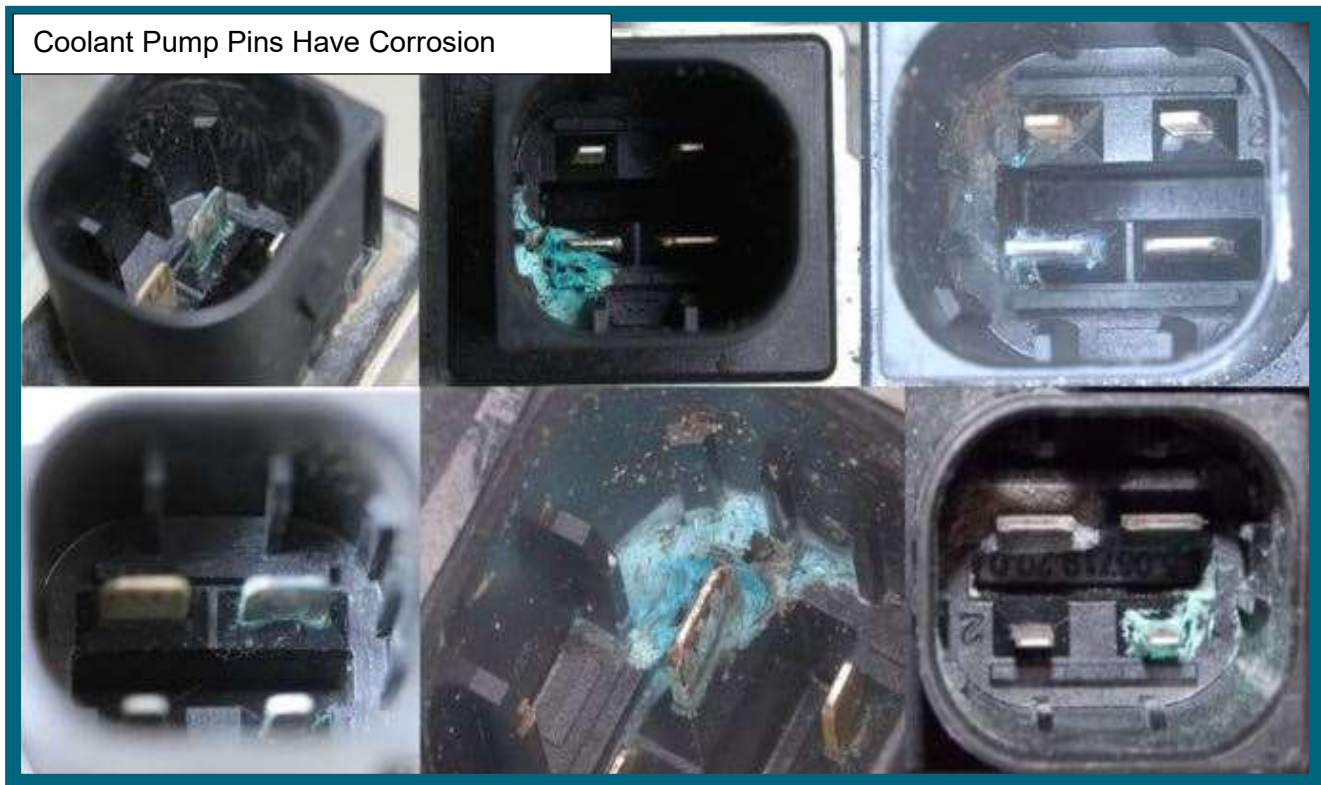
There is oil contamination and the pins on the coolant pump pins show signs of corrosion (illustration above).

Replace the coolant pump following Repair instruction **REP 1151100 Remove and install/replace coolant pump.**

Replace the connector housing and the pins on the coolant pump connector (wire harness side). Follow Repair Instruction **REP 6113 4-pin in-line connector, DFK ELA system.**

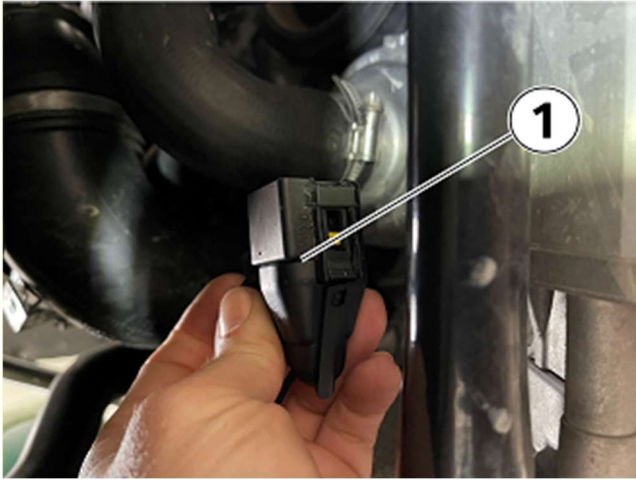
- Proper seating of the protective shield over the electrical connector for the water pump (1)

Reinstall the clean air pipe (**REP 1371165 Remove clean air pipe at bottom**).
