SIB 11 07 24

RECALL 24V-608: WATER PUMP ELECTRICAL CONNECTOR – RETROFIT SPLASH PROTECTION CAP

2026-01-02

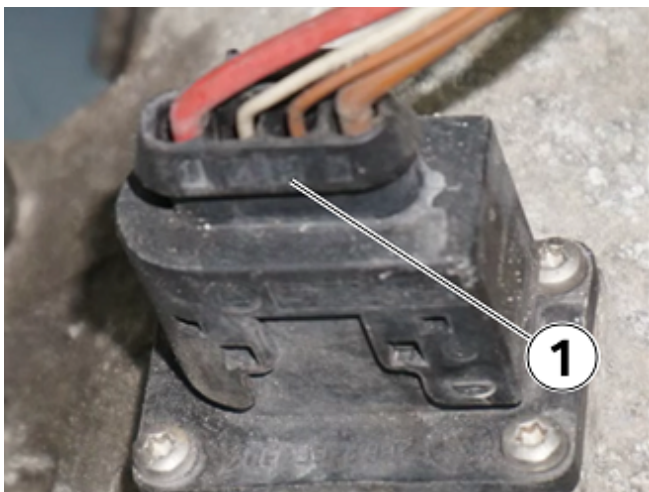
Vehicles with this style pump/connector (shown below) do not require any type of connector shield retrofit or repair.

The 200-W electric water pump engine harness socket and plug connector (1).

For these vehicles, reinstall the components that were removed to perform the required engine harness socket and plug connector inspection.

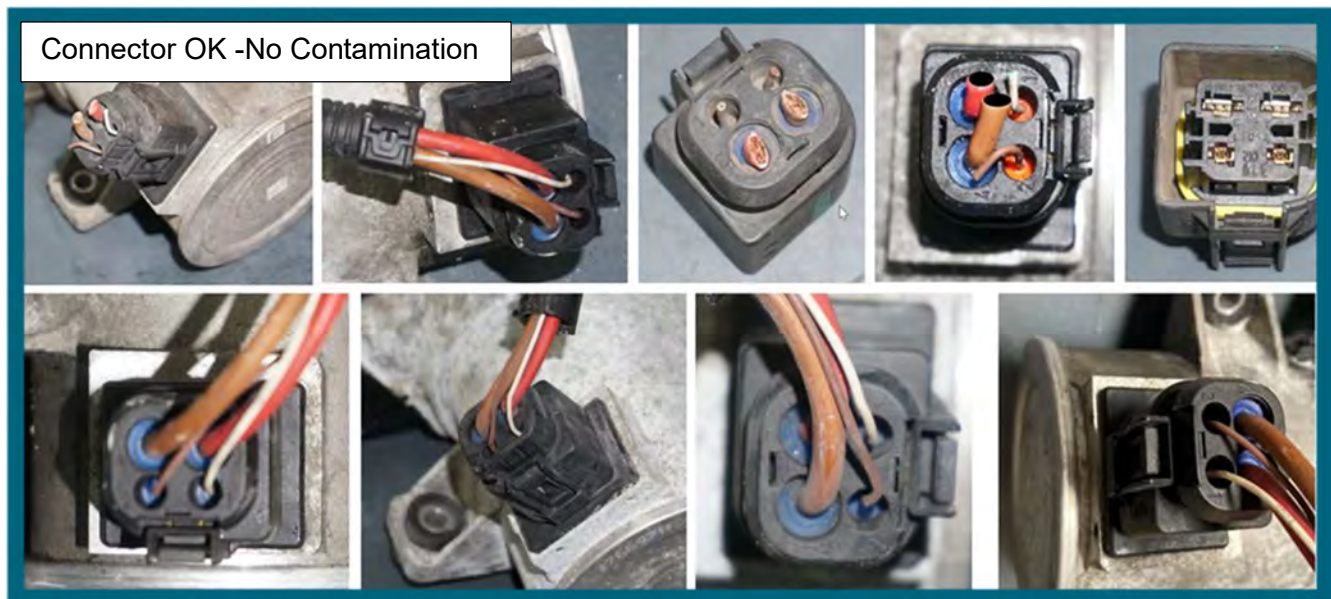
Check the connector for any oily or wet residue on the wiring on the back of the connector. Refer to the illustrations for examples of clean or contaminated connectors.

If the connector is dry or no contamination proceed to **Procedure 2.**

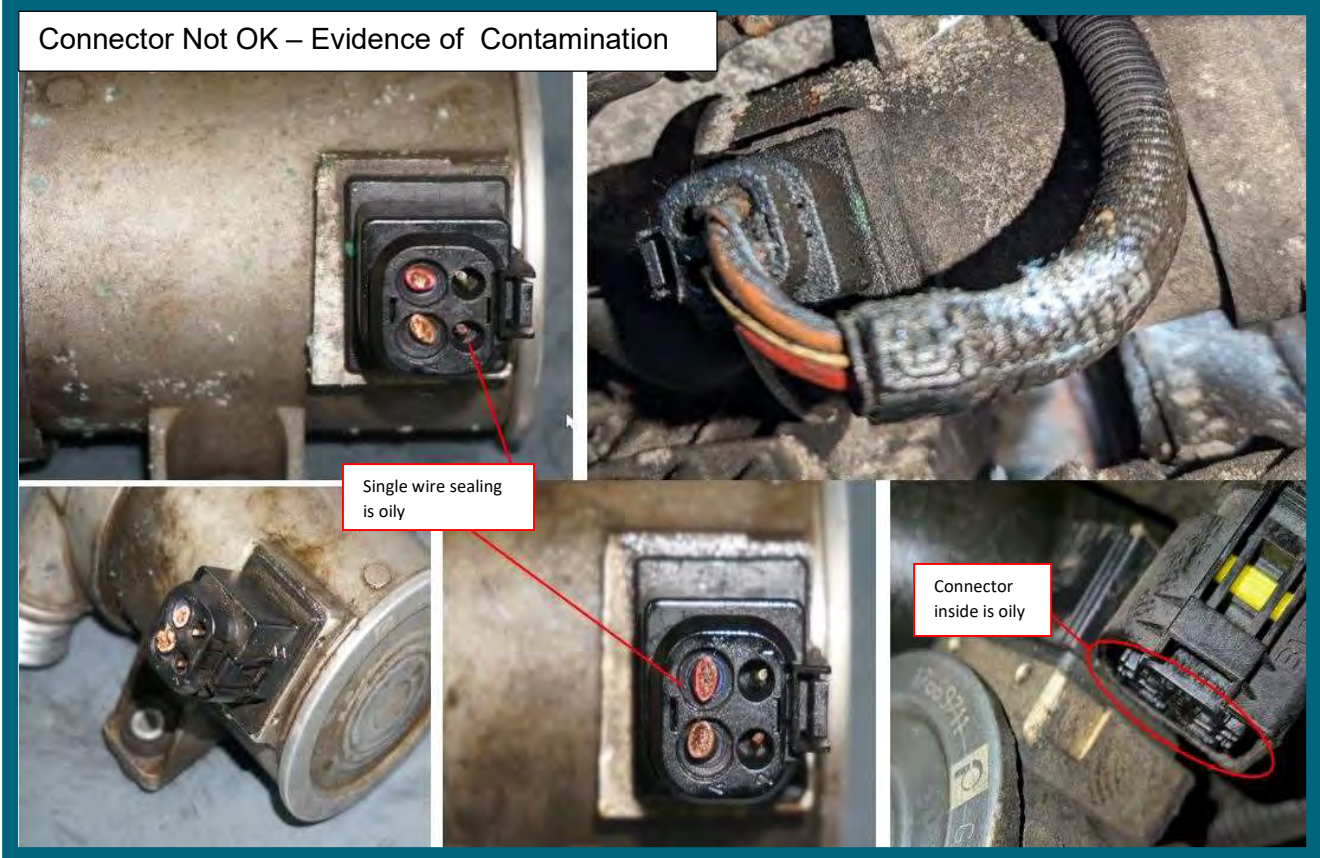
Connector Not OK – Evidence of Contamination

Single wire sealing is oily

Connector inside is oily

If there is contamination, check the extent of oil residue on the inside of the connection on the coolant pump (illustrations below).

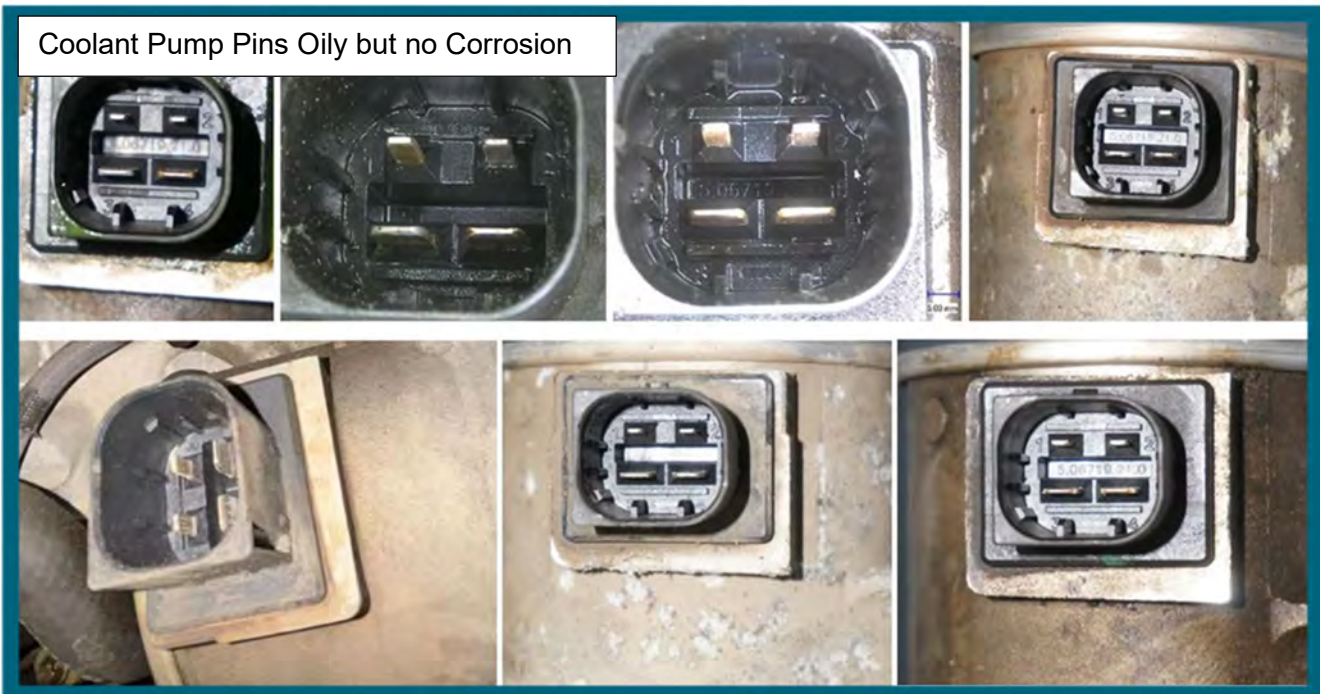
Coolant Pump Pins Oily but no Corrosion

Oil contamination on the connector or oil residue has made it into the connector on the coolant pump:

Replace the connector housing and the pins on the coolant pump connector (wire harness side).
Follow Repair Instruction **REP 6113 4-pin in-line connector, DFK ELA system**.

Clean the connector pins on the coolant pump with a suitable spray cleaner (electronics spray cleaner or spray brake cleaner).
