SIB 11 07 24

RECALL 24V-608: WATER PUMP ELECTRICAL CONNECTOR – RETROFIT SPLASH PROTECTION CAP

This Service Information Bulletin (Revision 7) replaces SI B11 07 24 **dated May 2025**.

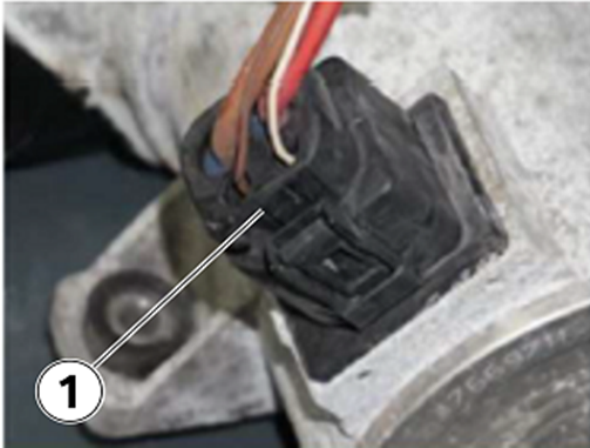
Vehicles Equipped with a 400-Watt Electric Coolant Pump

Small droplets of liquid from the positive crankcase ventilation (PVC) system could drip onto and penetrate into the coolant pump's electrical socket and plug connector.

Over time, this situation could lead to a short circuit and, in rare cases, a thermal event.

Water pump connector on 400 W electric water pump (1) require a shield covering on the connector.

2. All Affected Vehicles, retrofit the splash guard/protection cap on the electrical plug connector for the electric coolant pump.

Follow the procedure in the attachment (B110724_AT_1 SR Repair Procedure).

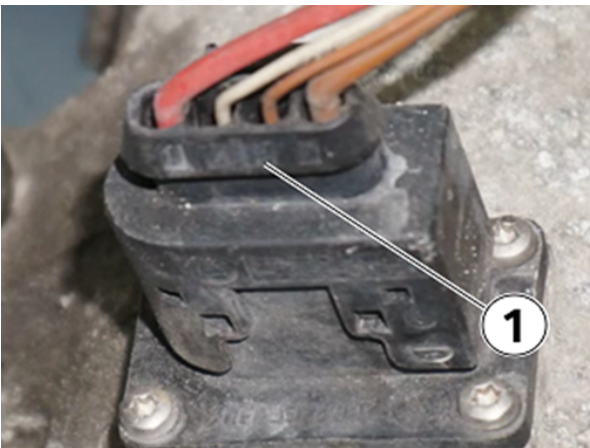
Vehicles Equipped with a 200-Watt Electric Coolant Pump

Vehicles with this style pump/connector (shown below) do not require any type of connector shield retrofit or repair.

The 200-W electric water pump engine harness socket and plug connector (1).

For these vehicles, reinstall the components that were removed to perform the required engine harness socket and plug connector inspection.
