## SIB 11 07 24

### RECALL 24V-608: WATER PUMP ELECTRICAL CONNECTOR – RETROFIT SPLASH PROTECTION CAP

2026-02-18

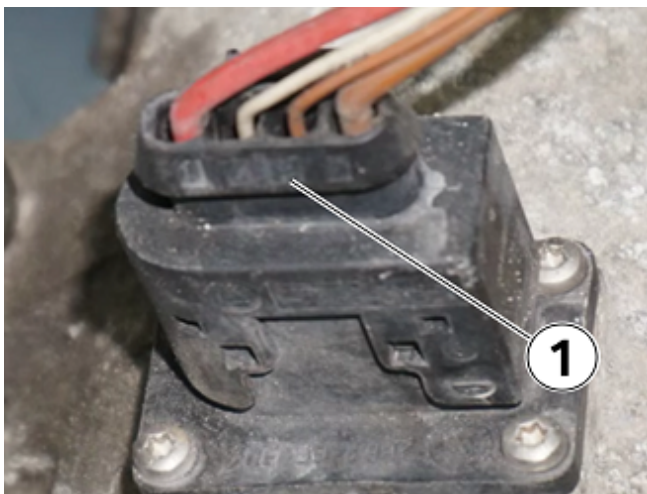
**Vehicles with this style pump/connector (shown below) do not require any type of connector shield retrofit or repair.**

The 200-W electric water pump engine harness socket and plug connector (1).

For these vehicles, reinstall the components that were removed to perform the required engine harness socket and plug connector inspection.

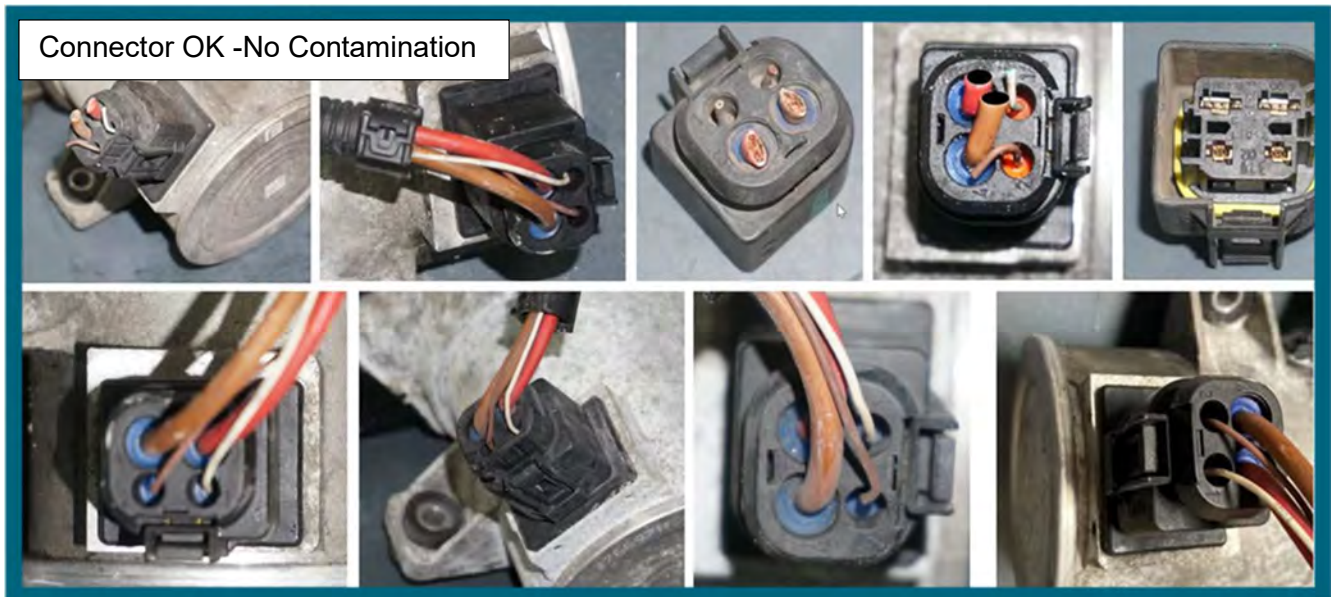
Check the connector for any oily or wet residue on the wiring on the back of the connector. Refer to the illustrations for examples of clean or contaminated connectors.

If the connector is dry or no contamination proceed to **Procedure 2.**

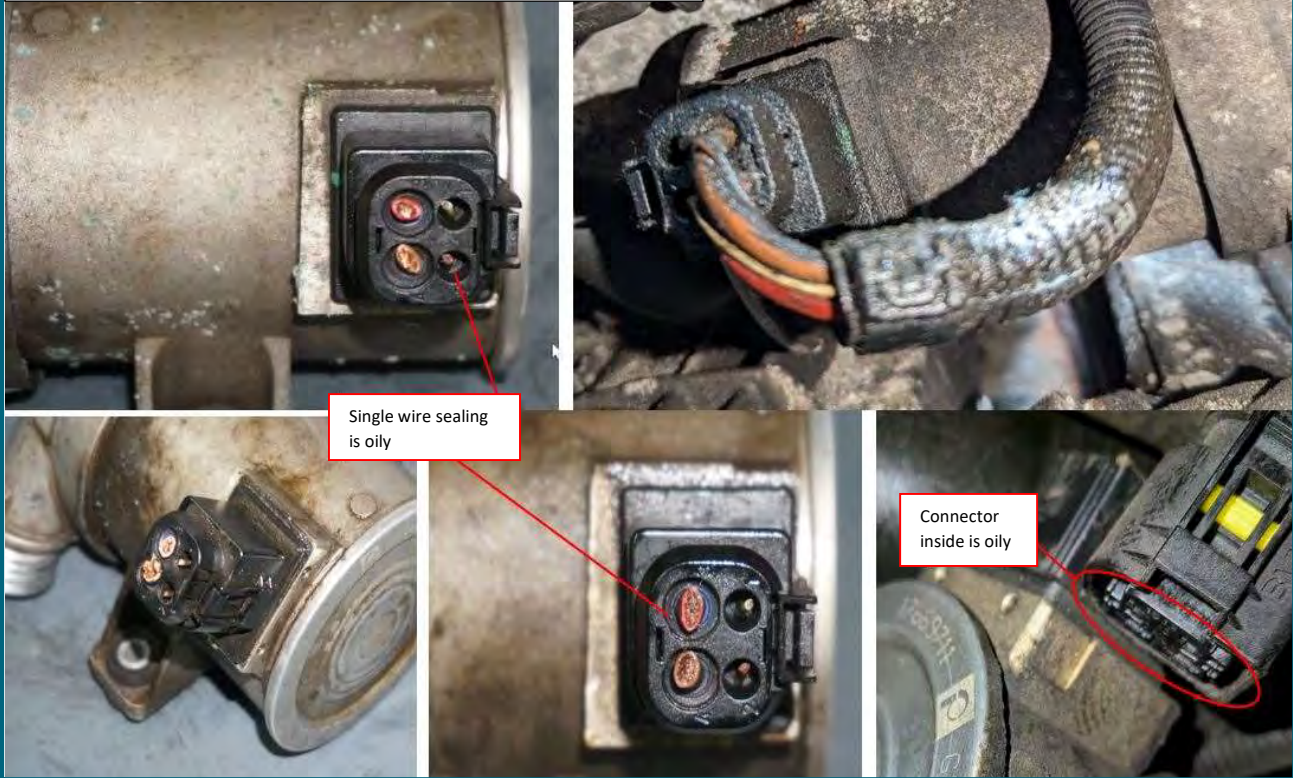
Connector Not OK – Evidence of Contamination

If there is contamination, check the extent of oil residue on the inside of the connection on the coolant pump (illustrations below).

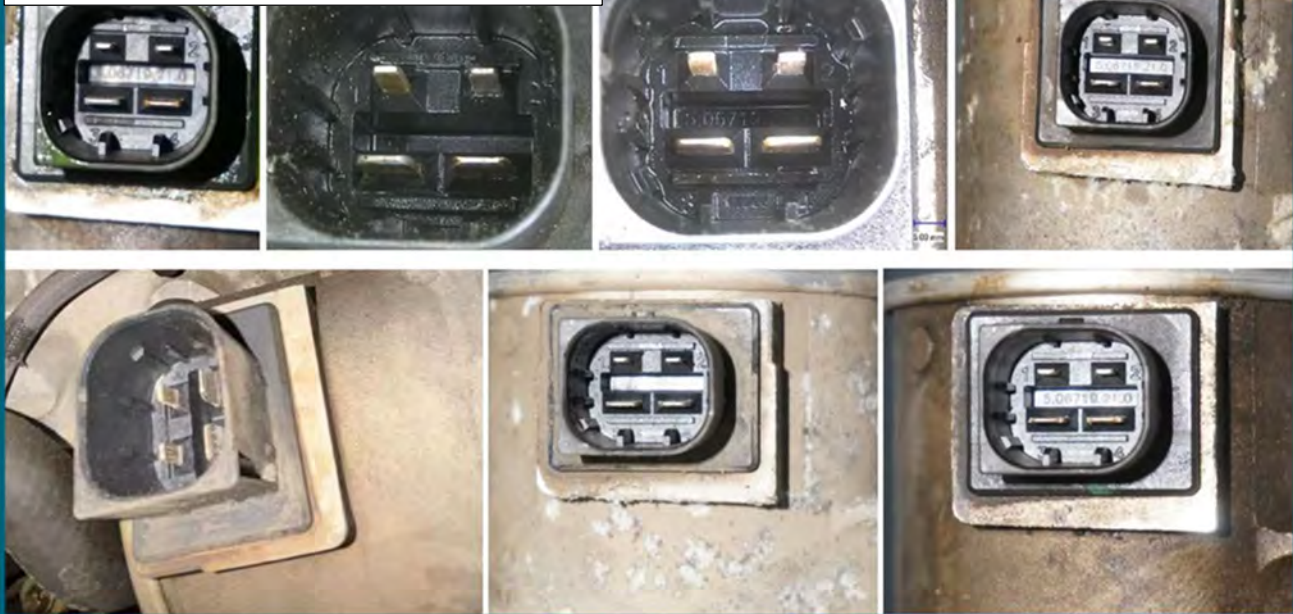
Coolant Pump Pins Oily but no Corrosion

Oil contamination on the connector or oil residue has made it into the connector on the coolant pump:

Replace the connector housing and the pins on the coolant pump connector (wire harness side).  
Follow Repair Instruction **REP 6113 4-pin in-line connector, DFK ELA system**.

Clean the connector pins on the coolant pump with a suitable spray cleaner (electronics spray cleaner or spray brake cleaner).

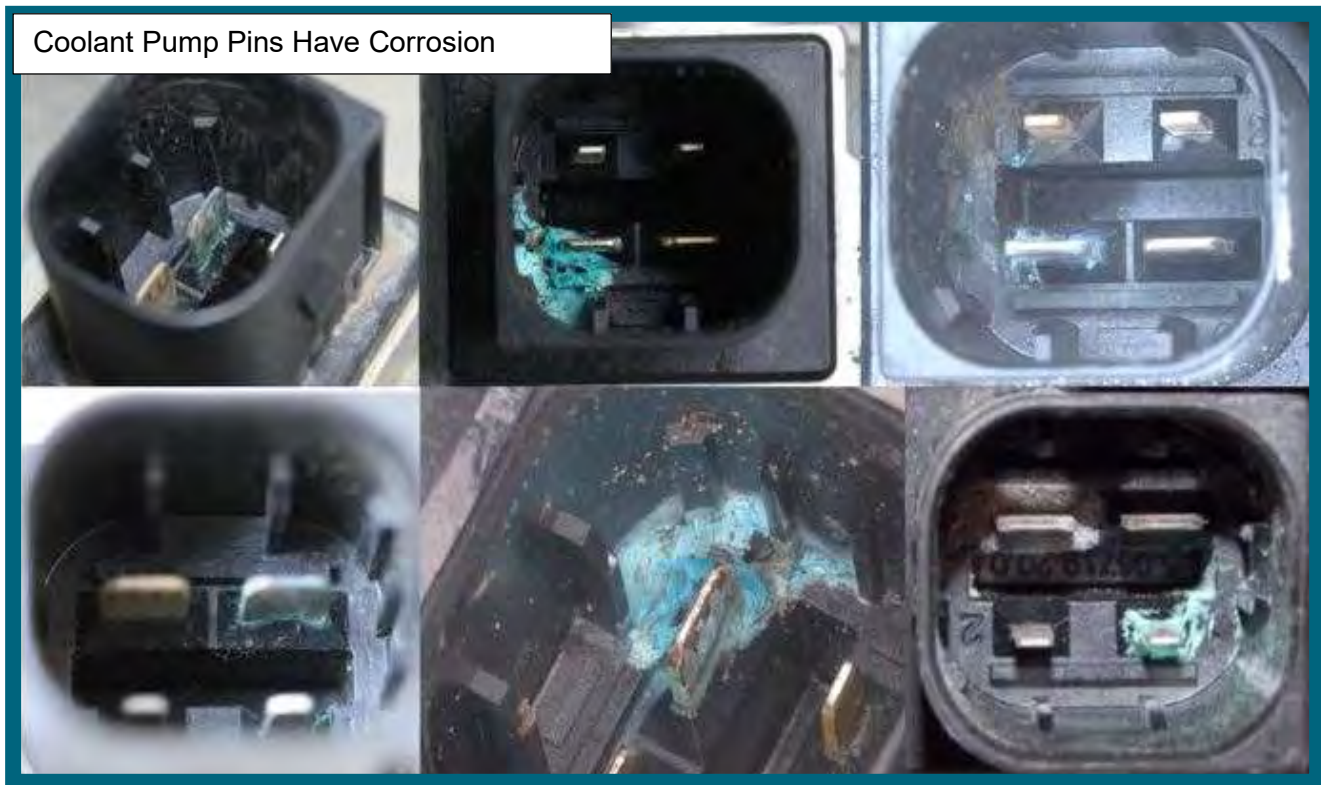
There is oil contamination and the pins on the coolant pump pins show signs of corrosion (illustration above).

Replace the coolant pump following Repair instruction **REP 1151100 Remove and install/replace coolant pump.**

Replace the connector housing and the pins on the coolant pump connector (wire harness side). Follow Repair Instruction **REP 6113 4-pin in-line connector, DFK ELA system.**
