This Service Information Bulletin (Revision 1) replaces SI B41 04 24 **dated August 2024**.

RE: Recall 24V-611: Rear Side Member – B41 04 24

Safety Recall
24V-611
Chassis
Model Year 2024
BMW i4
Issue Date: 08/09/2024

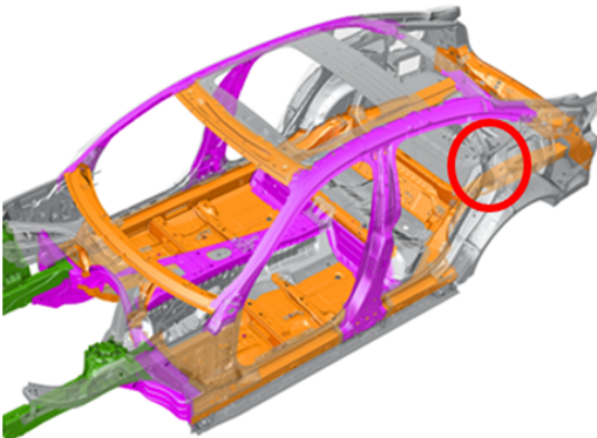
The left rear frame rail may not have been produced to specifications, and could contain a crack/tear.

Via an access hole in the left rear wheelwell cargo area, inspect the vehicle’s left rear frame rail using a borescope.

- If no crack/tear is observed, no further work is needed
- If a crack/tear is observed, replace the frame rail

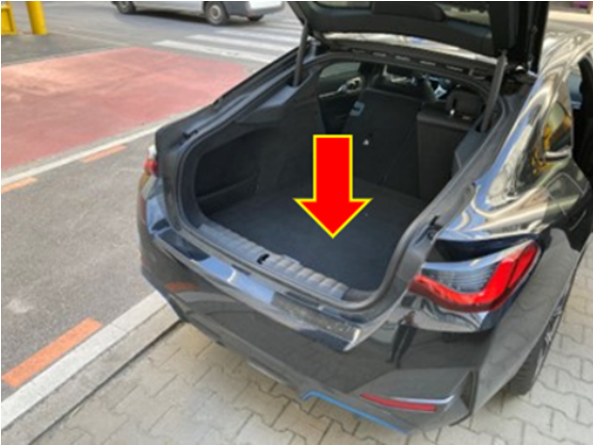
1. Open the tailgate and remove the floor panel (arrow).

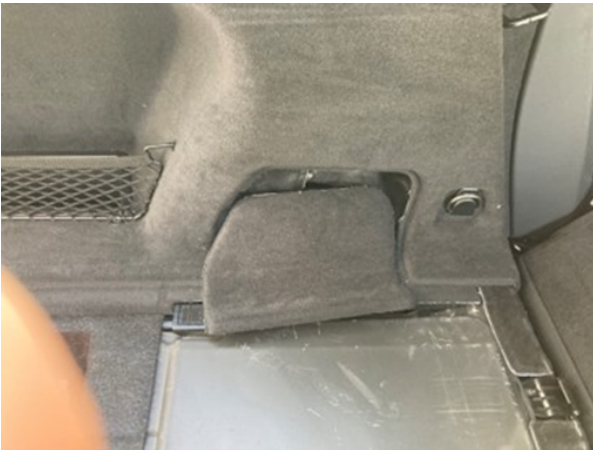
2. Remove the left side cover panel.

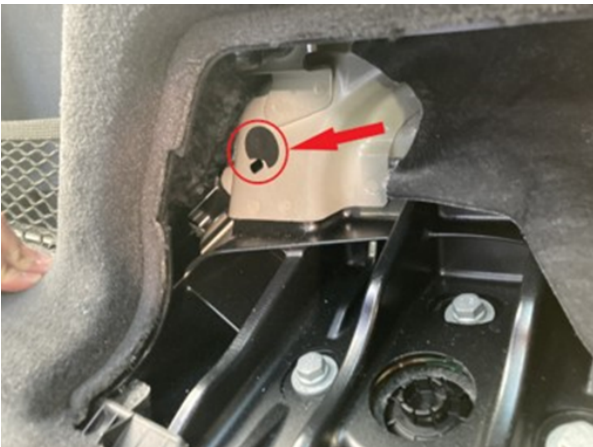
3. Remove the body plug circled in the photo.

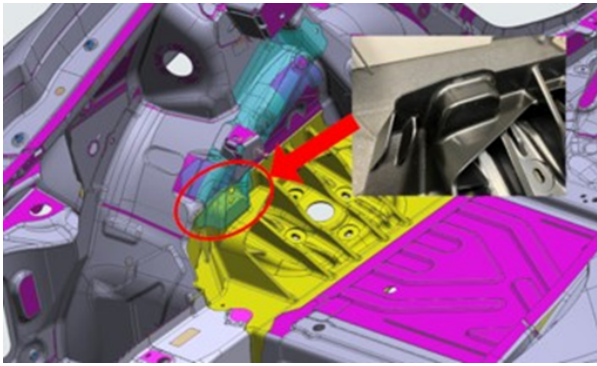
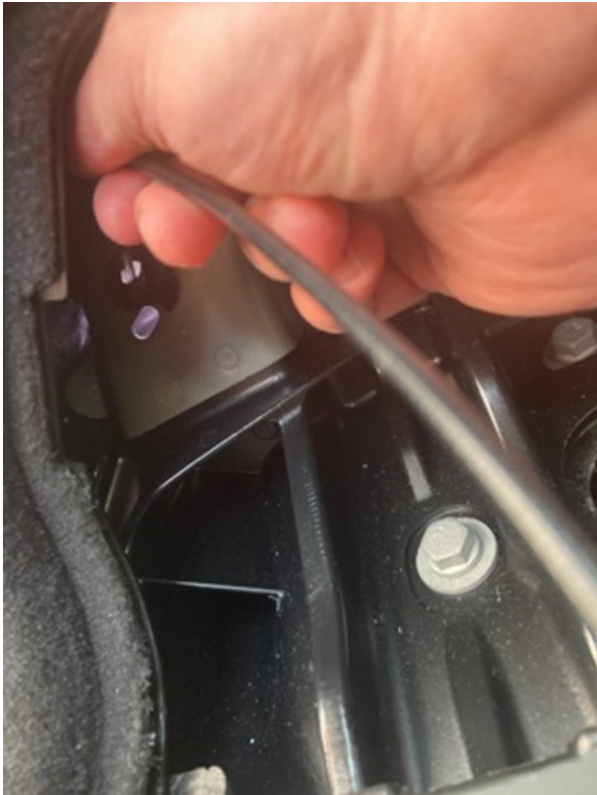
4. Area to be inspected, with the red arrow pointing to the frame rail.

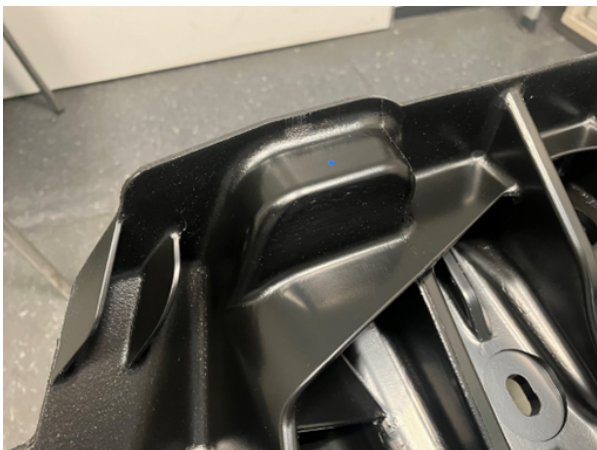
Photo is showing a **GOOD** frame rail.

- 6. No cracks/tears found: Apply sealing film over the access hole used to insert the borescope.
- 7. Crack/tear found: Submit a TSARA info-only case titled “Left frame rail recall” and instructions will be provided.
- 8. Reassemble the vehicle once body work is completed.

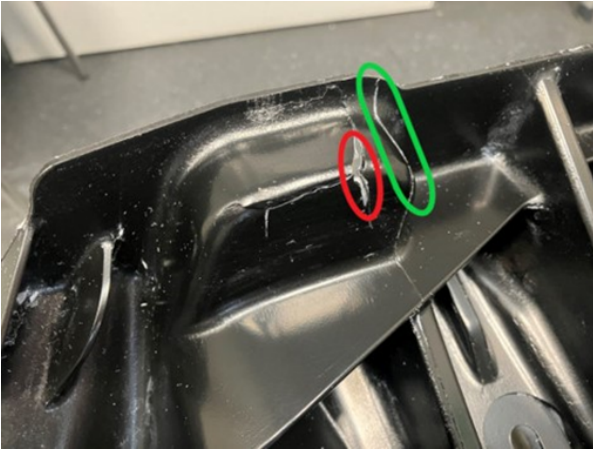
Photo is showing a **BAD** (cracked/torn per red circle) frame rail.

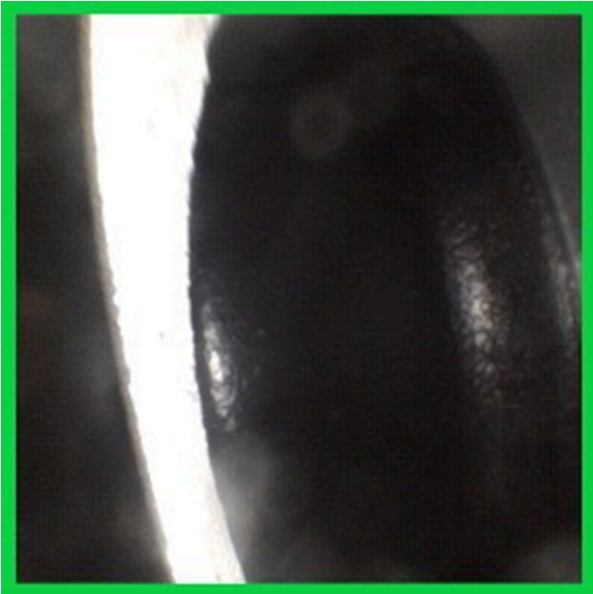
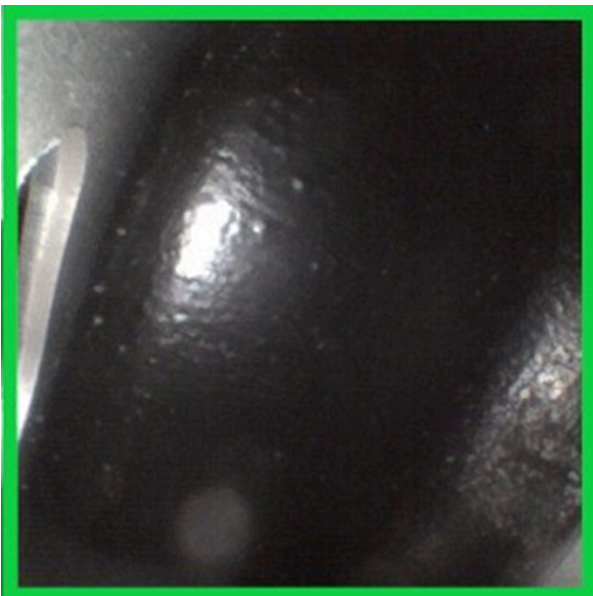
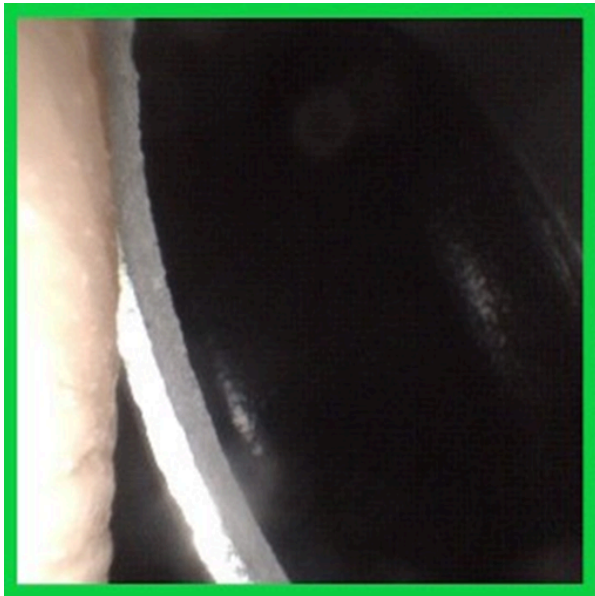
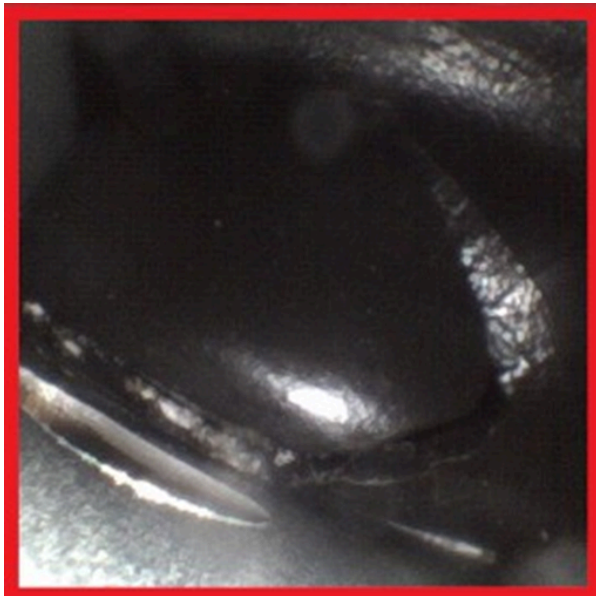
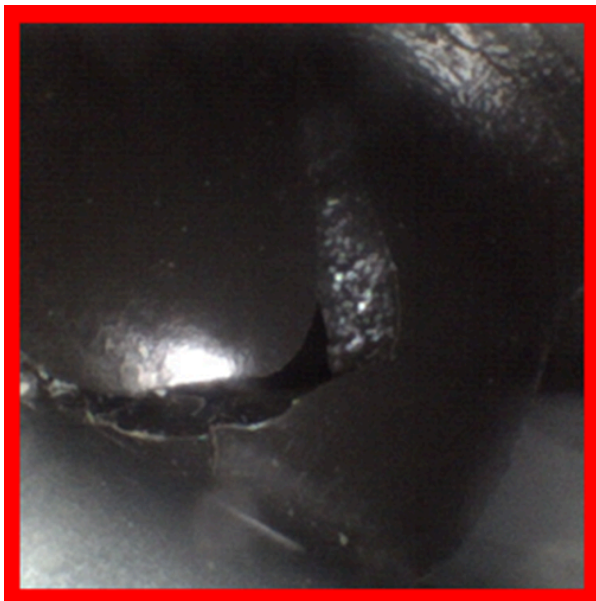
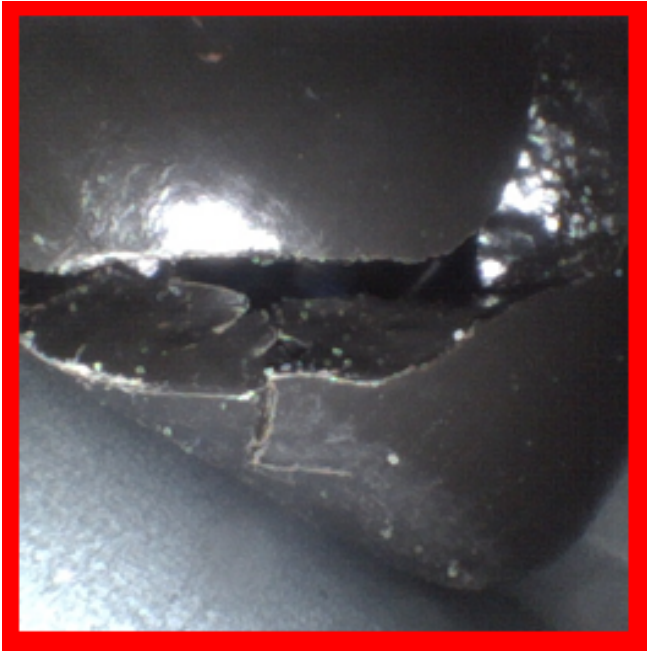
The area in the green circle is OK; it is a normal metal seam/parting line and not to be confused with being a crack.
