Tesla, Inc.
Service Bulletin

Inspect Front Roof and Center Spine Appliques for Lack of Adhesion

SB-24-12-008
August 30, 2024

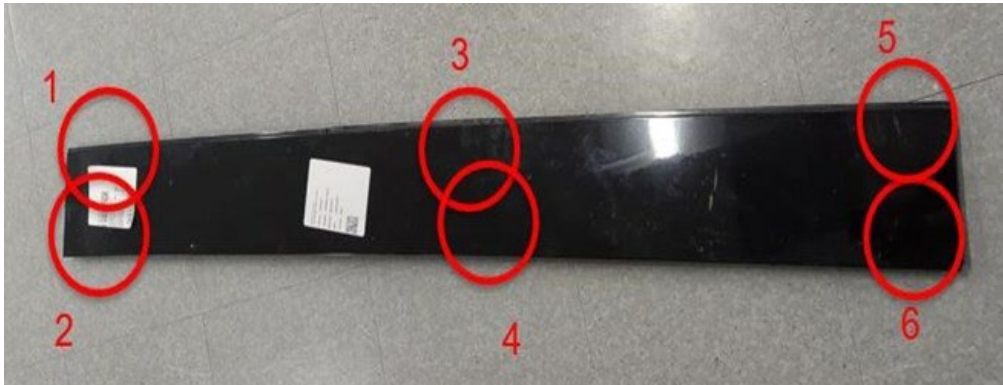
Figure 4 – Front roof applique inspection positions

4. Inspect the front roof applique for any signs of damage or looseness/separation from the roof and note down the force value applied.
 - If the front roof applique is in good condition and remains adhered, continue to the next step.
 - If the front roof applique is damaged, loose, or shows signs of separation, replace the front applique (refer to Service Manual procedure [12206002](#)) and proceed with step 7.
5. Carefully remove the vacuum cup from the center spine applique to prevent accidental damage to the applique and rear door roof glass seals.
6. Repeat steps 2 through 5 on the remaining front roof applique inspection positions (Figure 4). The circles indicate general locations, make sure that the actual suction cup does not overlap the edges.

**NOTE:** Record the maximum and minimum force value you applied on the front applique in SCA.

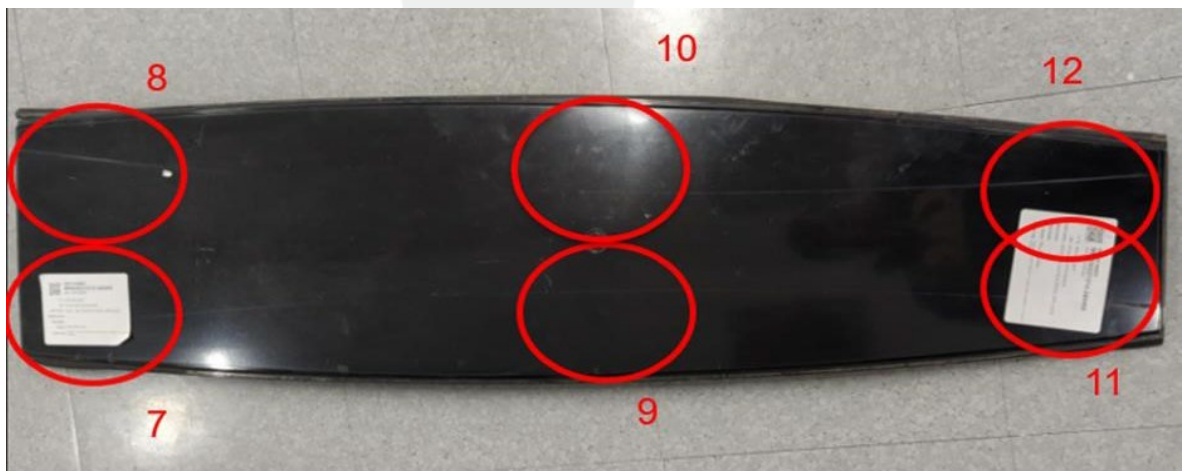
Figure 5 – Center spine applique inspection positions

9. Connect the vacuum cup to the force gauge and slowly pull the vacuum cup up with the force gauge with at least 120 N of force for 10 seconds.
10. Inspect the center spine applique for any signs of damage or looseness/separation from the roof and note down the force value applied.
 - If the center spine applique is in good condition and remains adhered, continue to the next step.
 - If the center spine applique is damaged, loose, or shows signs of separation, replace the center spine applique (refer to Service Manual procedure [10403002](#)) and proceed to step 11.

7. Clean the center spine roof applique to ensure that its surface is free of dirt or debris.
8. Secure the vacuum cup onto the LH front corner of the center spine applique (position 7 in figure 5).

11. Carefully remove the vacuum cup from the center spine applique to prevent accidental damage to the applique and rear door roof glass seals.
12. Repeat steps 8 through 11 on the remaining center spine applique inspection positions (Figure 5). The circles indicate general locations, make sure that the actual suction cup does not overlap the edges.
13. Allow the adhesive on any replaced applique panel to dry for 1 hour before returning the vehicle to the customer.
