# Safety Recall

## Code: 46P6

**Subject: Safety Recall 46P6 – Brake Booster**

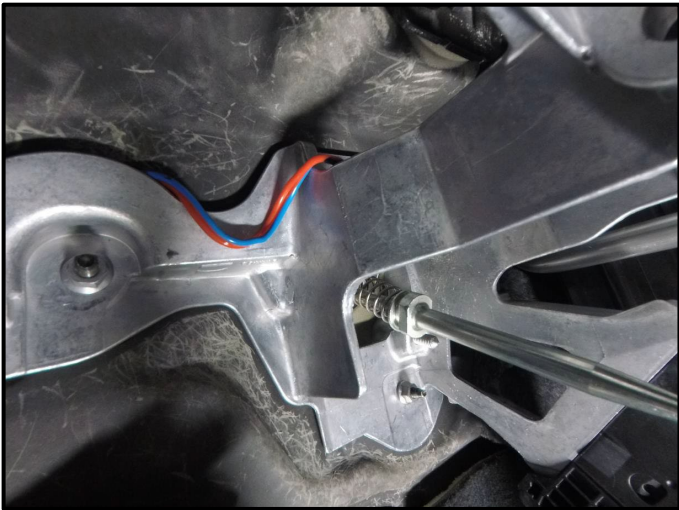
#### Access Ball Head/Push Rod:

Dust sleeve with filter, and the spring are not available as spare parts. If one of these components is defective, the brake pressure unit must be replaced.

If the screw connection has completely separated from the brake booster actuator rod, replace the brake pressure unit.

- Pull the dust boot off the ball head push rod with the filter to gain access to the components underneath.
- The following components are then exposed:
  - Ball Head Push Rod
  - Spring
- To prevent contamination, place the dust boot and spring in a clean location for later assembly
