To: McNeilus Refuse Product Owner
Re: VSR-TSB-044 – Zero Radius Arm Hook Latch Component Change
NHTSA Recall #24V-632
Certain 2015 to 2024 model year Zero Radius vehicles

Affected Vehicles

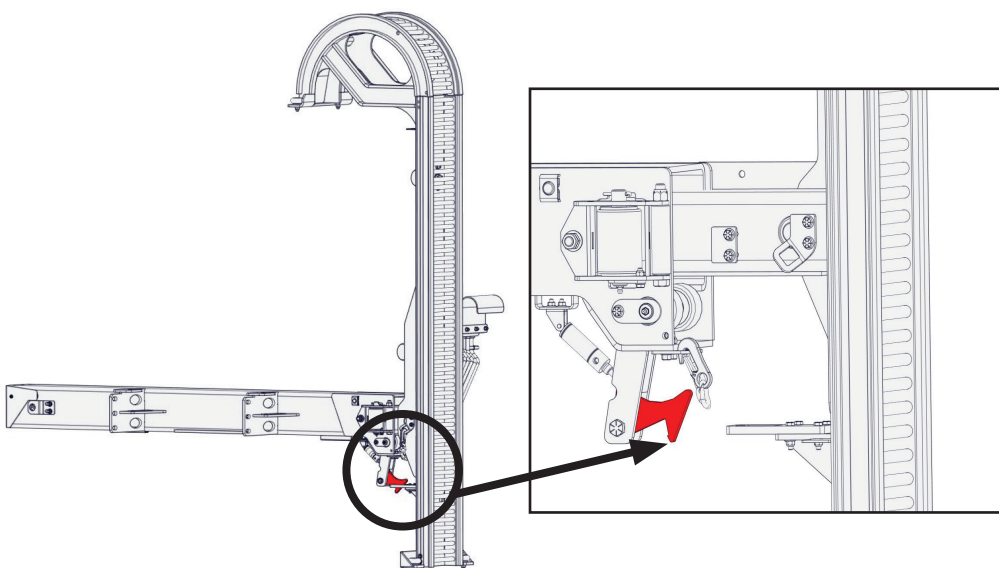
Figure 2

1. Locate the arm hook latch component on the boom of the arm mast assembly (Figure 2).

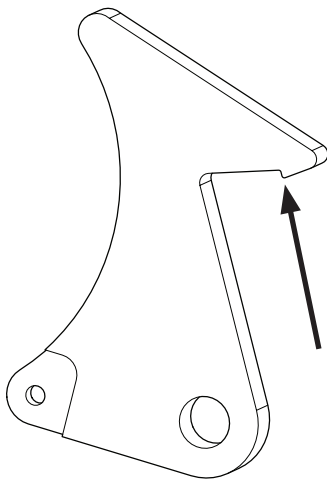
Figure 3

- If the notch on the arm hook latch component is present (Figure 3), then no changes are necessary to the component. Verify software version is 0.9.7.16 or later. If it is, then no action is required for software updating. See the verification procedures on page 7.
- Otherwise, the latest Production software must be installed by a McNeilus-authorized technician and you **must call the McNeilus service network at 1-888-686-7278 to make an appointment with your authorized dealer.**
- If the notch on the arm hook latch component is absent (Figure 4), then continue the procedure to **install the updated arm hook latch with notch** and order the updated arm hook latch component (PN 1675151) and the hardware.
- Before ordering parts, make sure you followed the instructions to inspect the wear items as well (see the instructions on page 3 under the IMPORTANT section).

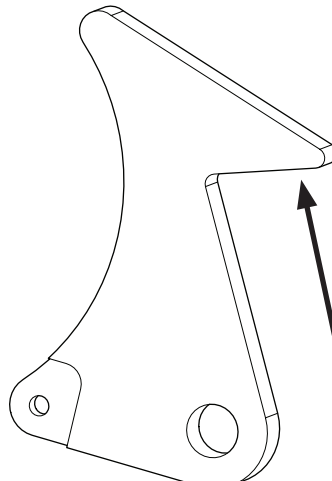
Figure 4

On trucks that lack the notch on the arm hook latch, the arm hook may walk itself out of the pocket, allowing for the arm to start to creep away from the truck body. This is especially true if the operator has neglected to manually latch the secondary arm transit latch chain. The updated arm hook latch component (PN 1675151) includes the notch.

All Zero Radius trucks with in-service dates of **June 7, 2015 to August 19, 2024** must be inspected for the arm hook latch with notch component. If the component is lacking the notch, then the arm hook latch must be replaced to the version with the notch.

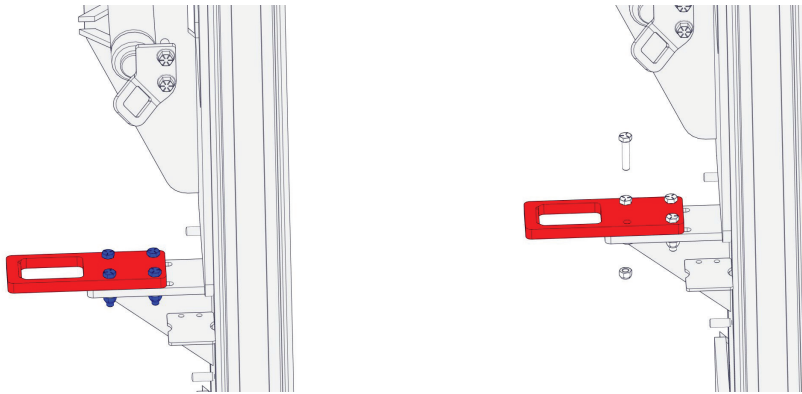
Figure 7

Inspect the latch receiving plate for damage. If replacement parts are needed, the parts and labor costs are at your own expense.

7. Check if there is a 1/4 inch gap between the receiving plate and the arm hook latch.
8. If adjustment is required to achieve a 1/4 inch gap between the receiving plate and the arm hook latch, loosen the hardware on the latch receiving plate and move the plate within the slots until the 1/4 inch gap is achieved. Tighten and torque the hardware to 15 ft.-lbs. to secure.
