Safety Recall 6824H – 2024 CX-30, Mazda3 and 2025 CX-50 – Forward Sensing Camera (FSC) Concern.

**SECTION A: VEHICLE INSPECTION PROCEDURE – AND PREPERATION FOR REPAIR**

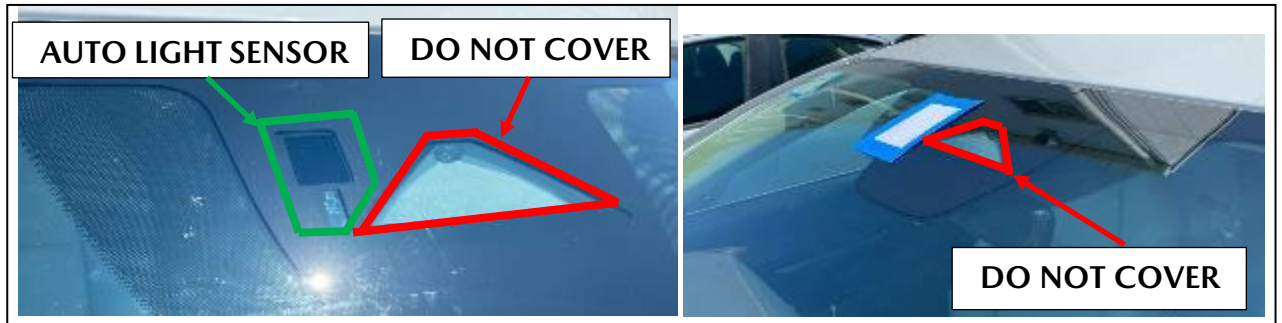
DO NOT COVER the FSC (Red triangle area). If any side of the paper sheet is not properly pasted to the windshield, the light will pass through to the sensor and the inspection procedure will not work.

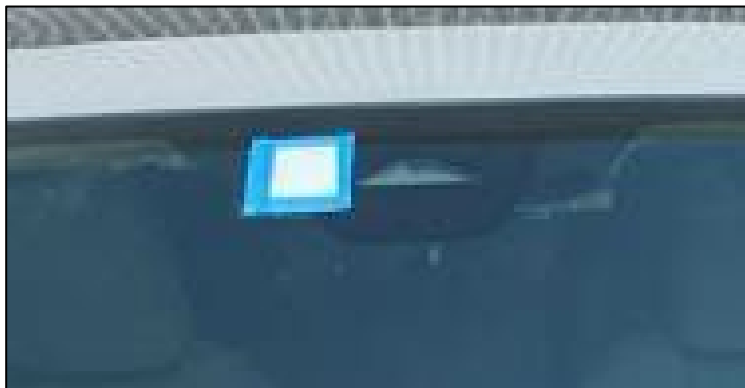
- PHOTO REQUIREMENT #1. Take a photo of vehicle with the folded paper properly attached to the windshield.

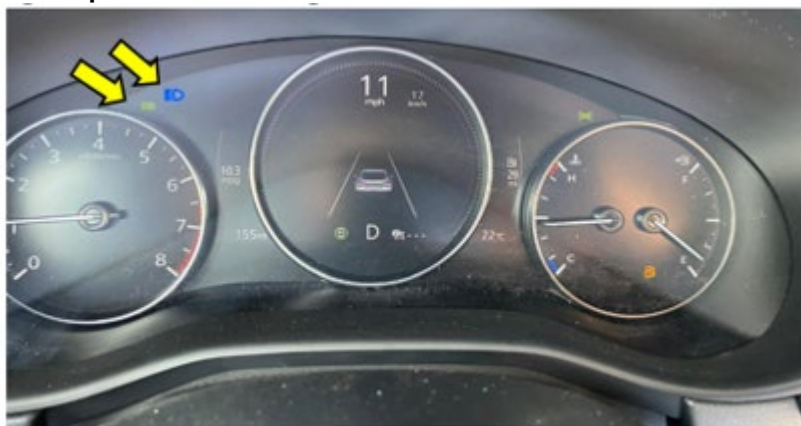
NO GOOD (NG)

**NO GOOD CONDITION – BLUE HIGH BEAM LIGHT IS ON ABOVE 10 MPH/16 KMH (ABNORMAL CONDITION).** The yellow arrows are not required to be in dealer photo.

- b. CX-30 NO GOOD – [MGSS - Replace the Forward Sensing Camera \(CX-30\)](#)
  - c. Mazda3 NO GOOD – [MGSS - Replace the Forward Sensing Camera \(Mazda3\)](#)

- d. CX-50 NO GOOD – [MGSS – Replace the Forward Sensing Camera \(CX-50\)](#)
12. If the vehicle is a long term stock vehicle the 25A fuse can be removed (Optional)

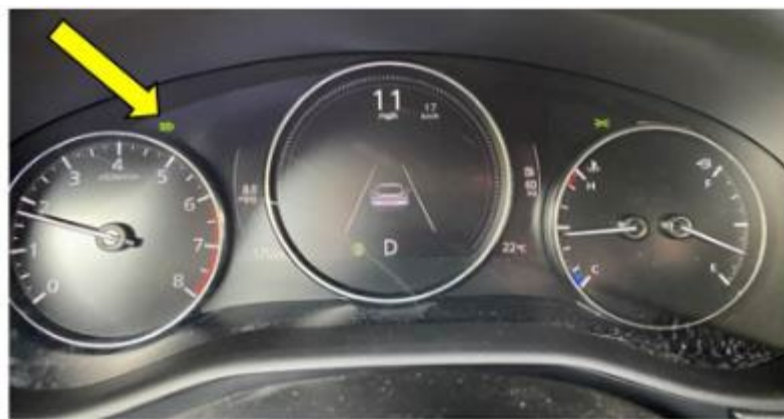
OK GOOD

**GOOD CONDITION – GREEN HIGH BEAM CONTROL ON. THE BLUE HIGH BEAM LIGHT IS OFF ABOVE 11MPH/16KMH (NORMAL CONDITION)**

11. Repair Decision – Click on the links below if NG - NO GOOD
- a. ALL VEHICLES - GOOD CONDITION RESULT - Return vehicle back to stock, submit warranty claim for Inspection - OK GOOD.
