Safety Recall

Code: 57J9

Subject Document History	Door Handles																			
	Date	Summary																		
	12/19/2024	Original publication																		
Affected Vehicles

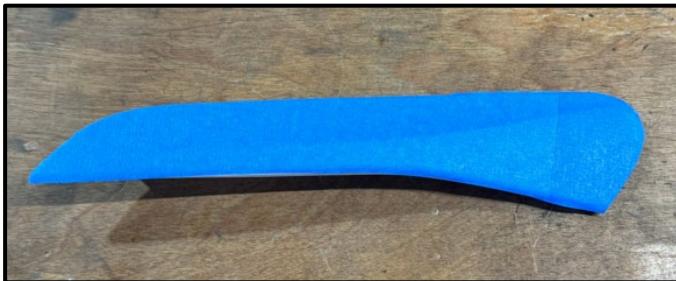
If the door handle cover is not modified or is modified incorrectly, the cover will not sit flush and there will be raised areas along the bottom of the cover. The cover pictured has not been modified in the rear section and is not sitting flush in the area indicated <1>.

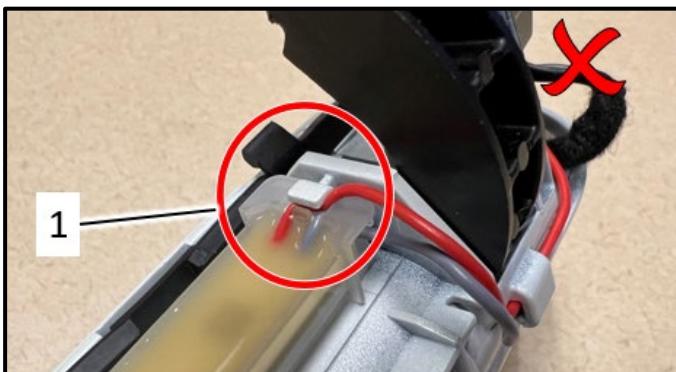
- Correct installation of wires <1> shown.
