RECALL

Original Creation Date	04/02/2024
Revision Date	10/14/2024
Subject	800vRR Vehicle Controller V4.10.2 and ESM V3.0.7 Software Recall
Rationale	The electrical connectors and terminals at one rooftop passthrough at issue in this recall are toward the max current limit that the terminals are rated for with radiator fans running at 100% speed.
VINs Affected	Service Specified Vehicles
Complete By	Next Service Opportunity
Service Bulletin Number	SC-24-009
Description	Software update for the 800vRRs Vehicle and ESM Software to reduce the radiator fan current draw to 80%. Additionally fix a bug to properly route ESM faults away from the coolant light icon.
NHTSA Recall Number	24V-655
Transport Canada Recall Number	2024-508
Remedy Kit Name/ Number:	066259 Service Retrofit Kit, BUSCOM 3.0 Software Package, 800V RR-ZX5
Labor Operation Code	EN70Z

800vRR Vehicle Controller V4.10.2 and ESM V3.0.7 Software Recall

(Service Campaign SC-24-009)

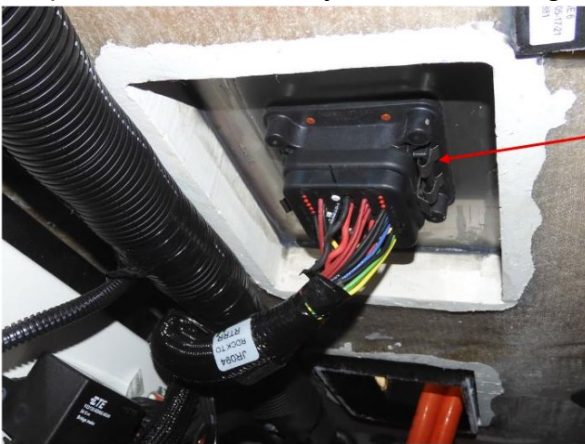
Step 31:

Inspect the rear 48 way for heat damage in the connector body.

Heat Damage

If any heat damage is found please take photos and escalate the findings to the back office support team.

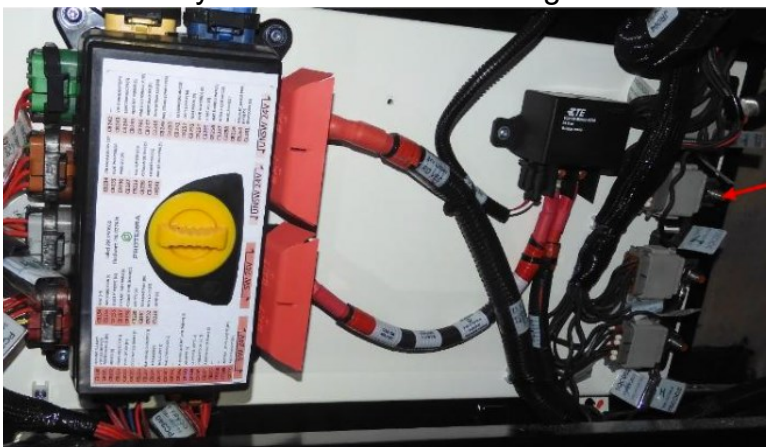
VEC Ground Bar

Finally the power and ground must be checked at the rear VEC. Please disconnect the corresponding plugs for the radiator fan circuitry and check the connector and pins for heat damage. The common plugs will be PC341, PC342, and PC337 the grounds 1QC001, 2QC001, and 3QC001. Check you schematics to verify due to model and configuration differences
