# F/CMVSS Noncompliance Recall

## N242468880 Headlamp Flicker

**Release Date:** October 2024

| Make | Model | Model Year | | RPO | Description |
|---|---|---|---|---|---|
| GMC | Canyon | 2024 | 2024 | | |

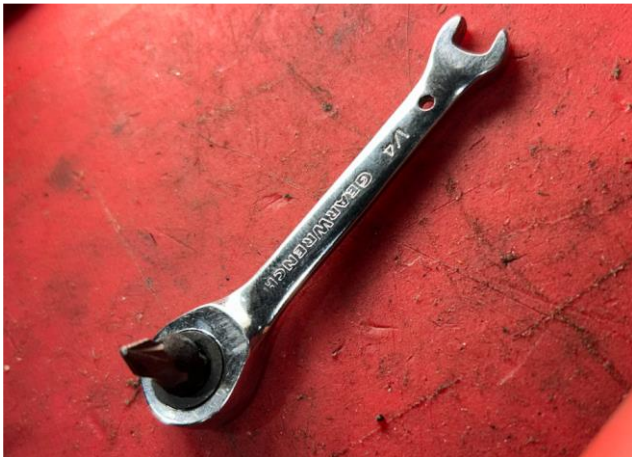
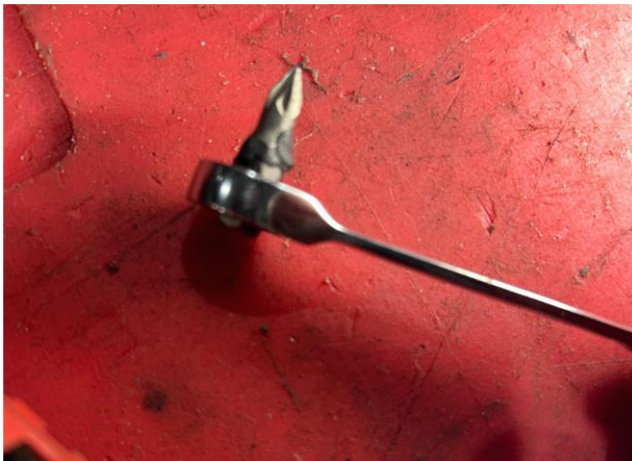
There are no Special Tools required for this procedure, however it is recommended to use an ultra low profile ratcheting wrench/driver or similar to perform this repair. Pictured below are examples of the recommended tools. Depending on build date, the vehicle may have Torx or Phillips head screws.
