UPDATE: June 16, 2025 – Clarified step 7 when error on MDRT is displayed.

[Section B: Repair Procedure Recall 6924I](#) 7

SUBJECT VEHICLES RECALL 6924I

Model	Subject VIN range	Subject production date range
2017-2023 MX-5	JM1NDA****1 100016– 560957	From April 20, 2015 through November 2, 2023

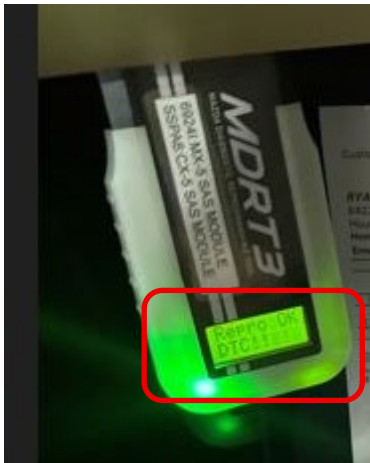
If display shows message as "REPRO_OK DTC!!!", proceed with following procedure steps 7 (a-h). By performing this procedure, MDRT can erase DTC automatically. If display does not show message "REPRO_OK DTC!!!", move to step 8.

THIS IS A NO GOOD SITUATION PLEASE PERFORM STEPS a-h. If this does not resolve, please contact tech hotline

- a. Turn IG off
- b. Disconnect the MDRT
- c. Turn IG on (with Engine RUNNING)
- d. Idle the vehicle for **5 seconds**.
- e. Turn IG off (Engine is OFF).
- f. Connect the MDRT.
- g. Press Start button twice - IG on (Engine is OFF).
- h. Wait for 5 minutes then go to step 8.

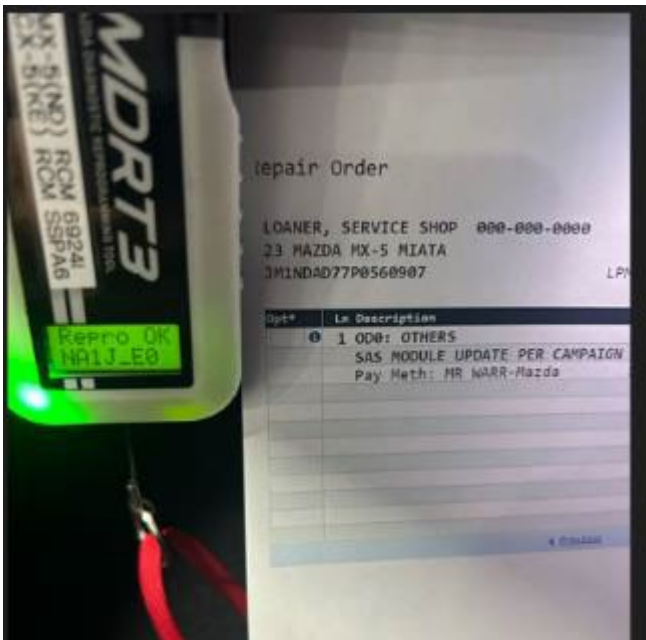
EXAMPLE – GOOD PHOTO#1

Repair Completion Note: The VIN on the RO must be clearly recognizable. The LCD must say "REPRO OK" as in the below photo. The characters "NA1J_E0" may be different or not appear, but REPRO OK must be in the LCD screen.
