[Section B: Repair Procedure Recall 6924I](#) 7

SUBJECT VEHICLES RECALL 6924I

**REPAIR PROCEDURE
SAFETY NON-COMPLIANCE RECALL 6924I**

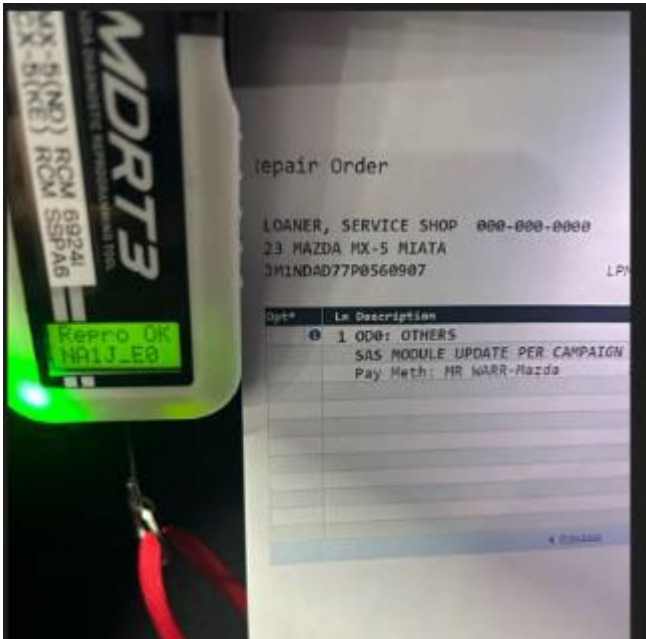
EXAMPLE – GOOD PHOTO#1

Repair Completion Note: The VIN on the RO must be clearly recognizable. The LCD must say "REPRO OK" as in the below photo. The characters "NA1J_E0" may be different or not appear, but REPRO OK must be in the LCD screen.
