# RECALL REPAIR PROCEDURE

Horizontal Hinged Egress Windows Part# 510175/ Missing Rivets

## RECALL#24V-696

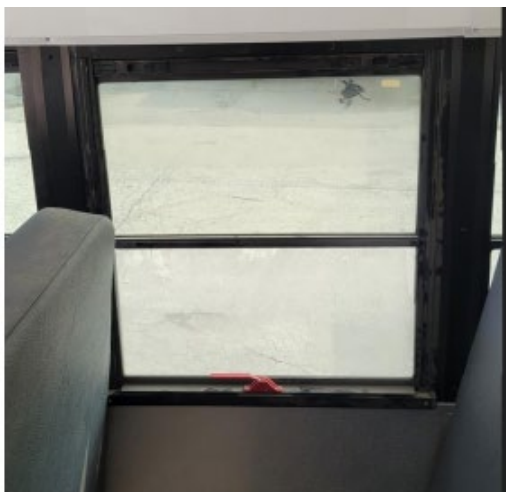
EMERGENCY WINDOW  
VERSION 1-2020

Interior View  
Curbside

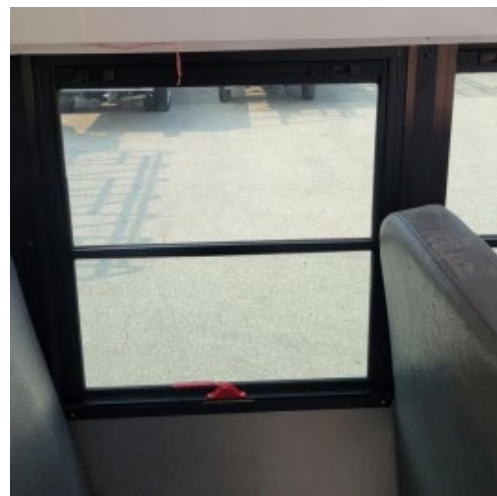
Interior View  
Street Side

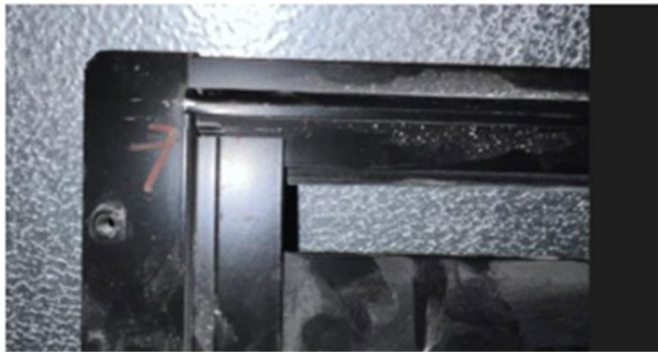
2. Inspect the emergency window for missing rivets. Inspect for scratches on lower catch plate. Inspect for gap at the top of window extension. Proceed with Step 3 if window is determined to need Recall.

Window Exterior View (Uninstalled)  
No Rivets

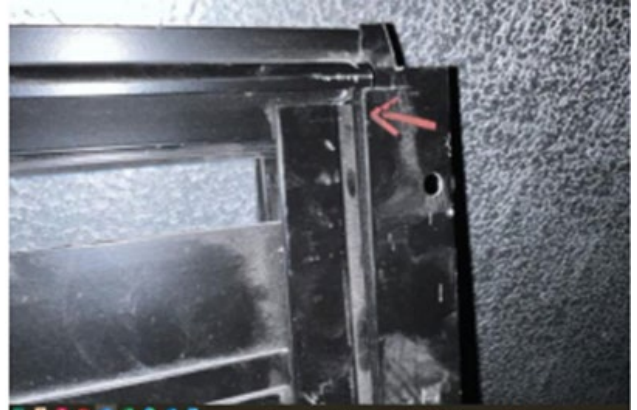
Window Exterior View (Uninstalled)  
No Rivets
