SIB 34 04 24

2024-10-03

**RECALL 24V-697: INTEGRATED BRAKE SERVOMOTOR**

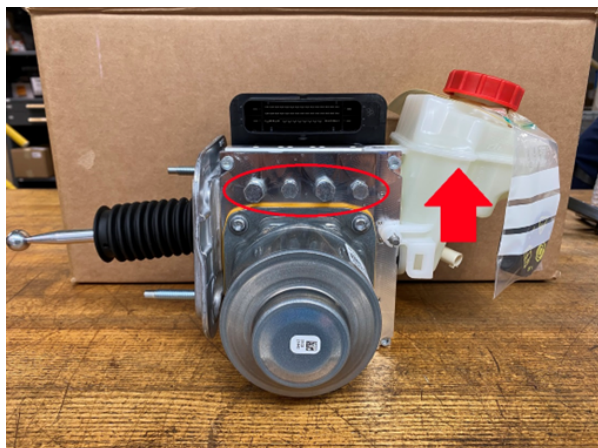
**“Wet” IB pre-filled:** Brake fluid reservoir is filled (arrow) and brake fluid line ports are plugged with bolts (circled).

If you have received a “wet” unit, follow the repair per the Attachment 1, “Service Function and replace wet IB pre-filled”.

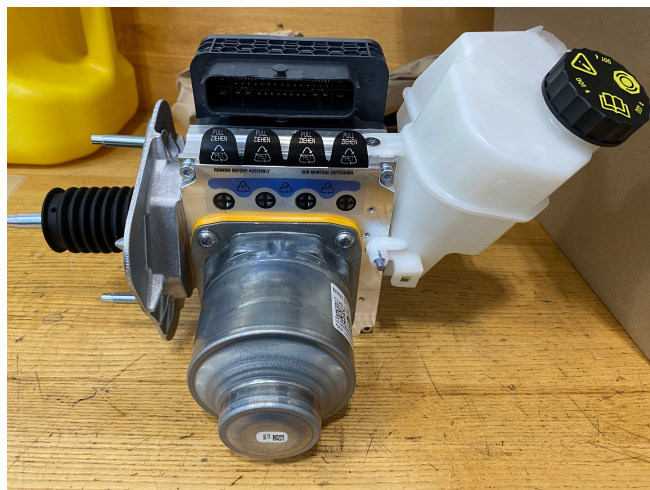
**“Dry” IB unfilled:** Brake fluid reservoir is empty; brake fluid line ports are sealed with labels.

If you have received a “dry” unit, follow the repair per the Attachment 2, “Service Function and replace dry IB unfilled”.

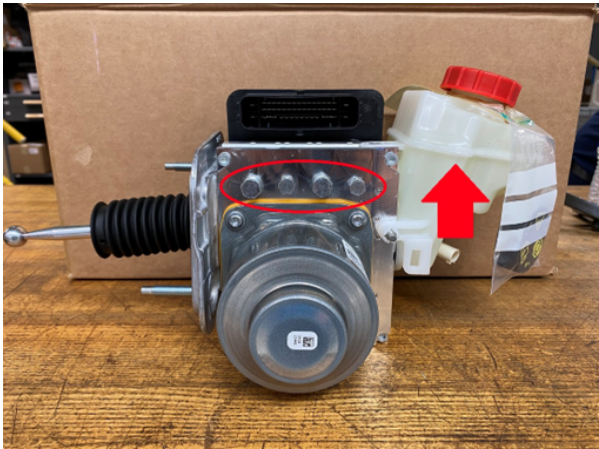
“Wet” IB pre-filled: Brake fluid reservoir is filled (arrow) and the four brake fluid line ports are plugged with bolts (circled).
