SIB 34 04 24

RECALL 24V-697: INTEGRATED BRAKE SERVOMOTOR

2026-01-09

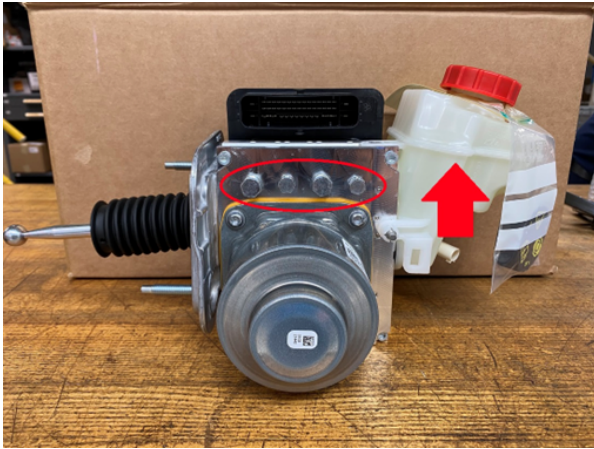
“Wet” IB pre-filled: Brake fluid reservoir is filled (arrow) and brake fluid line ports are plugged with bolts (circled).

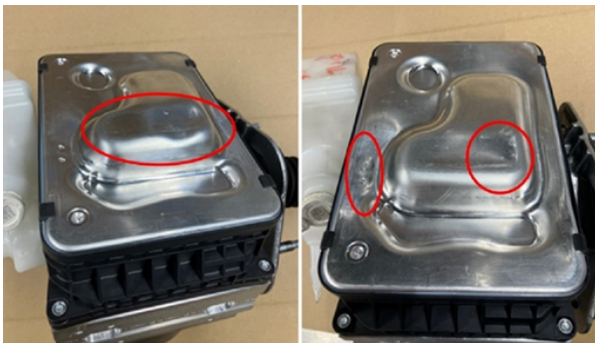
- Prior to installation, the Integrated Brake Modules should be inspected for damage upon arrival. Light scratches are acceptable; but if the aluminum cover is dented or bent, please send photos in a Recall IDS Ticket for review prior to entering a claim. If approved, please claim in accordance with the Dealer Services Return and Claims Manual.

Do not install any part which shows visual damage as shown, or has been dropped from any height.

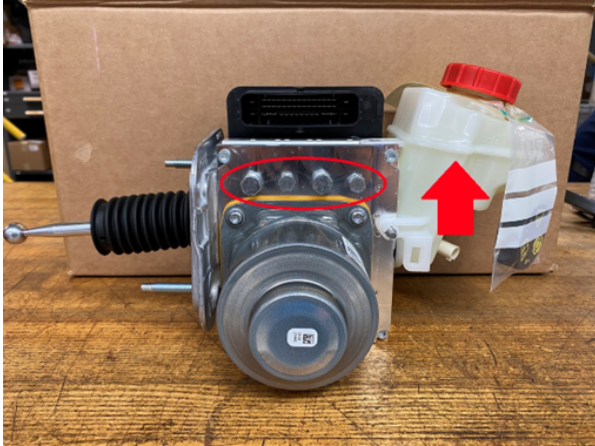
“Wet” IB pre-filled: Brake fluid reservoir is filled (arrow) and the four brake fluid line ports are plugged with bolts (circled).

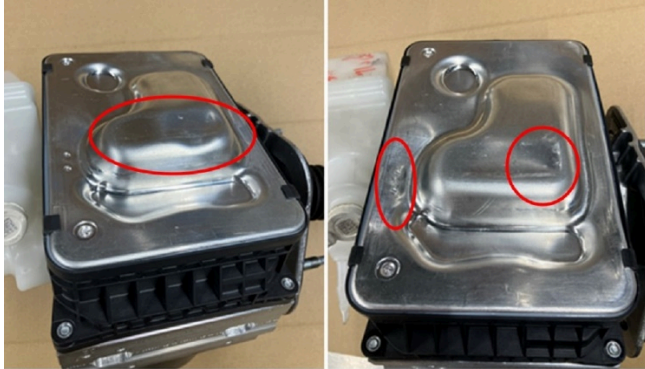
- Prior to installation, the Integrated Brake Modules should be inspected for damage upon arrival. Light scratches are acceptable; but if the aluminum cover is dented or bent, please send photos in a Recall IDS Ticket for review prior to entering a claim. If approved, please claim in accordance with the Dealer Services Return and Claims Manual.
- For further information regarding IB parts updates follow the link [Integrated Brake System Recall's Flowpage](#)

Do not install any part which shows visual damage as shown, or has been dropped from any height.
