SIM 34 02 24

2025-07-18

RECALL 24V-697: INTEGRATED BRAKE SERVOMOTOR

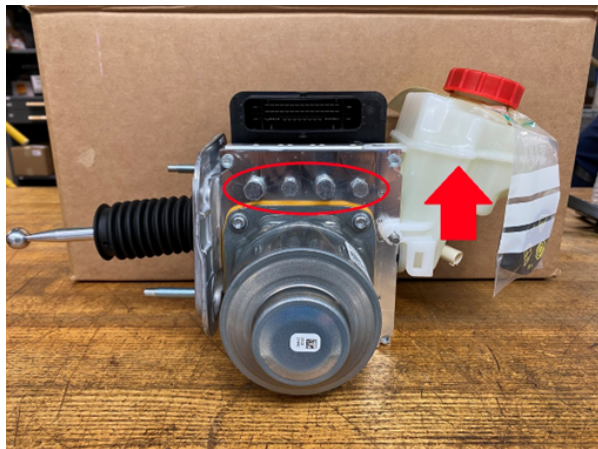
“**Wet**” IB pre-filled: Brake fluid reservoir is filled (arrow) and the four brake fluid line ports are plugged with bolts (circled).

Part number:
5B67B85
5B72715
5B72716
5B6A736

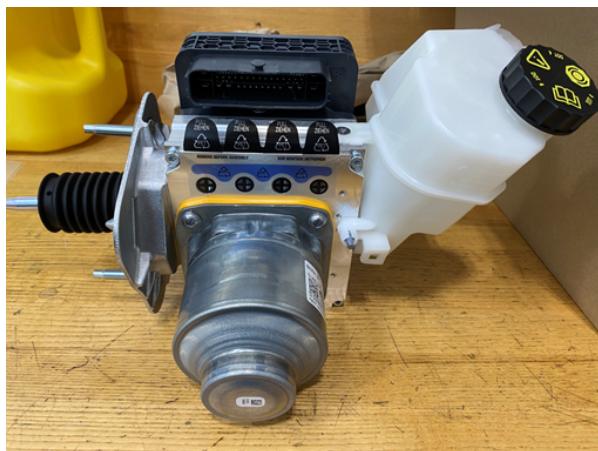
“**Dry**” IB unfilled: Brake fluid reservoir is empty, and the brake fluid line ports are sealed with labels.

Part number:
5B3C874
5B6C7F1

Note: Additional work is necessary to install these “Dry” units; refer to the Claim Information section.

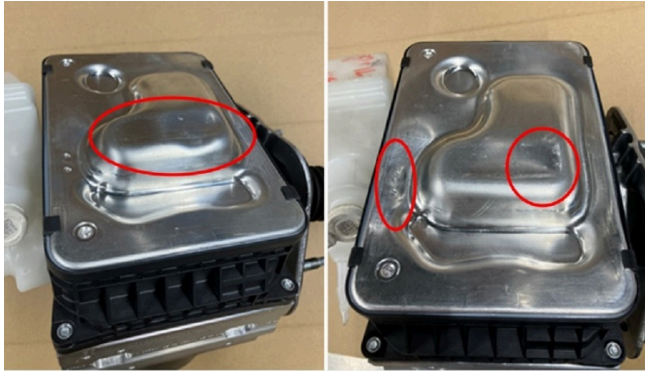
Do not install any part which shows visual damage as shown, or has been dropped from any height.

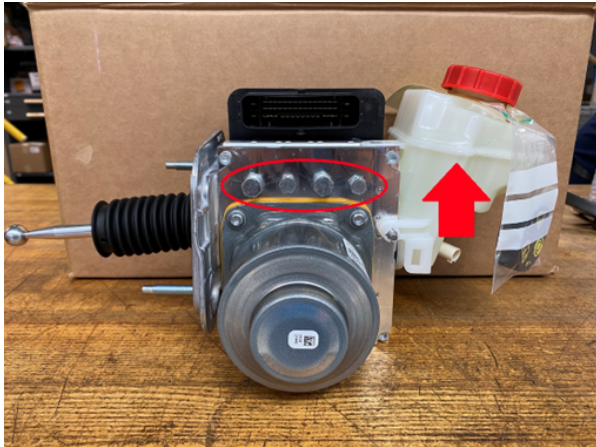
“Wet” IB pre-filled: Brake fluid reservoir is filled (arrow) and brake fluid line ports are plugged with bolts (circled).

Part numbers:

5B67B85
5B6E463
5B6E465
5B6E467
5B69D65
5B69D61
5B69D63
5B6F947
5B72715
5B72716
5B6F943

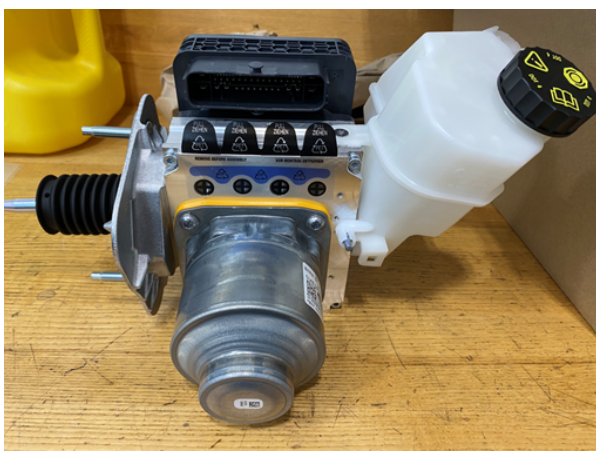
“Dry” IB unfilled: Brake fluid reservoir is empty; brake fluid line ports are sealed with labels.

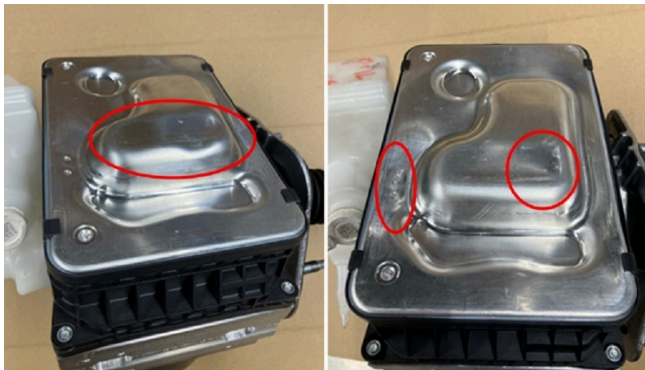
- Prior to installation, the Integrated Brake Modules should be inspected for damage upon arrival. Light scratches are acceptable; but if the aluminum cover is dented or bent, please send photos in a Recall IDS Ticket for review prior to entering a claim. If approved, please claim in accordance with the Dealer Services Return and Claims Manual.

Do not install any part which shows visual damage as shown, or has been dropped from any height.
