SIB 34 04 24

## RECALL 24V-697: INTEGRATED BRAKE SERVOMOTOR

This Service Information Bulletin (Revision 11) replaces SI B34 04 24 **dated July 2025**.

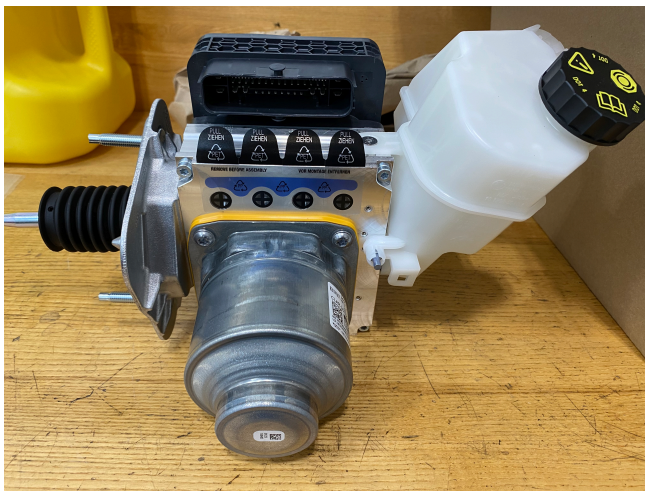
**“Dry” IB unfilled:** Brake fluid reservoir is empty; brake fluid line ports are sealed with labels.

**Note:** Additional work is necessary to install these “Dry” units; refer to the Claim Information section.

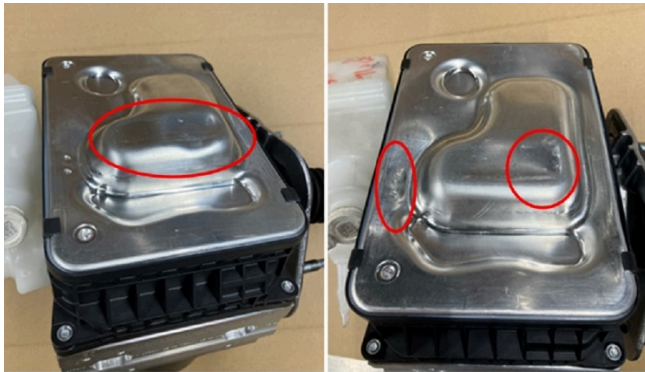
Do not install any part which shows visual damage as shown, or has been dropped from any height.

- Prior to installation, the Integrated Brake Modules should be inspected for damage upon arrival. Light scratches are acceptable; but if the aluminum cover is dented or bent, please send photos in a Recall IDS Ticket for review prior to entering a claim. If approved, please claim in accordance with the Dealer Services Return and Claims Manual.

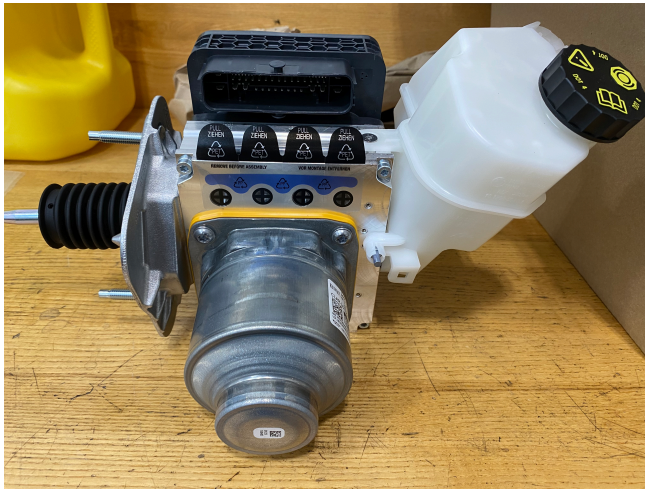
“Dry” IB unfilled: Brake fluid reservoir is empty, and the brake fluid line ports are sealed with labels.
