SIB 34 04 24

RECALL 24V-697: INTEGRATED BRAKE SERVOMOTOR  
2025-10-31

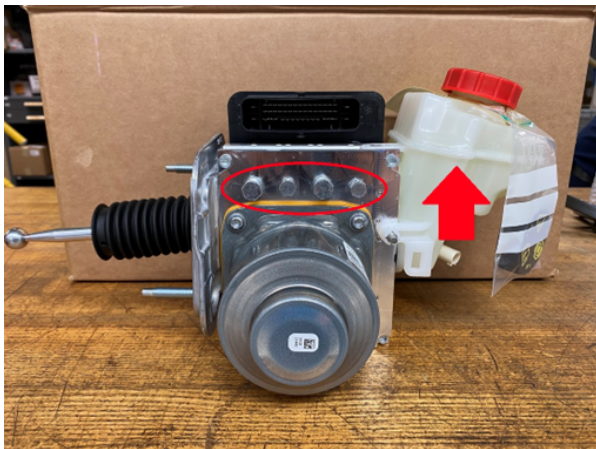
**“Wet” IB pre-filled:** Brake fluid reservoir is filled (arrow) and brake fluid line ports are plugged with bolts (circled).

If you have received a “**wet**” unit, follow the REP34 51 601 Replacing hydraulic unit.

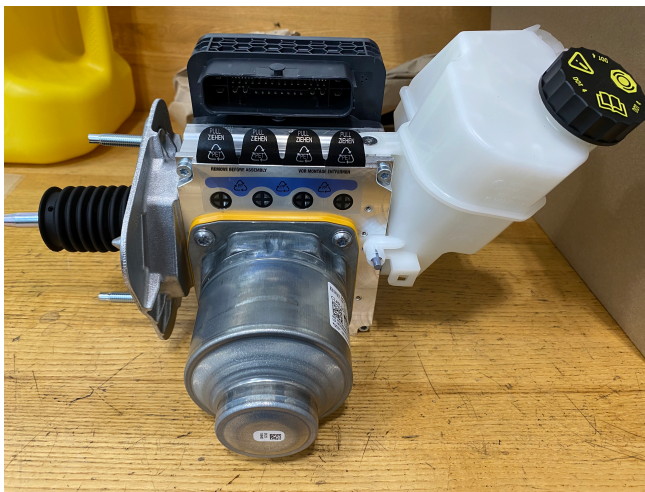
**“Dry” IB unfilled:** Brake fluid reservoir is empty; brake fluid line ports are sealed with labels.

**Note:** Additional work is necessary to install these “Dry” units; refer to the Claim Information section.

If you have received a “**dry**” unit, follow the REP 34 51 602 Replacing the hydraulic unit (not filled).

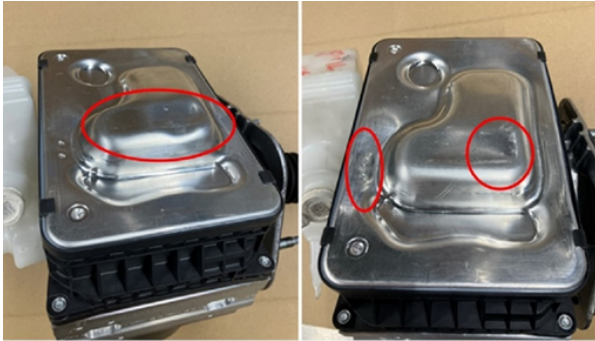
- Prior to installation, the Integrated Brake Modules should be inspected for damage upon arrival. Light scratches are acceptable; but if the aluminum cover is dented or bent, please send photos in a Recall IDS Ticket for review prior to entering a claim. If approved, please claim in accordance with the Dealer Services Return and Claims Manual.

Do not install any part which shows visual damage as shown, or has been dropped from any height.
