## SIB 34 04 24

### RECALL 24V-697: INTEGRATED BRAKE SERVOMOTOR

2026-05-06

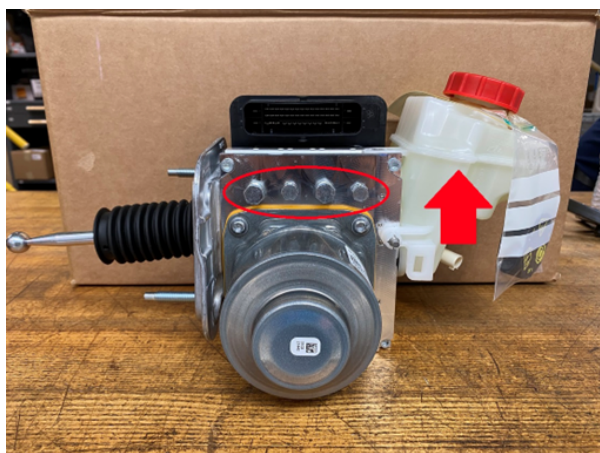
**“Wet” IB pre-filled:** Brake fluid reservoir is filled (arrow) and brake fluid line ports are plugged with bolts (circled).

Replace the IB with a “wet” pre-filled unit.

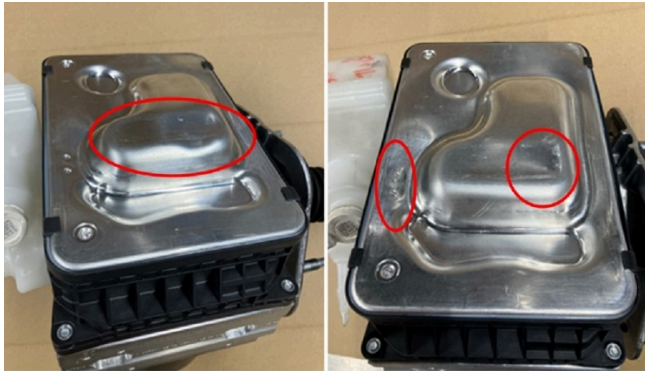
Do not install any part which shows visual damage as shown or has been dropped from any height.

If you have received a “**wet**” unit, follow the REP34 51 601 Replacing hydraulic unit.

If you have received a “**dry**” unit, **do not install**, follow TEC848 Power Brake Return.

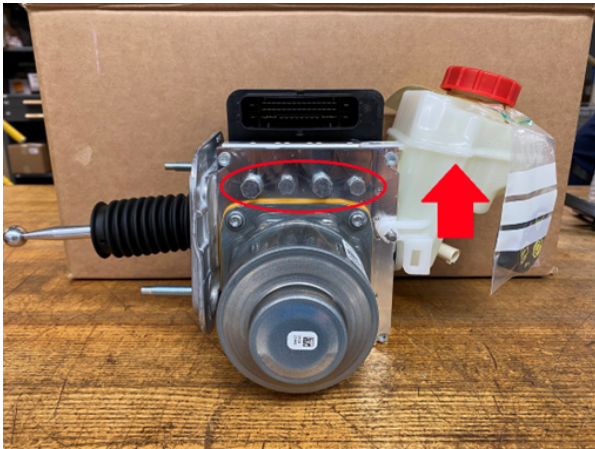
**“Wet” IB pre-filled:** Brake fluid reservoir is filled (arrow) and the four brake fluid line ports are plugged with bolts (circled).

Replace the IB with a “wet” pre-filled unit.

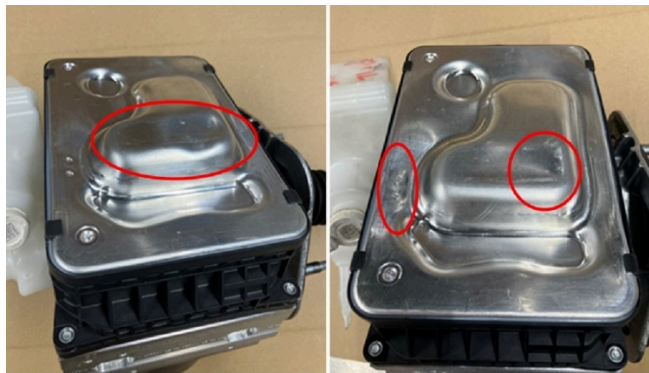
- Prior to installation, the Integrated Brake Modules should be inspected for damage upon arrival. Light scratches are acceptable; but if the aluminum cover is dented or bent, please send photos in a Recall IDS Ticket for review prior to entering a claim. If approved, please claim in accordance with the Dealer Services Return and Claims Manual.

Do not install any part which shows visual damage as shown, or has been dropped from any height.

If you have received a “**wet**” unit, follow the REP34 51 601 “Replacing hydraulic unit”.
