SIM 34 02 24

RECALL 24V-697: INTEGRATED BRAKE SERVOMOTOR

This Service Information Bulletin (Revision 4) replaces SI M34 02 24 **dated February 2025**.

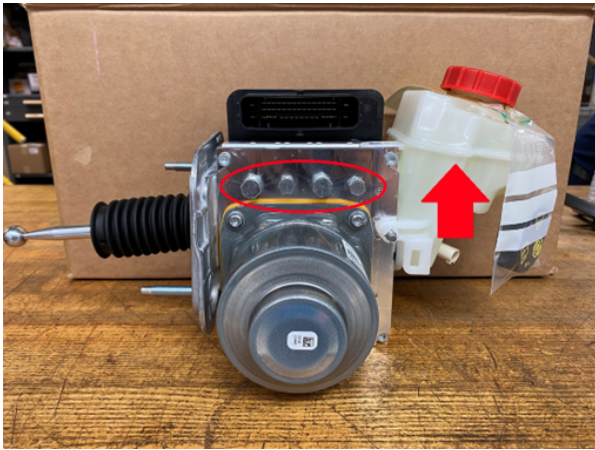
Part number:
5B67B85

"Wet" IB pre-filled: Brake fluid reservoir is filled (arrow) and the four brake fluid line ports are plugged with bolts (circled).

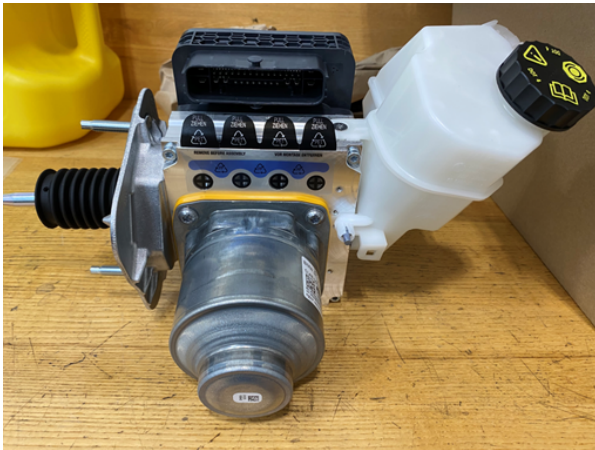
Part number:
5B3C874

Note: Additional work is necessary to install these “Dry” units; refer to the Claim Information section.
