# VOLUNTARY RECALL CAMPAIGN

Classification: EL25-008C	Reference: NTB25-043C	Date: January 28, 2026
------------------------------	--------------------------	---------------------------

## VOLUNTARY SAFETY RECALL CAMPAIGN 2019-2022 LEAF; HV BATTERY

**CAMPAIGN ID #:** P5A22  
**APPLIED VEHICLES:** Specific 2019-2022 LEAF (ZE1)

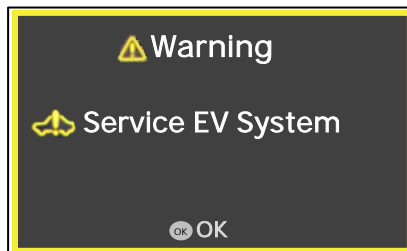
- Be sure to review and understand the drive pattern before beginning.
- If one of the warning messages shown in Figure 32 and Figure 33 sets during the drive pattern, return to the dealership without turning the vehicle OFF.
  - Do NOT turn the vehicle OFF until the vehicle has been returned to the dealership as the vehicle may not restart (Enter Ready mode) until DTCs are checked/erased. Skip to step 49 on page 26.

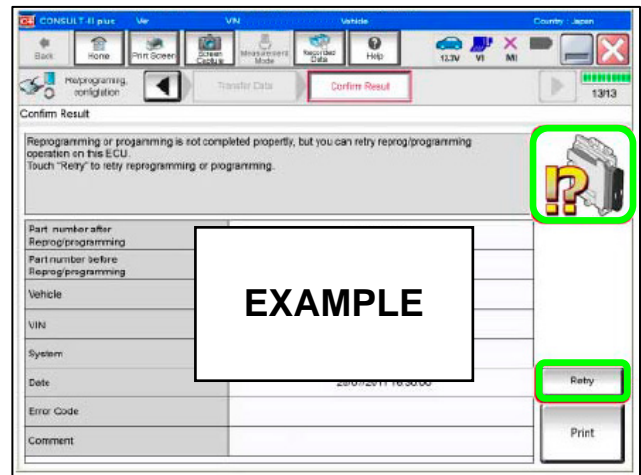
Figure 38

If reprogramming does not complete and the “!?” icon displays, as shown in Figure 38:

- Check battery voltage (12.0 - 13.5 V).
- EV system ON, Not in Ready mode.
- External Bluetooth® devices are OFF.
- **All** electrical loads are OFF.
- Select **Retry** and follow the on screen instructions.
- Retry may not go through on first attempt and can be selected more than once.

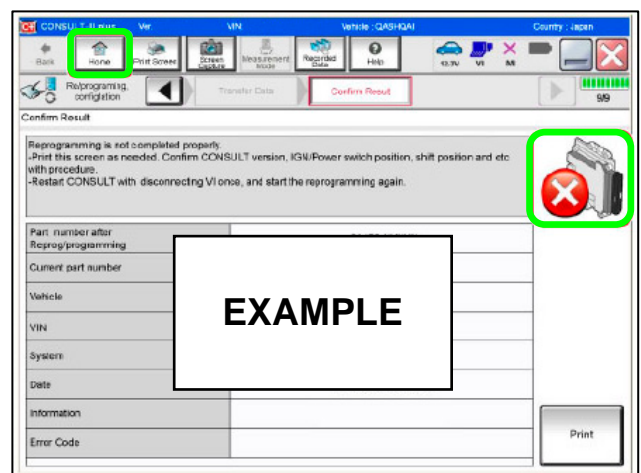
Figure 39

If reprogramming does not complete and the “X” icon displays, as shown in Figure 39:

- Check battery voltage (12.0 - 13.5 V).
- CONSULT A/C adapter is plugged in.
- EV system ON, Not in Ready mode.
- Transmission is in Park.
- All CONSULT VI cables are securely connected.
- All C-III plus updates are installed.
- Select **Home**, and restart the reprogram procedure from the beginning.
