L62X-  
R.03.24

To: After Sales Official Network  
Subject: crash relevant bracket assembly  
Date: 31/10/2024  
Pages: 4

**Campaign code:**  
L62X-R.03.24

Model:  
Huracan Spyder

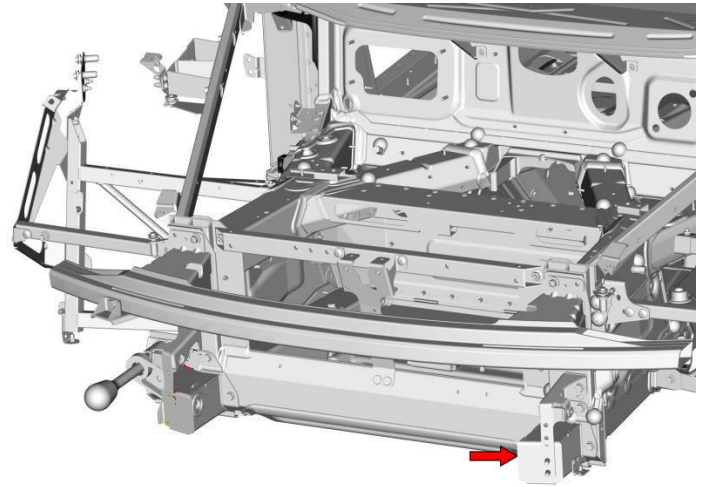
Figure – Incorrect Assembly (Case 2)

**CASE 2 – Bracket on the left side**

If the bracket is mounted on the left side (wrong side - Figure 2), the bracket must be disassembled and reassembled correctly on the right side (correct side).

To do this, follow these steps:  
Select correct car: Huracan-->Spyder-->LP640-4-Evo Spyder-->MY24  
Follow the path:  
Body--> Frame-->Front--> Structural Components of Front Frame 1-->803.01.26-Front Chassis Brace

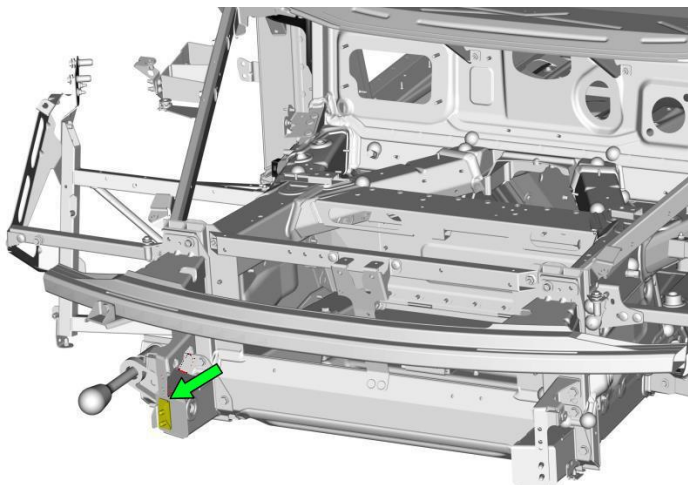
Figure 1 – Correct Assembly (Case 1)

**CASE 1 – Bracket on the right side**

If the bracket is correctly located on the right side (Figure 1), the car can be reassembled by following the final steps.
