TECHNICAL INSTRUCTIONS

SAFETY RECALL 24TA11

TEMPORARY HARD BRAKE PEDAL DURING CORNERING

CERTAIN 2023-2025 MODEL YEAR COROLLA HV

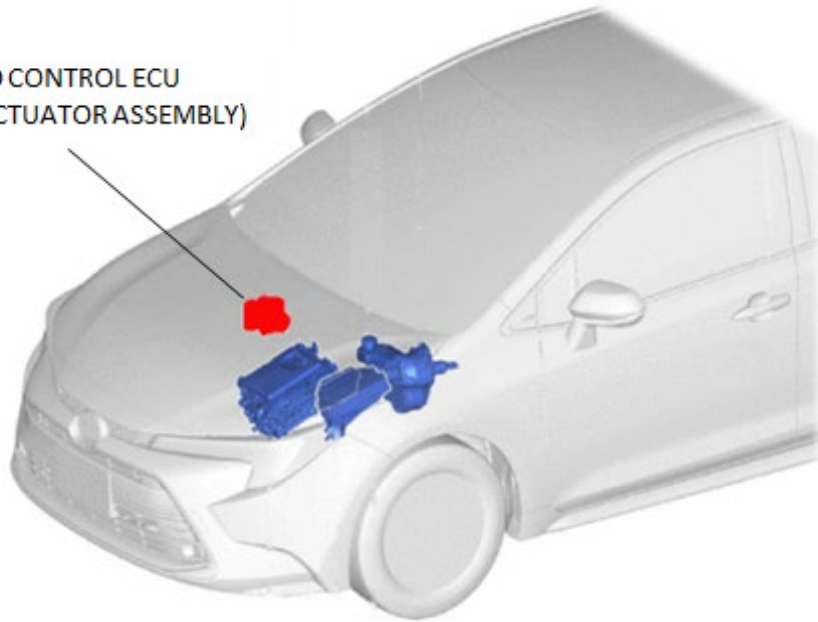
SKID CONTROL ECU
(BRAKE ACTUATOR ASSEMBLY)

In certain situations, during brake application when turning a corner, a driver may temporarily experience a hard brake pedal that can cause the stopping distance to be more than expected. This can increase the risk of a crash.
