## SAFETY RECALL 24TA11

### TEMPORARY HARD BRAKE PEDAL DURING CORNERING

### CERTAIN 2023-2024 MODEL YEAR COROLLA CROSS HV

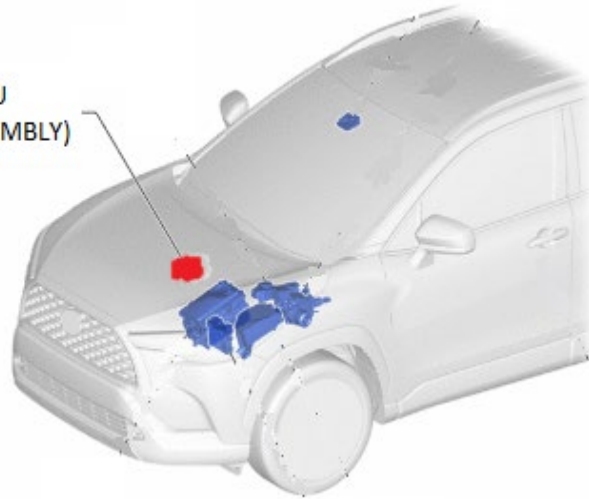
SKID CONTROL ECU  
(BRAKE ACTUATOR ASSEMBLY)

In certain situations, during brake application when turning a corner, a driver may temporarily experience a hard brake pedal that can cause the stopping distance to be more than expected. This can increase the risk of a crash.
