SIB 41 05 24

RECALL 24V-711: RIGHT SIDE FRONT END CONNECTION

SIM 41 01 24

RECALL 24V-711: FRONT END CONNECTION

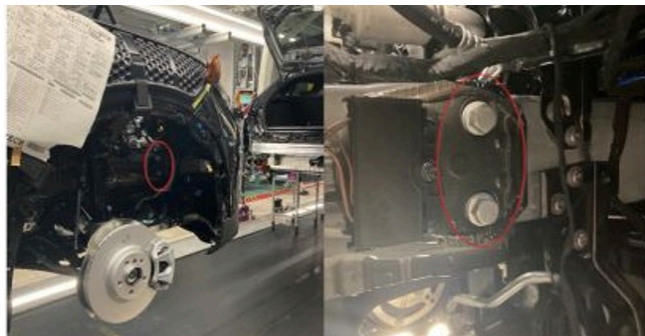
During vehicle assembly, the bolts, which connect the front module to the vehicle chassis, may not have been tightened according to specifications which, in a crash, could increase the risk of injury.

2. Inspect that the two bolts that secure the front end are installed and review repair instructions 51 11 760 for the torque spec.

1. Remove the right front wheel weld cover following repair instructions 51 71 038 listed in ISTA/AIR.

Note: If one and/or both bolts are missing, new bolts will need to be installed and torqued.

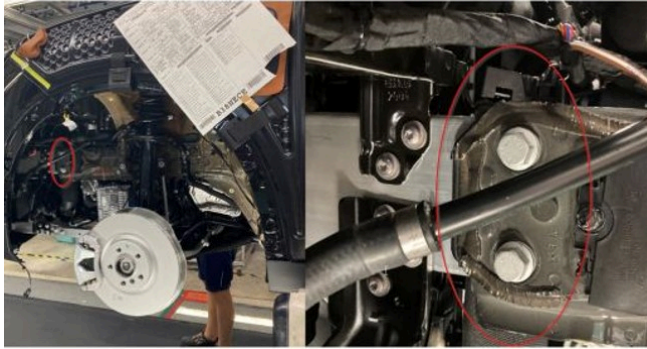
During vehicle assembly, the bolts which connect the front module to the vehicle chassis, may not have been tightened according to specifications which, in a crash, could increase the risk of injury.

3. Inspect the two bolts that secure the front end are installed. Review repair instructions 51 11 760 for the torque spec.

2. Depending on what side needs to be inspected, remove the front wheelwell cover (aka fender inner liner) following repair instructions 51 71 040 listed in ISTA/AIR.

Note: If one and/or both bolts are missing, new bolts will need to be installed and torqued.
