SIB 32 05 24

RECALL 24V-714: STEERING SHAFT (DOUBLE UNIVERSAL JOINT)

This Service Information Bulletin (Revision 3) replaces SI B32 05 24 **dated October 2024**.

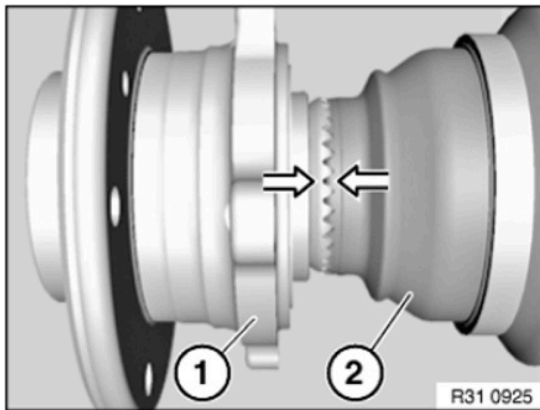
NOTE: For vehicle which require the output shaft to be removed and installed. Ensure the proper installation of the output shaft to wheel bearing as shown in the photo below.

The front gearing of wheel bearing and driven shaft must be installed with a positive fit (tooth in tooth position).

- Ensure positive locking by twisting wheel bearing (1) and output shaft (2) against each other.
