SIB 32 05 24

RECALL 24V-714: STEERING SHAFT (DOUBLE UNIVERSAL JOINT)

This Service Information Bulletin (Revision 4) replaces SI B32 05 24 **dated November 2024**.

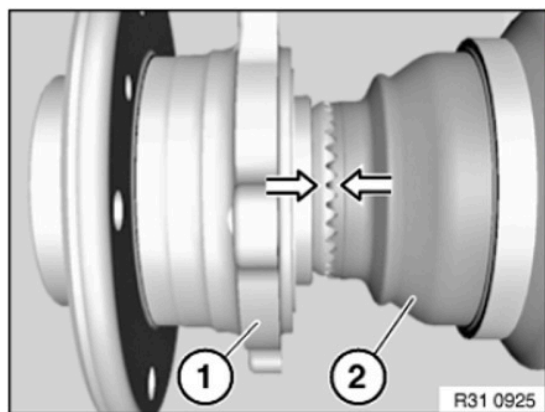
NOTE: For vehicle which require the output shaft to be removed and installed. Ensure the proper installation of the output shaft to wheel bearing as shown in the photo below.

The front gearing of wheel bearing and driven shaft must be installed with a positive fit (tooth in tooth position).

- Ensure positive locking by twisting wheel bearing (1) and output shaft (2) against each other.
