SIB 32 05 24

**RECALL 24V-714: STEERING SHAFT (DOUBLE UNIVERSAL JOINT)**

This Service Information Bulletin (Revision 5) replaces SI B32 05 24 **dated January 2024**.

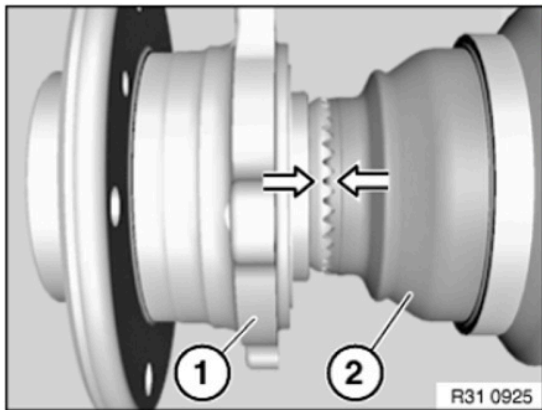
**NOTE: For vehicle which require the output shaft to be removed and installed. Ensure the proper installation of the output shaft to wheel bearing as shown in the photo below.**

The front gearing of wheel bearing and driven shaft must be installed with a positive fit (tooth in tooth position).

- Ensure positive locking by twisting wheel bearing (1) and output shaft (2) against each other.
