SIB 61 09 24 RECALL 24V-716: Disable Reverser

2025-01-24

General Electrical Systems

RECALL 24V-716 DISABLE REVERSER

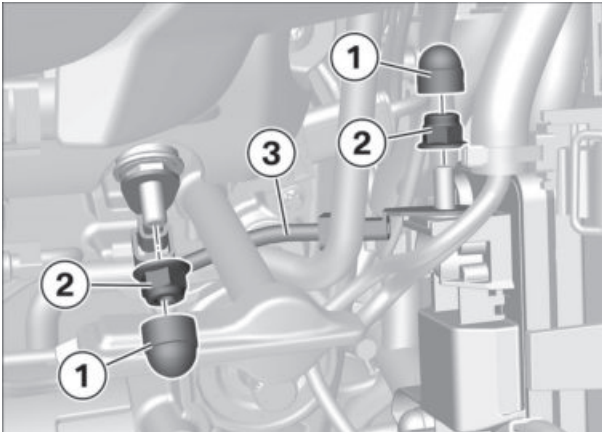
6

► **Removing cables to transmission housing and reverser**

- Remove protective caps **(1)** and nuts **(2)**.
- Remove cable **(3)**.
 - Positive cable to starter motor.
- Reinstall nuts **(2)** and protective caps **(1)** **without cable**.
 - Nuts and protective caps are required for subsequently enabling control unit.
