# Safety Recall

## Code: 471F

| Subject | Brake Master Cylinder | | | | |

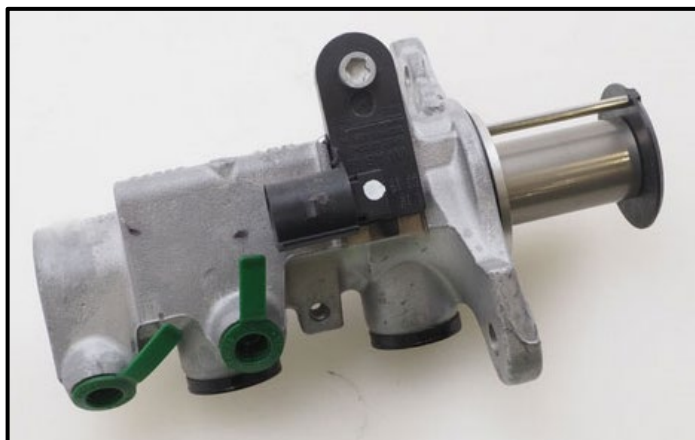
| | An incorrect secondary piston spring retainer may have been installed in the brake master cylinder. The incorrect part is shorter than the specified part and can cause the piston to not return to its proper resting position, potentially blocking the brake fluid port. This can lead to reduced brake performance, increasing the risk of a crash. | | | | |

- Replace brake master cylinder.
