Recall Campaign Bulletin

Campaign No. 2024100006, October 2024

SUBJECT: **Model GLE (167 platform)**
Model Year 2021 – 2022

Check Acceleration Sensor Wiring Harness Routing

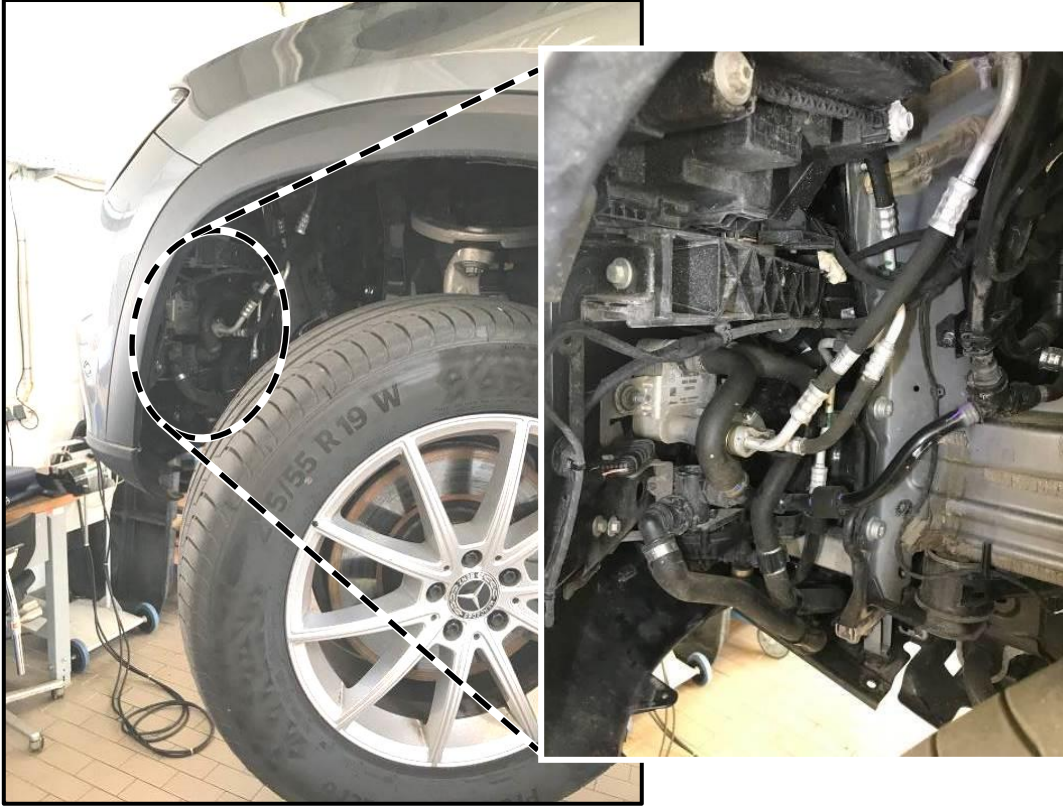
Figure 1

1. Remove front section from the front left fender liner.
