RAM Remedy available for
 2023-2024 (DT) RAM 1500 Pickup

Turn Signal Lever Latch

Reference: A1B / NHTSA 24V-729

FCA US LLC

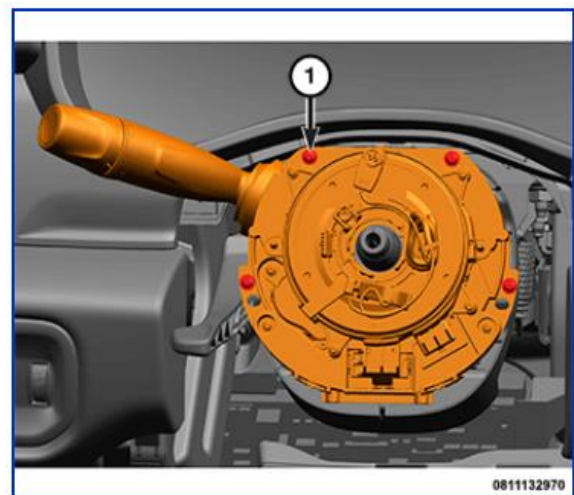
Figure 3 – SCCM Fasteners

1 - Fastener

1. Place the front wheels in the straight-ahead position and inhibit the steering column shaft from rotation.
2. Extend the steering column to the fully extended position and lower it to its lowest (down) position.
3. Disconnect and isolate the negative battery cable(s) (Refer to 08 - Electrical/Battery System/Standard Procedure).
4. Remove the steering wheel (Refer to 19 - Steering/Column/WHEEL, Steering/Removal and Installation).
5. Remove the outer shroud from the steering column (Refer to 19 - Steering/Column/SHROUD, Steering Column/Removal and Installation).
6. Remove the fasteners (1) from the SCCM (Figure 3).
7. Release the integral retainers for the inner shroud and push the inner shroud toward the instrument panel as far as it will go.

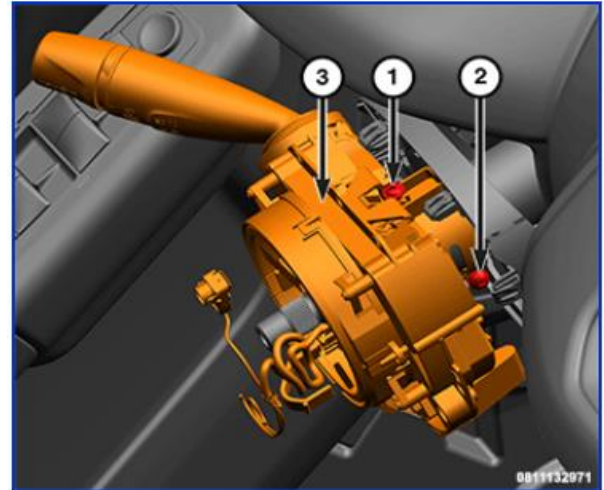
Figure 4 – SCCM Fasteners

- 1 - Attachment Fastener
- 2 - Clamp Fastener
- 3 - SCCM

8. Loosen the centering attachment fastener (1) on the top, rear of the SCCM. Do not remove the fastener completely (Figure 4).
9. Loosen the clamp fastener (2) to allow the SCCM to be removed. Do not remove the fastener completely (Figure 4).
10. Pull the SCCM (3) away from the steering column inner shroud far enough to disconnect the instrument panel wire harness connectors (Figure 4).
11. Remove the SCCM from the steering column.

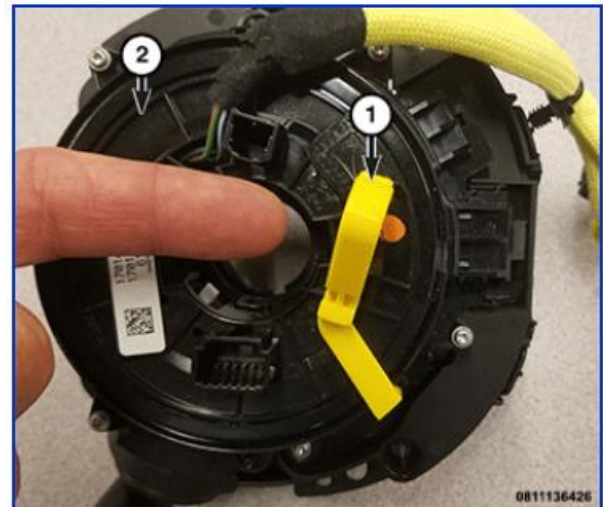
Figure 5 – SCCM

1 - Lock
2 - Clockspring Rotor

- A service replacement SCCM is shipped with the clockspring centered and with a molded plastic lock (1) installed. This lock should not be broken off until the SCCM has been installed on the steering column (Figure 5).
- Tighten the fasteners securely.
- Engage the integral inner shroud retainers with the SCCM. Be certain all integral inner shroud retainers are engaged with the SCCM.
- If a new SCCM is being installed, break off the plastic lock (1) that secures the clockspring rotor (2) to the SCCM housing to maintain clockspring centering (Figure 5).

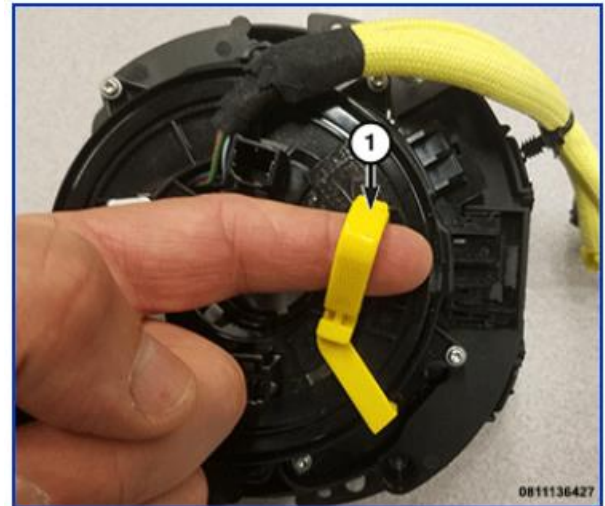
Figure 6 – SCCM Lock

1 - Lock

- Rotate the lock (1) towards the center of the SCCM to break it off in the SCCM housing (Figure 6).

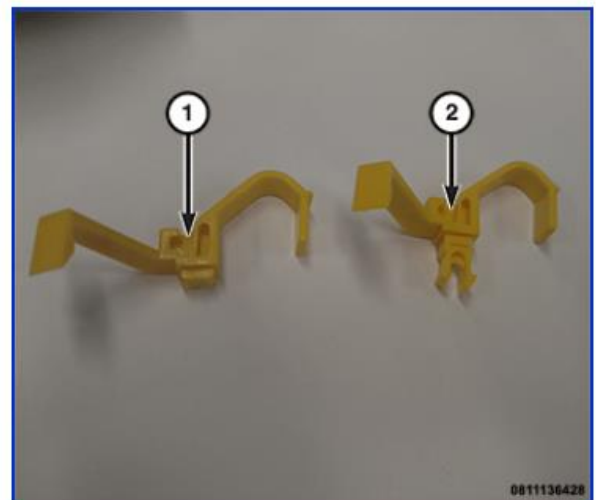
Figure 7 – SCCM Locks

1 - Lock Legs

2 - Original Lock

- When the lock has been broken off properly, both legs will be missing (1) when compared to the original lock (2) (Figure 7).
- Tighten the **NEW** steering wheel nut to 45 N·m (33 Ft. Lbs.).
- After installation of the air bag, but before reconnecting the battery negative cable, perform the Supplemental Restraint System Verification Test. See 10 - Restraints / Standard Procedure / Supplemental Restraint System Verification Test.
