## Noncompliance Turn Lights

Recall 189 – Remedy A

RECALL #189 NON-COMPLIANT LIGHTS, REMEDY A

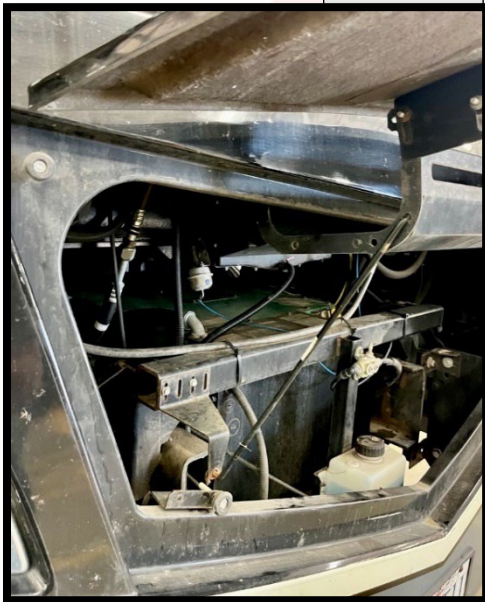
Figure 1

**Step 1** – Open the hood to gain access to the back side of the turn signals (See Figure 1). Some vehicle models may require access to the lights through under the front-end panel.

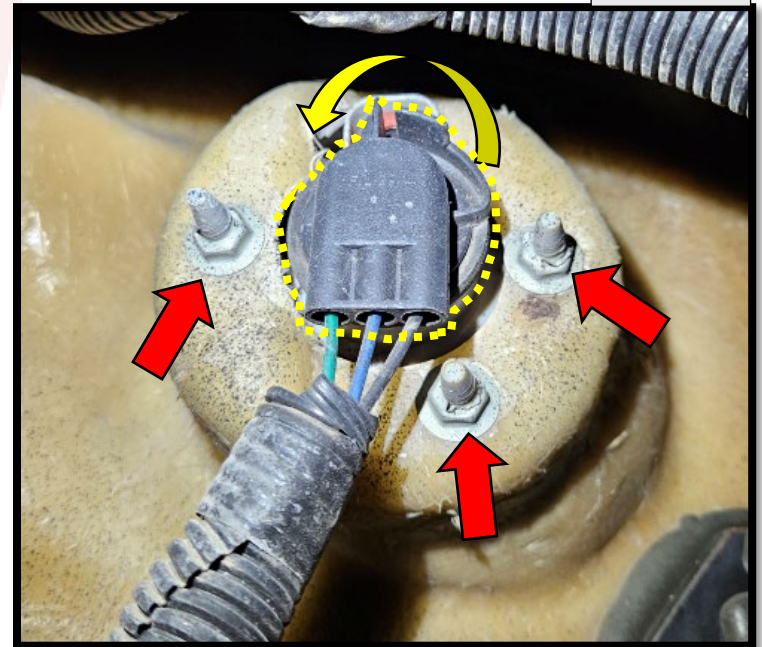
**Step 2** – Reach the back side of both turn signal lenses and rotate the turn signal bulb housings counterclockwise to detach them from the existing turn signal lenses. (See Figure 2 Yellow Arrow).

- There are 3 nuts that need to get removed on the back side of both lenses (6 total). (See Figure 2- Red Arrows)
- Remove and discard the existing turn signal lenses (one on each side).

**Step 3** – Use a 7/16" deep well socket and socket wrench to remove and discard the existing self-threading Pal nuts.
