SIB 34 07 24

2024-11-19

RECALL 24V-739: INTEGRATED BRAKE SYSTEM (IB)

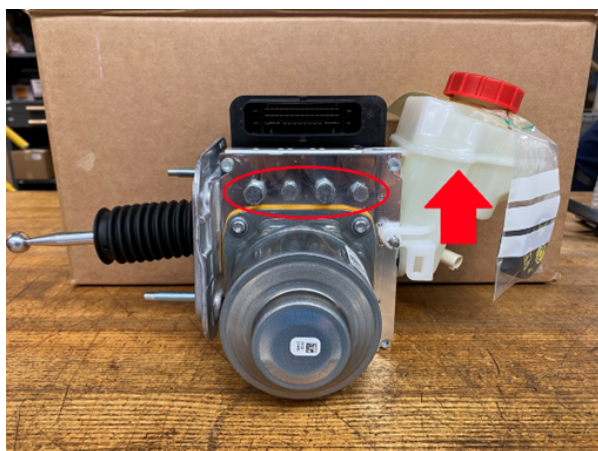
“Wet” IB pre-filled: Brake fluid reservoir is filled (arrow) and brake fluid line ports are plugged with bolts (circled).

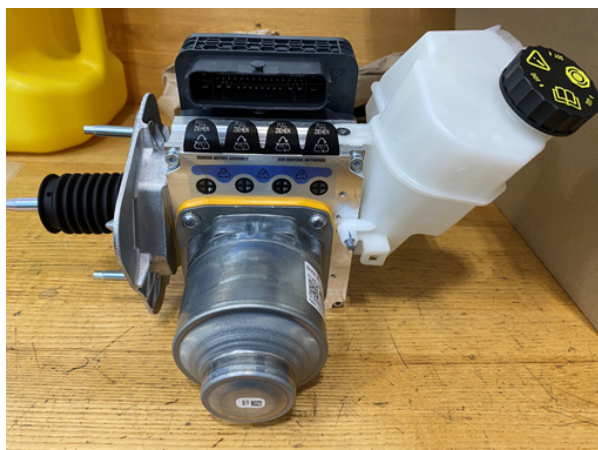
“Dry” IB unfilled: Brake fluid reservoir is empty; brake fluid line ports are sealed with labels.

Note: Additional work is necessary to install these “Dry” units. Refer to the Claim Information section.

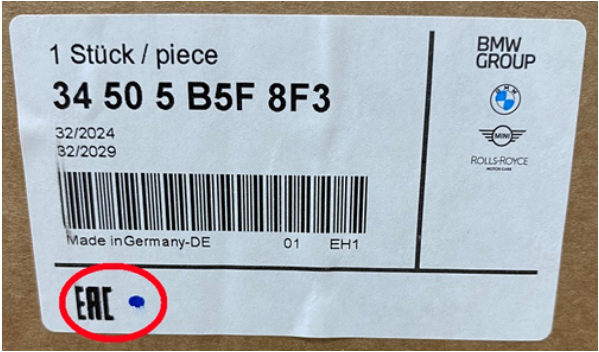
1. For “Wet” pre-filled part numbers listed above in blue. Verify the blue dot is located on the part number label as shown in the photo.

Note: Photo shown for location of blue dot on the parts label and does not indicate the part number for all models

3. Return the part if the Blue-Dot is not found on the label or unit

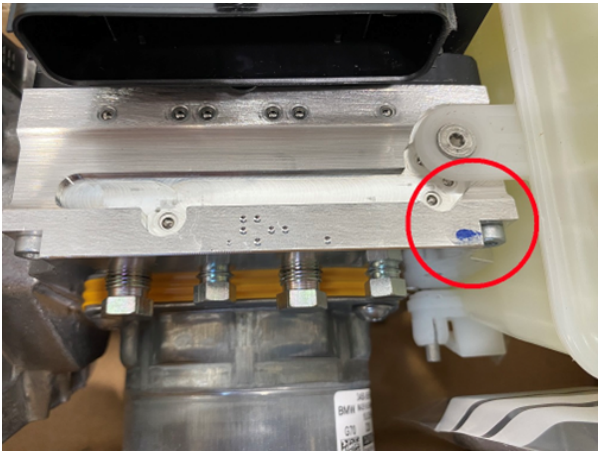
2. Verify the blue mark is located on the new component as shown in the photo.

Note: Some IB's may have an additional blue dot on the brake fluid reservoir. Disregard that blue dot. The only blue mark to be verified is shown here.
