SIB 34 07 24

RECALL 24V-739: INTEGRATED BRAKE SYSTEM (IB)

2026-05-06

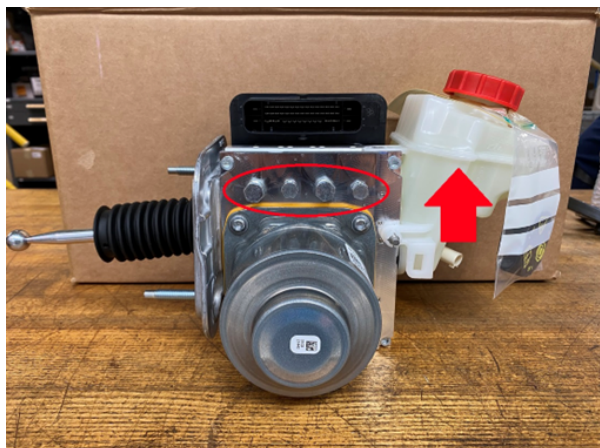
“Wet” IB pre-filled: Brake fluid reservoir is filled (arrow) and brake fluid line ports are plugged with bolts (circled).

Replace the IB with a “wet” pre-filled unit.

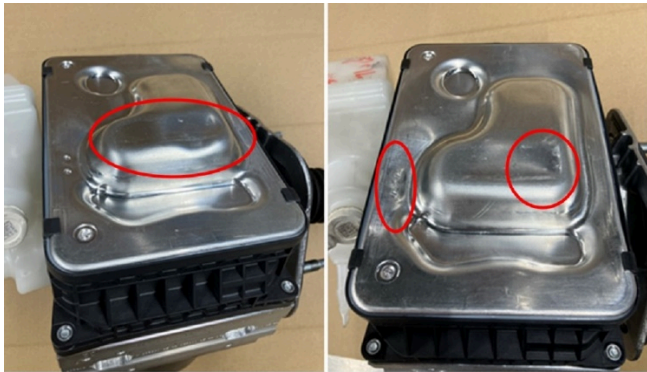
- Prior to installation, the Integrated Brake Modules should be inspected for damage upon arrival. Light scratches are acceptable, but if the aluminum cover is dented or bent, please send photos in a Recall IDS Ticket for review prior to entering a claim. If approved, please claim in accordance with the Dealer Services Return and Claims Manual-

Do not install any part which shows visual damage as shown or has been dropped from any height.

If you have received a “**dry**” unit, **do not install**, follow TEC848 Power Brake Return.
