SIB 34 07 24

2025-07-17

RECALL 24V-739: INTEGRATED BRAKE SYSTEM (IB)

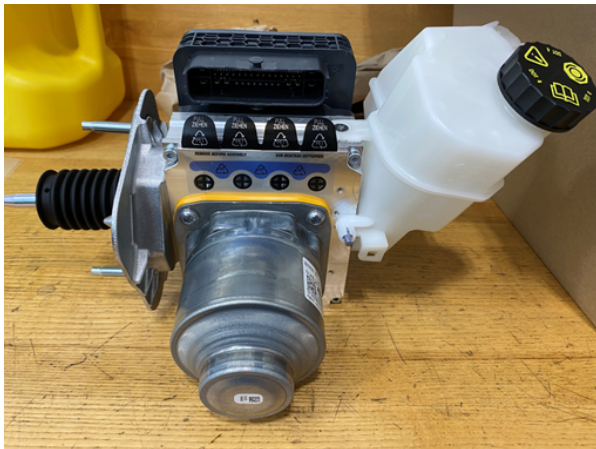
“Dry” IB unfilled: Brake fluid reservoir is empty; brake fluid line ports are sealed with labels.

Note: Additional work is necessary to install these “Dry” units. Refer to the Claim Information section.

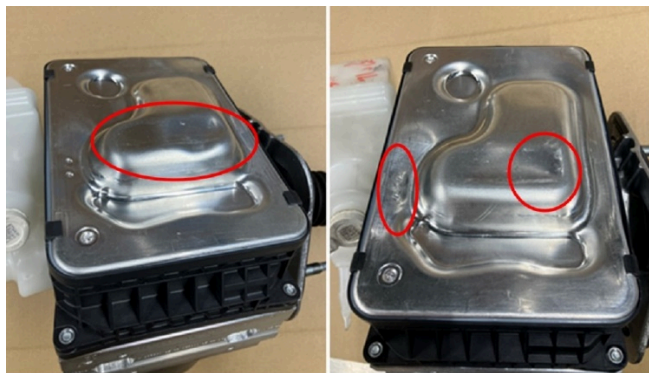
- Prior to installation, the Integrated Brake Modules should be inspected for damage upon arrival. Light scratches are acceptable, but if the aluminum cover is dented or bent, please send photos in a Recall IDS Ticket for review prior to entering a claim. If approved, please claim in accordance with the Dealer Services Return and Claims Manual.

Do not install any part which shows visual damage as shown, or has been dropped from any height.
