SIB 34 07 24

2025-03-04

**RECALL 24V-739: INTEGRATED BRAKE SYSTEM (IB)**

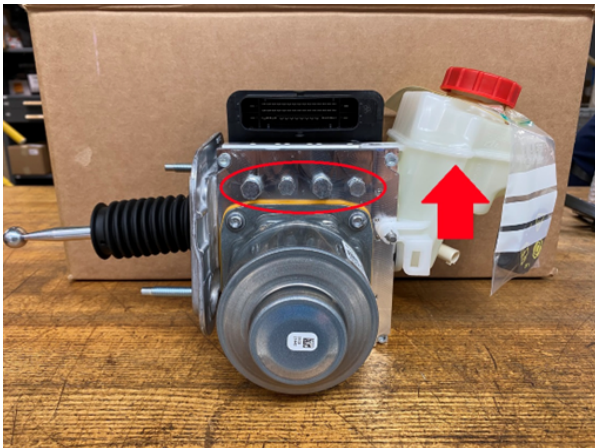
**“Wet” IB pre-filled:** Brake fluid reservoir is filled (arrow) and brake fluid line ports are plugged with bolts (circled).

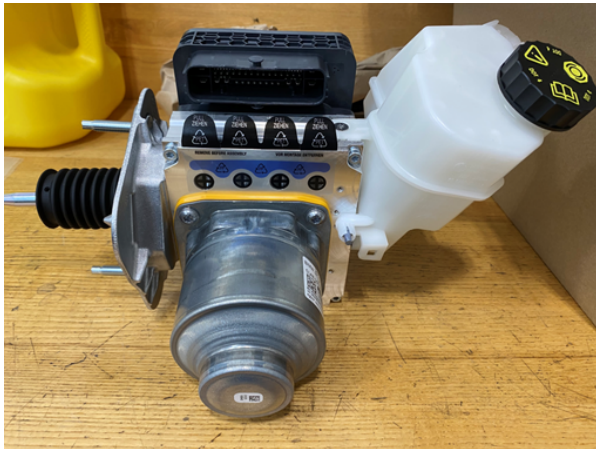
**“Dry” IB unfilled:** Brake fluid reservoir is empty; brake fluid line ports are sealed with labels.

**Note:** Additional work is necessary to install these “Dry” units. Refer to the Claim Information section.
