SIB 34 07 24

2025-05-09

RECALL 24V-739: INTEGRATED BRAKE SYSTEM (IB)

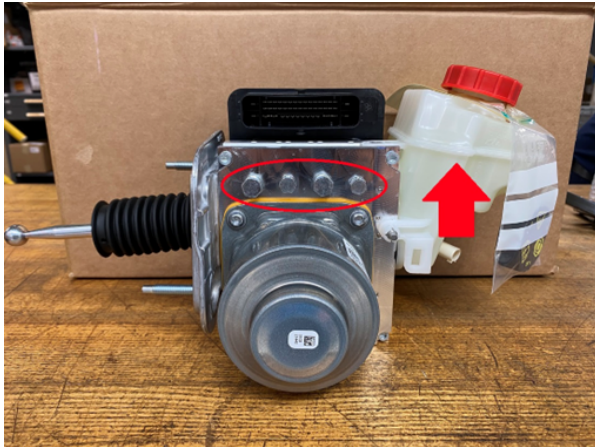
“Wet” IB pre-filled: Brake fluid reservoir is filled (arrow) and brake fluid line ports are plugged with bolts (circled).

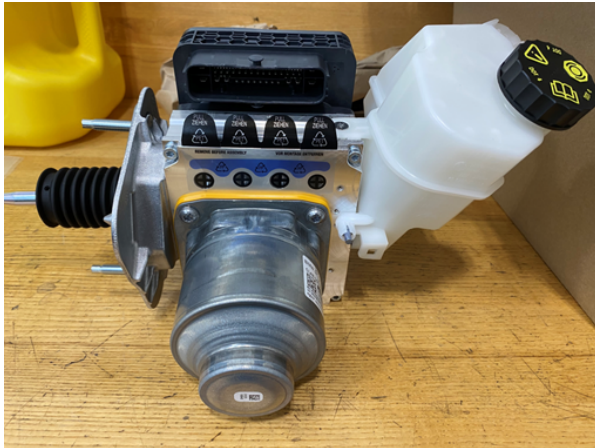
“Dry” IB unfilled: Brake fluid reservoir is empty; brake fluid line ports are sealed with labels.

Note: Additional work is necessary to install these “Dry” units. Refer to the Claim Information section.

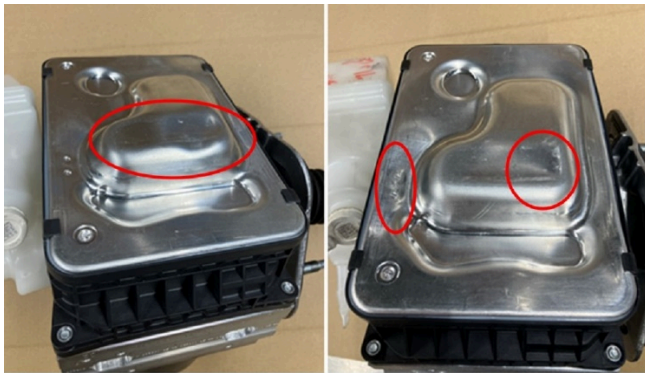
- Prior to installation, the Integrated Brake Modules should be inspected for damage upon arrival. Light scratches are acceptable, but if the aluminum cover is dented or bent, please send photos in a Recall IDS Ticket for review prior to entering a claim. If approved, please claim in accordance with the Dealer Services Return and Claims Manual.

Do not install any part which shows visual damage as shown, or has been dropped from any height.
