## SIB 34 07 24

### RECALL 24V-739: INTEGRATED BRAKE SYSTEM (IB)

2025-10-31

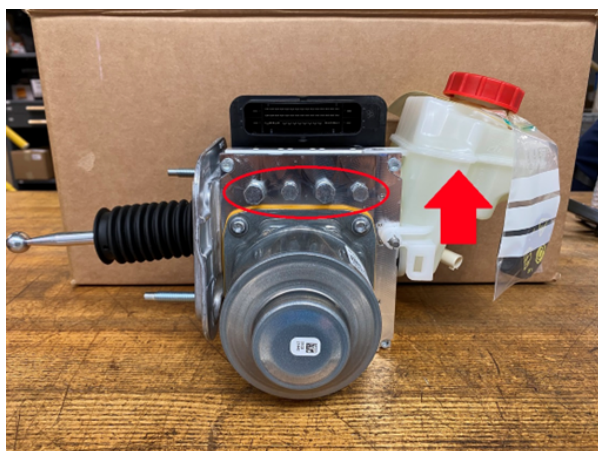
**“Wet” IB pre-filled:** Brake fluid reservoir is filled (arrow) and brake fluid line ports are plugged with bolts (circled).

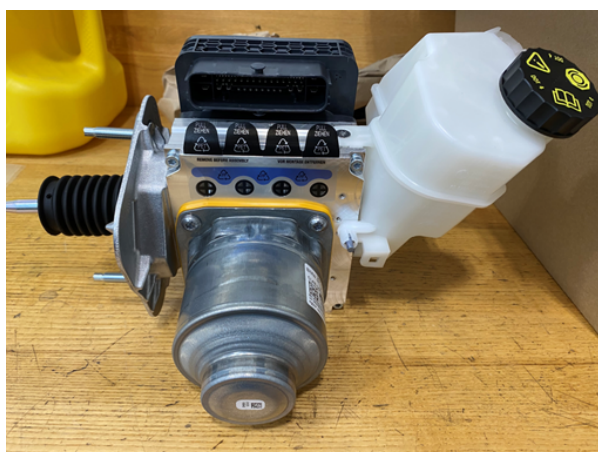
**“Dry” IB unfilled:** Brake fluid reservoir is empty; brake fluid line ports are sealed with labels.

**Note:** Additional work is necessary to install these “Dry” units. Refer to the Claim Information section.
