SIB 34 07 24

RECALL 24V-739: INTEGRATED BRAKE SYSTEM (IB)

This Service Information Bulletin (Revision 4) replaces SI B34 07 24 **dated March 2025**.

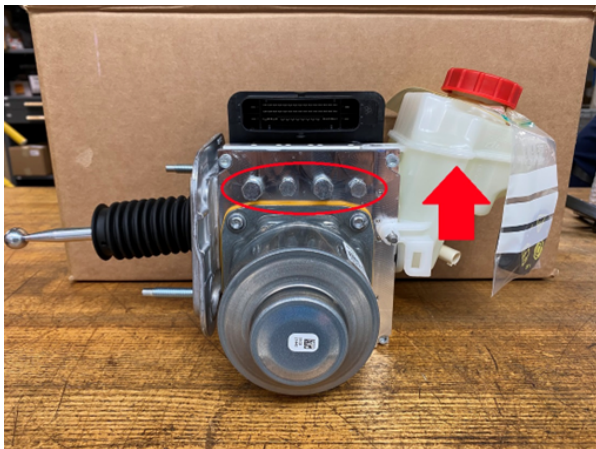
“Wet” IB pre-filled: Brake fluid reservoir is filled (arrow) and brake fluid line ports are plugged with bolts (circled).

If you have received a “**wet**” unit, follow the REP34 51 601 Replacing hydraulic unit

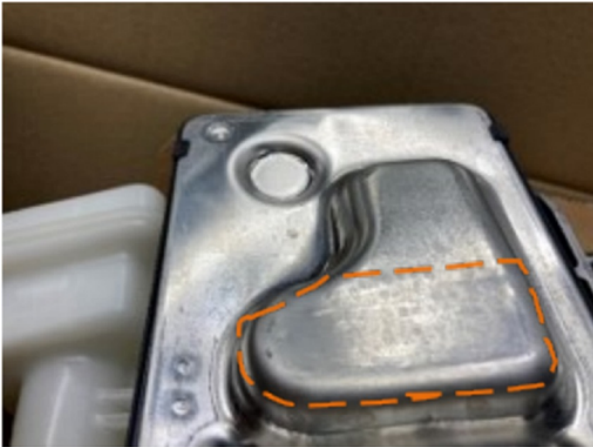
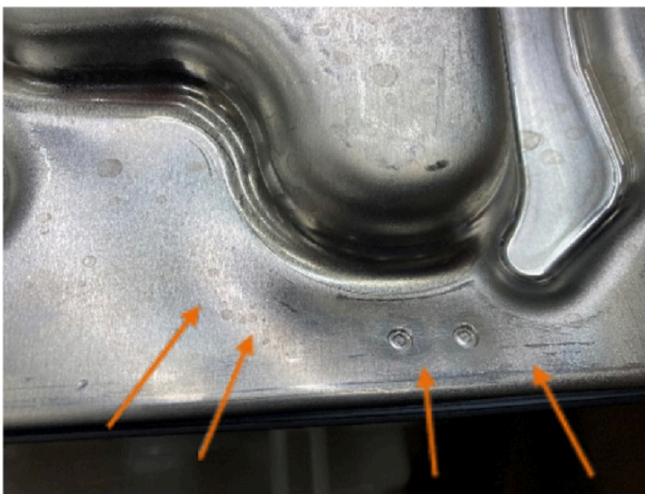
Do not install any part which shows visual damage as shown in these 2 photos, or has been dropped from any height.
