## IMPORTANT SAFETY RECALL

**NHTSA Safety Recall 24V-742**

**TO: Winnebago Motorhome Dealers**  
**SUBJECT: Campaign # 190 – Seat Belt Retractor**

# View/Navion Seat Belt Retractor Rework – Recall #190:

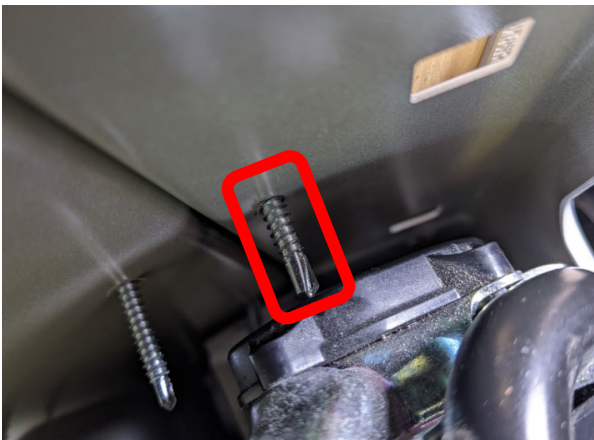
2. With the B Pillar cover now pulled away, Inspect the retractor. Ensure on the wingwall side that no screws have contacted the retractor. See Image 1 for an example of a screw impacting the retractor.
3. **If any screws tip has contacted the retractor, follow the rest of the rework instructions. Only rework the side of the coach that had a screw impact the retractor.**
4. **If no screws have contacted the retractor, then the unit does not need to be reworked.**
5. If the coach does not require rework, reinstall the B Pillar cover.
  - a. **Note:** When reinstalling the B Pillar cover, ensure that the tab on the B pillar cover is in alignment with the mating connection on the B pillar. See Image 2. Confirm alignment after reinstallation of the cover by actuating the seat belt height adjustment. See Image 3.
