Safety Recall

N242474500 Roof Rail Airbag Inflator May Rupture

Release Date: November 2024

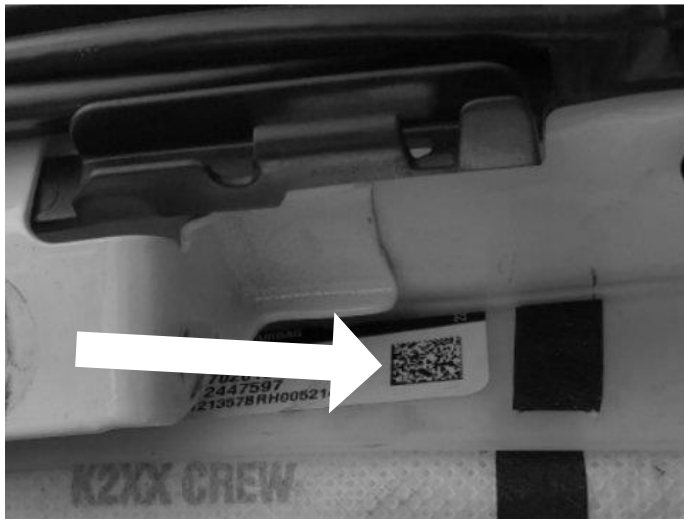
6058834

Record the serial number on each of the white airbag labels.

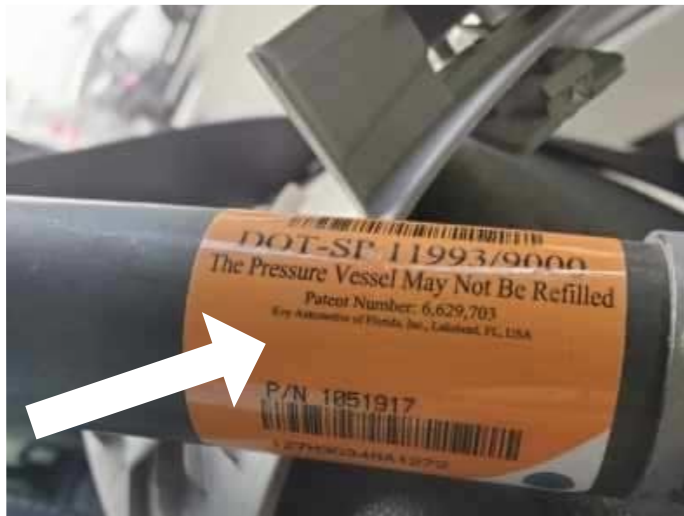
6058836

Do Not record the serial number (orange label) on the inflator.
