SIB 51 28 24

**RECALL 24V-764: REAR CARGO RAILS**

This Service Information Bulletin (Revision 1) replaces SI B51 28 24 **dated October 2024**.

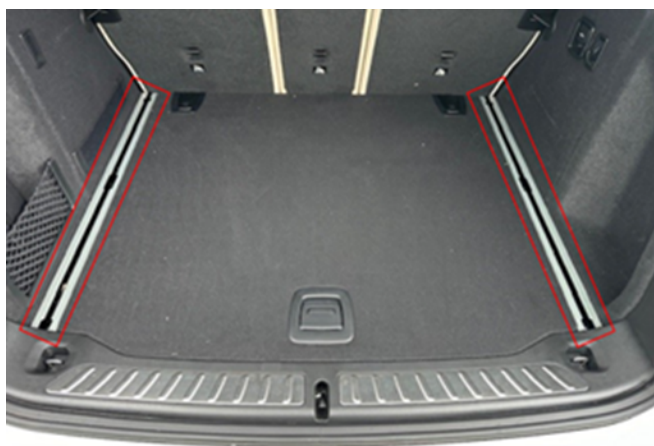
It was determined that the new bolts used in B51 17 24 Recall 24V-534: Rear Cargo Rails (0051960500), do not always provide a secure screw connection.

In an extreme rear crash, the attachment between the rear cargo rail (circled at left, new photo) and the vehicle body could become damaged. In a rare case, the rail could start to separate from the vehicle body, which could increase the risk of injury.
