P.O. Box 70
524 East Highway St.
Dodge Center, MN 55927

To: McNeilus Refuse Product Owner
Re: VSR-TSB-046 – Incorrectly Located License Plate Light/FMVSS 108
NHTSA Recall #24V-766

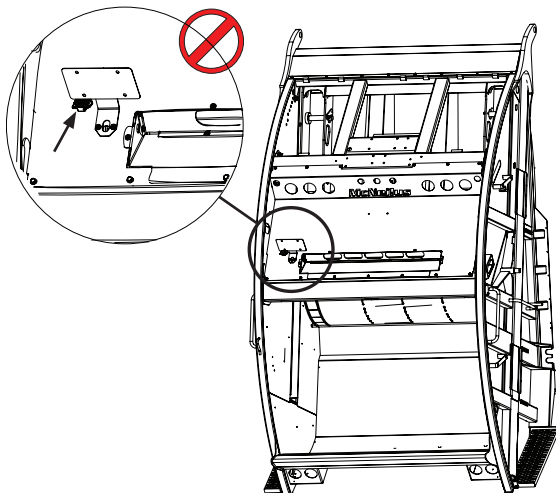
To be in compliance, the license plate light must illuminate the license plate from the top (FMVSS 108). This recall provides the instructions to relocate the light using a new bracket to mount the light above the license plate.

- If the license plate light is located on the bottom of the mount (Figure 1), it is noncompliant. Follow the instructions in this safety recall to relocate the light to the correct position.
- If the license plate light is located above the plate (Figure 2), it is in compliance.

Figure 1
Incorrect location

1. Perform your company’s Lockout/Tagout procedure. If your company does not have a Lockout/Tagout procedure, follow OSHA 1910.147 and 1910.146 Confined Space as appropriate.
2. Install the new bracket (Figure 3, Item 1) on the tailgate at the same holes as the old bracket.
3. Use the existing hardware from the old bracket (see note in Figure 3) and tighten.
4. Install the new loom clamp (PN 1243632) and route the harness through it. Secure using bolt (PN 1134366 HEX .25-20X.75) and nut (PN 1243909 lock nut .25-20). See Figure 3, Items 2, 3, and 4.
5. Install the existing gaskets on the new bracket (see note in Figure 3).
6. Route the existing harness through the hole and gaskets (back to front) of the new bracket.
7. Connect the existing harness connector to the existing light component (pin connector).

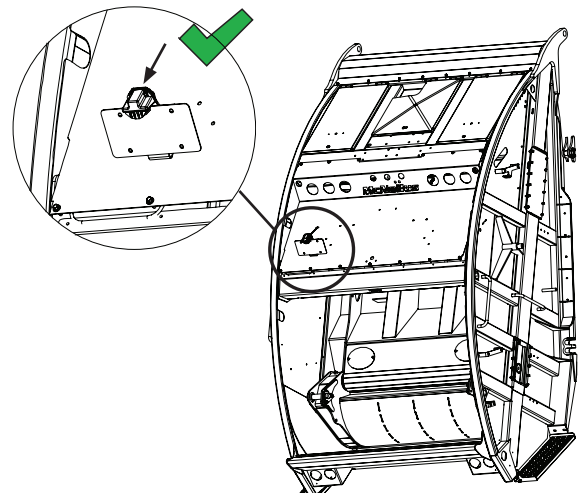
Figure 2
Correct location
