Mercedes-Benz

Campaign No. 2024100014, November 2024

SUBJECT: **Model GLB (247 platform)**
Model Year 2024

Check & Replace Right-Side Tires

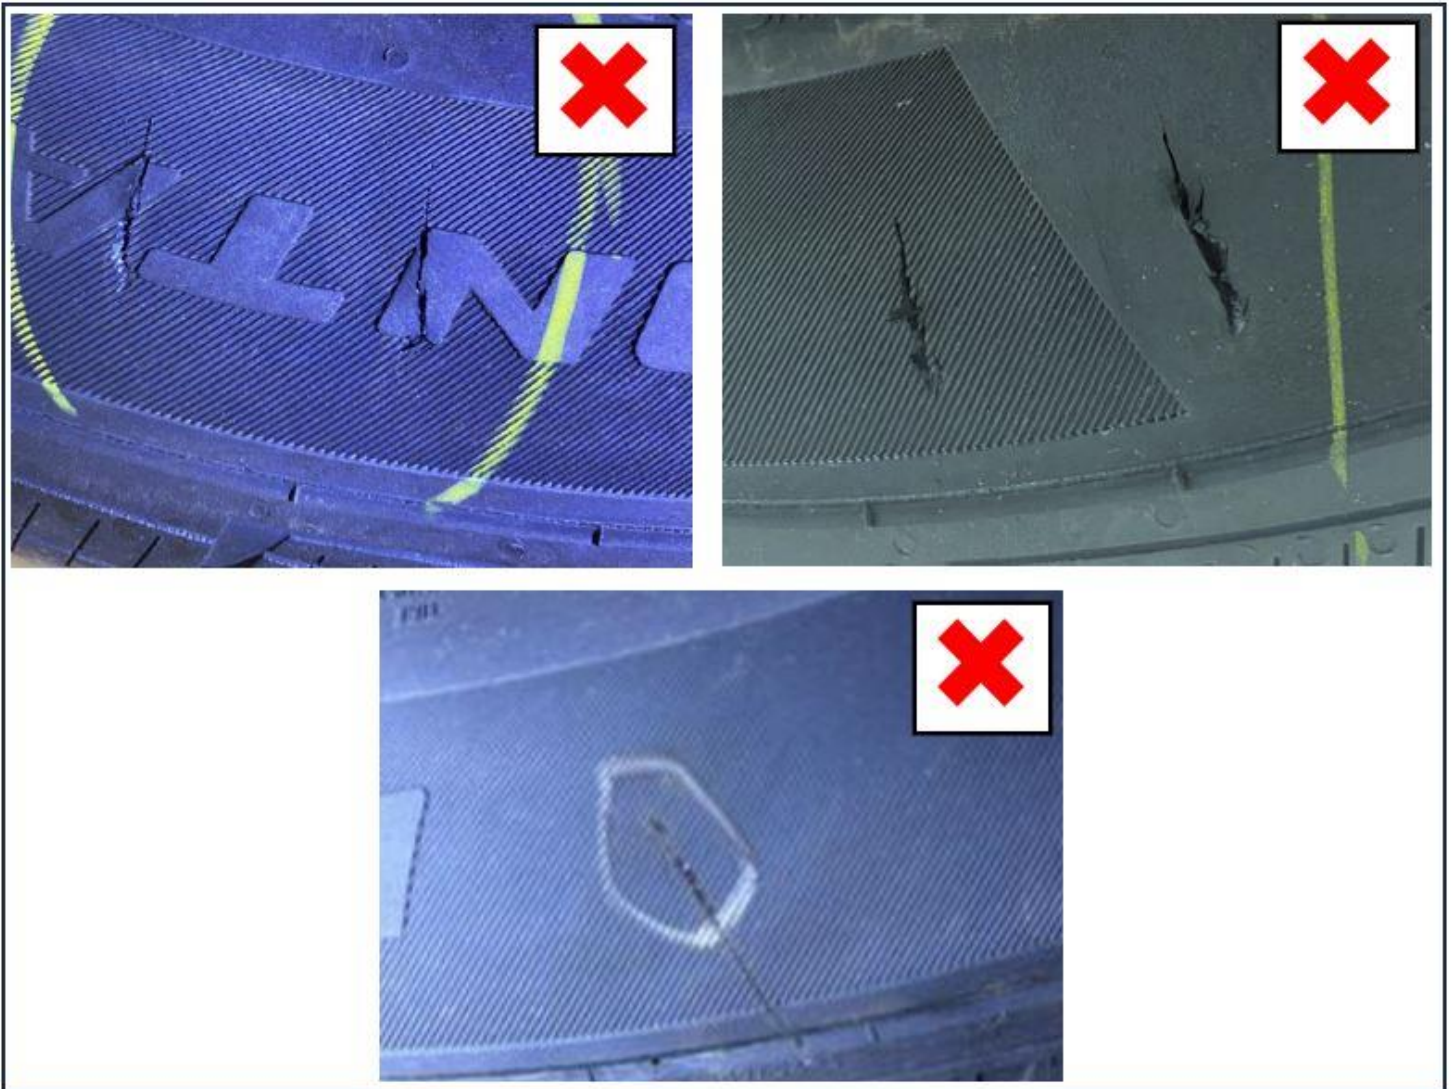
Figure 1: Damage to sidewall (tires must be replaced)

1. Check vehicle tires on passenger side (front and rear axle) for sidewall damage (vehicle-facing side).
 - a. If **damage or cuts** are present (**Figure 1**): **Carry out Work Procedure.**
 - b. If only **superficial marks or cuts** with a depth of **less than 1 mm** are present (**Figure 2**): **Do not replace tires; End measure.**

2. Replace tires that have damage on the sidewall (vehicle-facing side).

i Only replace damaged tires. However, **if the tread depth of a damaged tire is < 4 mm, then the opposite tire on the same axle must also be replaced.**

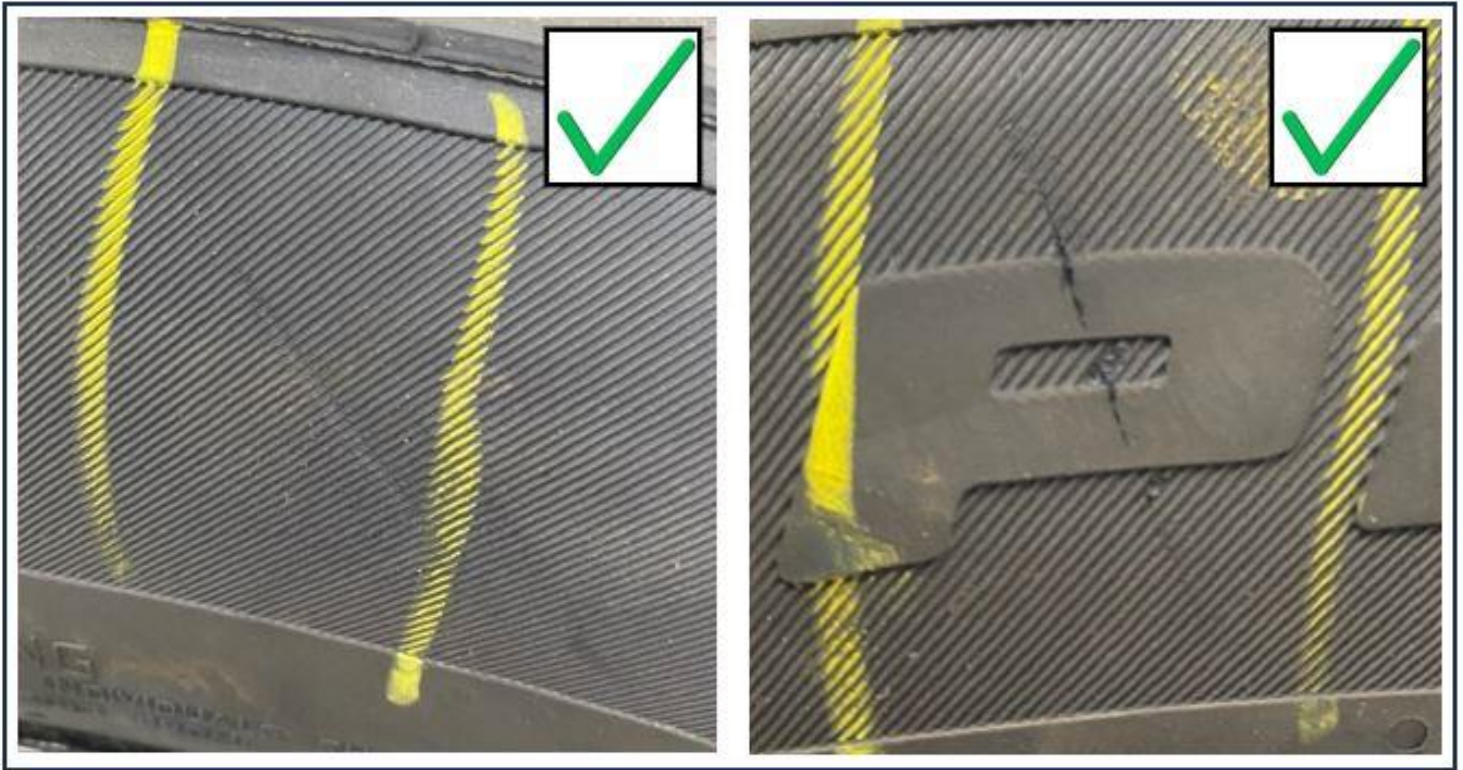
Figure 2: Superficial marks on sidewall with a depth of less than 1 mm (do not replace tires)
