SAFETY RECALL

Volvo Trucks North America

Release Date	Number	Release	Page
11.2024	RVXX2409	04	1(9)

**Bendix ABS ECU
VAH, VHD, VN, VNRE**

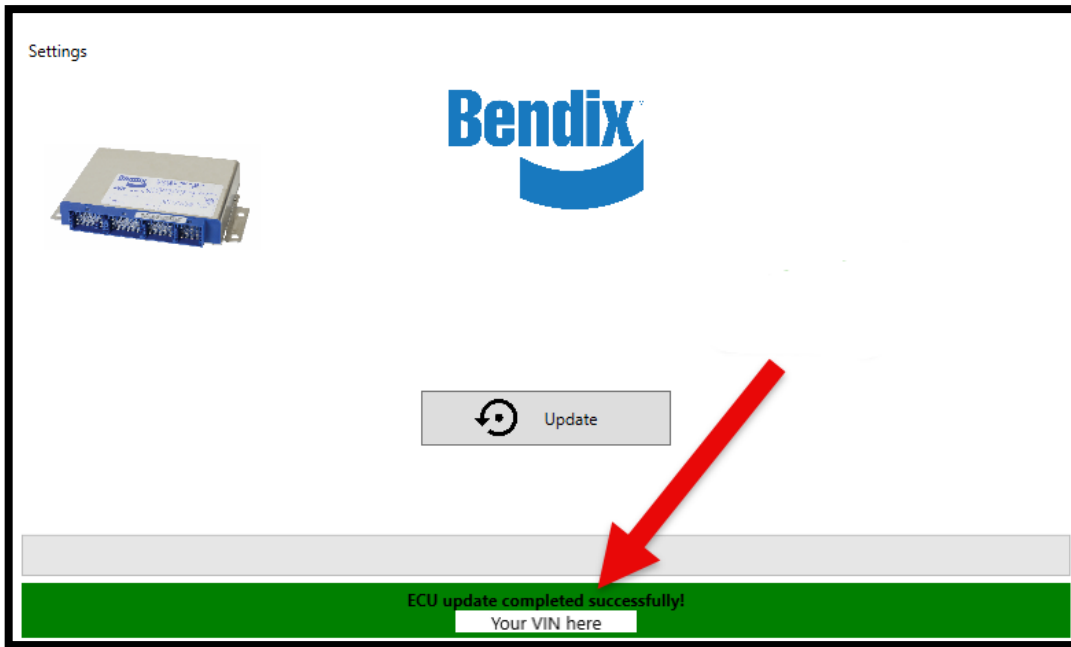
1. If the update is **successful**, the screen will show that the software has been updated and the procedure is complete.

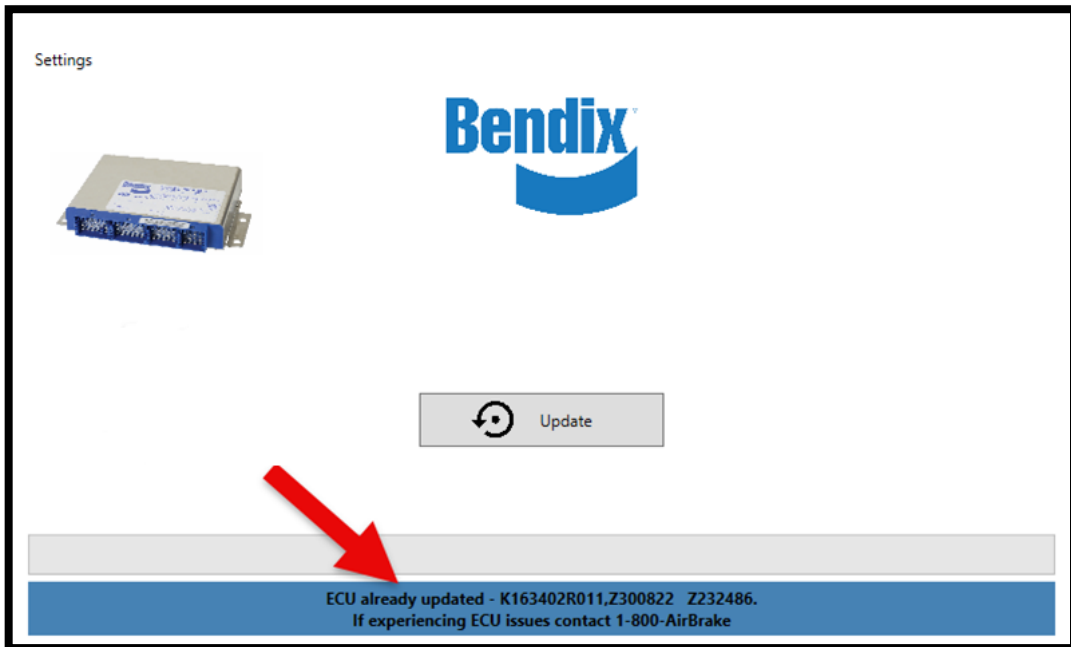
15. If the update has already been performed, no further action is required.

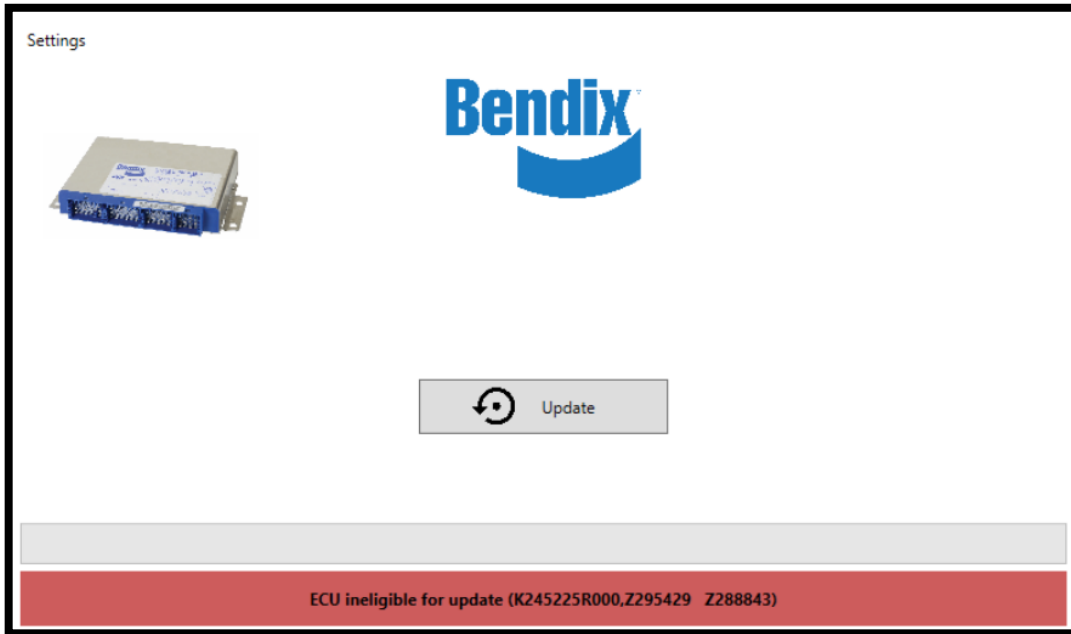
1. If the detected ECU is not eligible for an update, truck can be released for service.

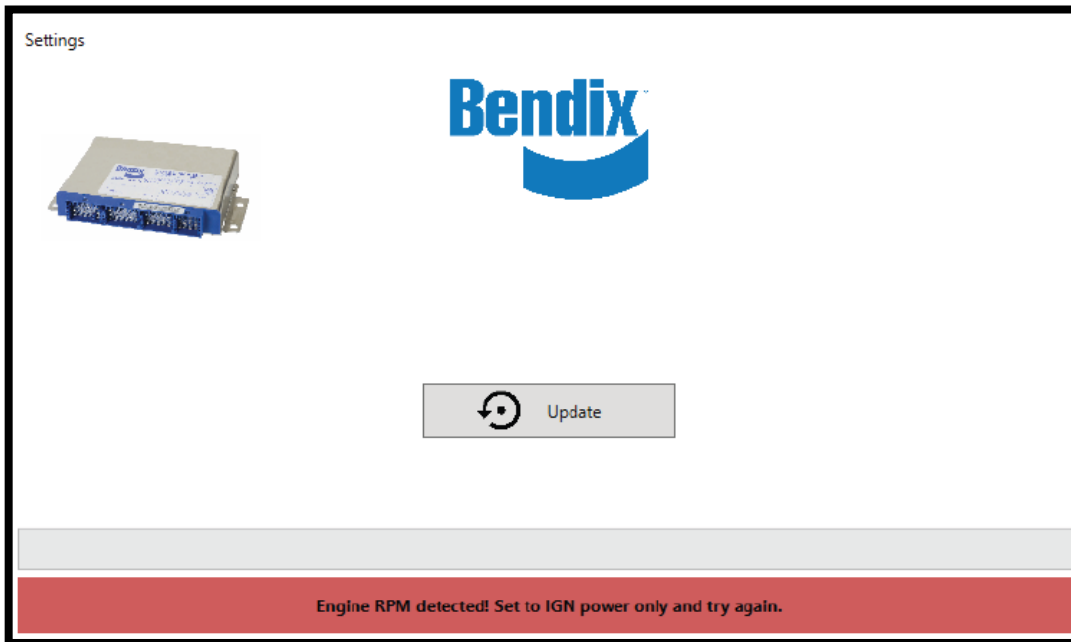
2. If engine RPM is detected during the procedure, power cycle to ignition only and restart the update procedure from Step 11.

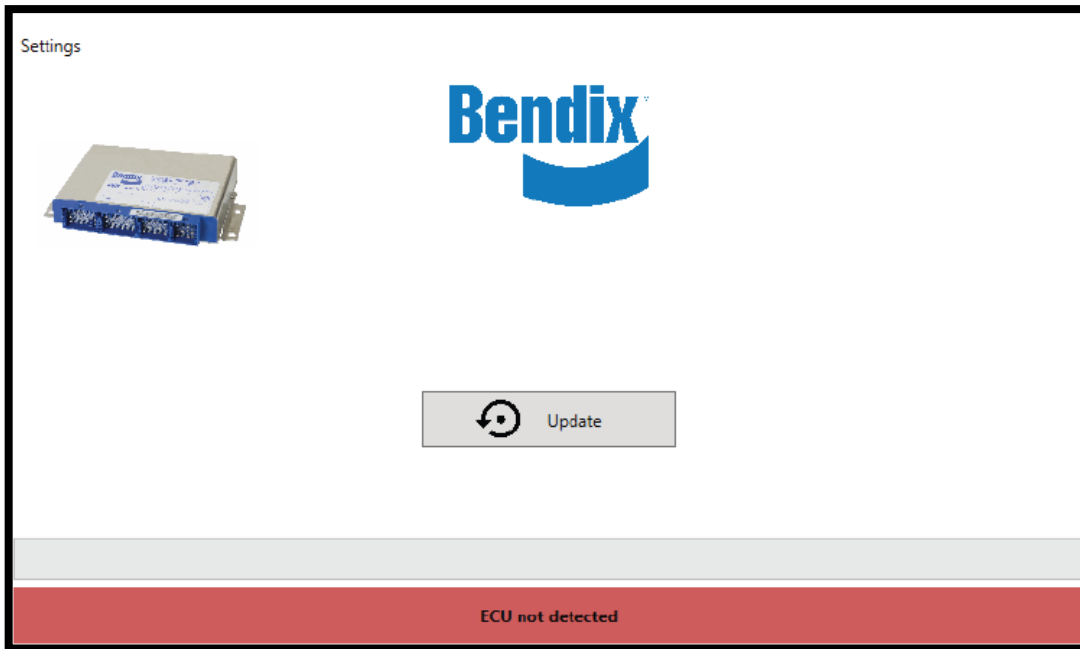
3. If the ECU is not detected, verify the ignition power is ON and/or ensure the correct channel is selected. Verify user is connected to the proper diagnostic connector. Then, restart the update procedure from step 11.
