# SAFETY RECALL

Volvo Trucks North America

| Release Date | Number | Release | Page |
|---|---|---|---|
| 11.2024 | RVXX2409 | 05 | 1(9) |

**Bendix ABS ECU  
VAH, VHD, VN, VNRE**

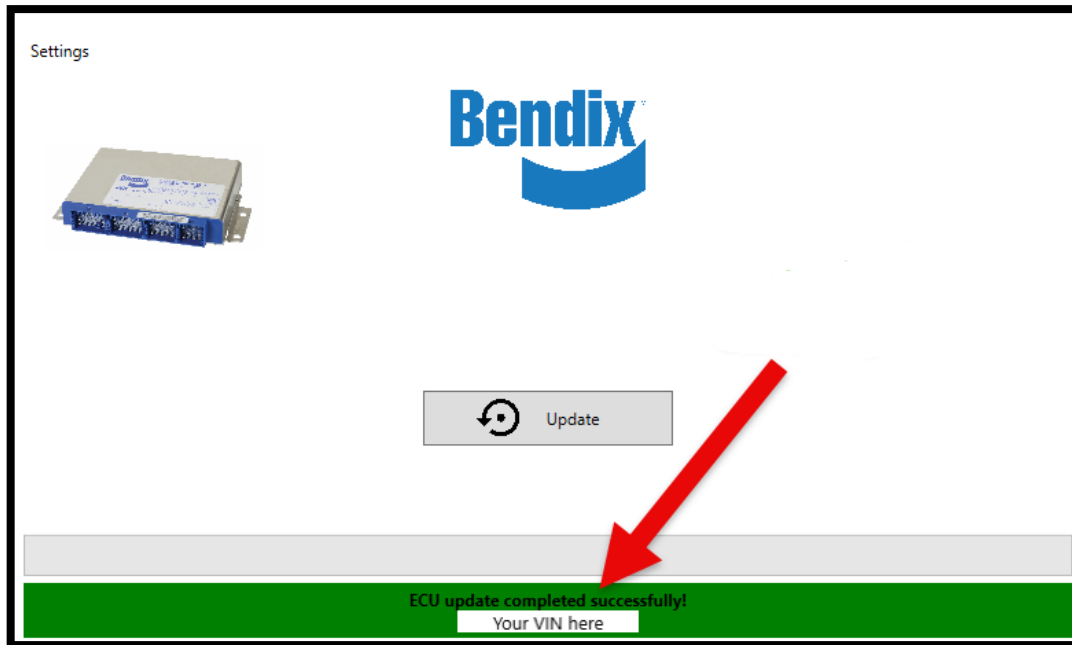
1. If the update is **successful**, the screen will show that the software has been updated and the procedure is complete.

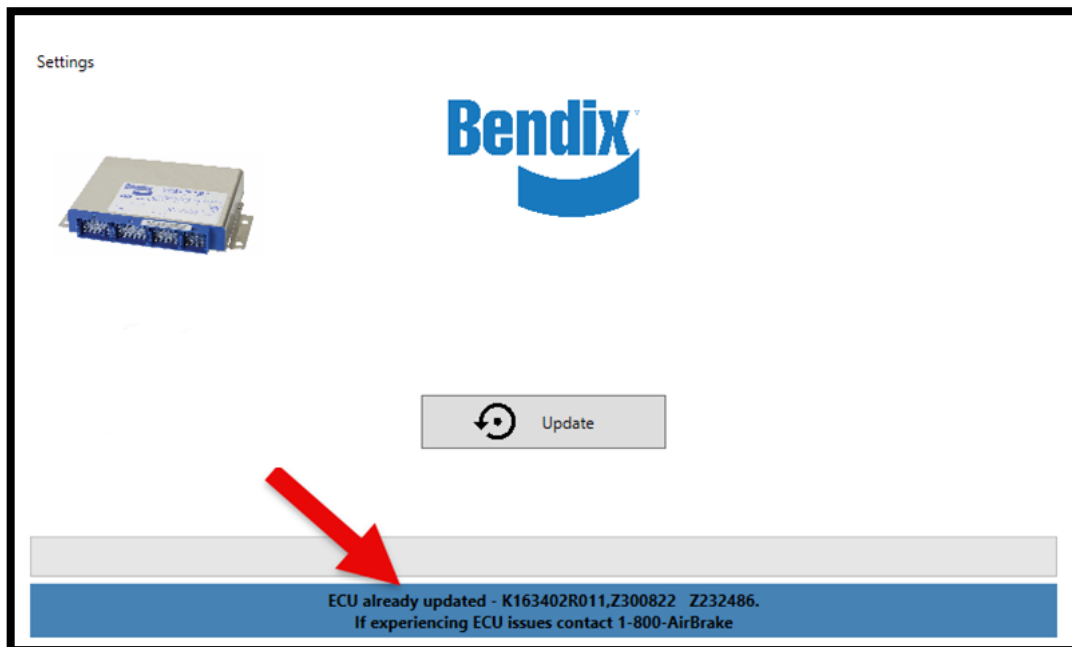
15. If the update has already been performed, no further action is required.

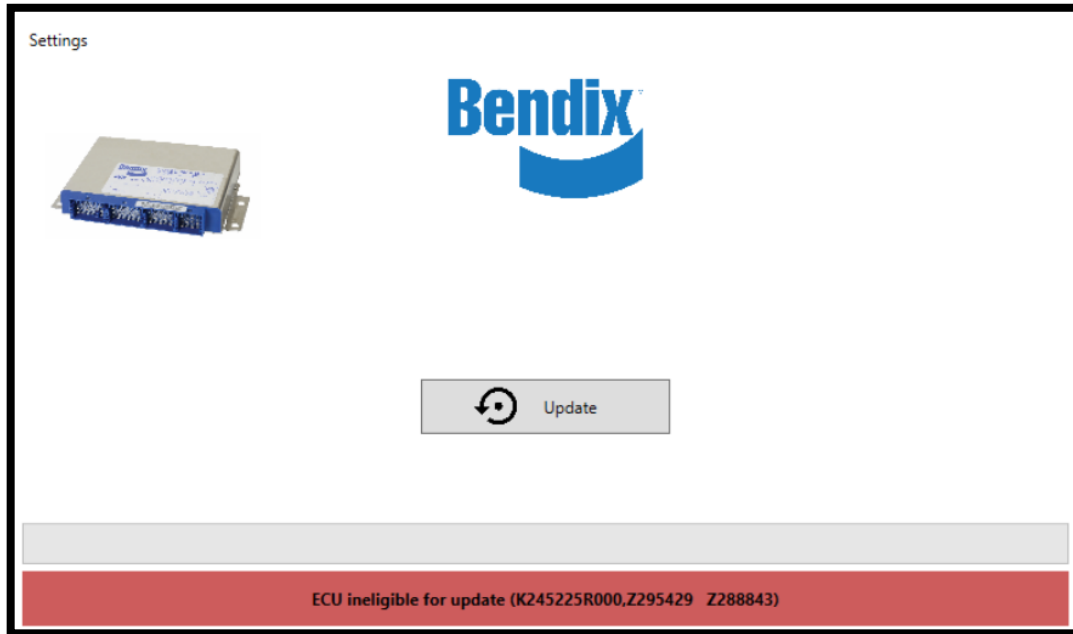
1. If the detected ECU is not eligible for an update, truck can be released for service.

16. If the update ***fails or ends in an errored state (examples of errors below)***, the screen will show the software was not able to update. Power cycle the vehicle and restart the update procedure from Step 11.
